City of Gardena

SEWER MASTER PLAN

FINAL | September 2023

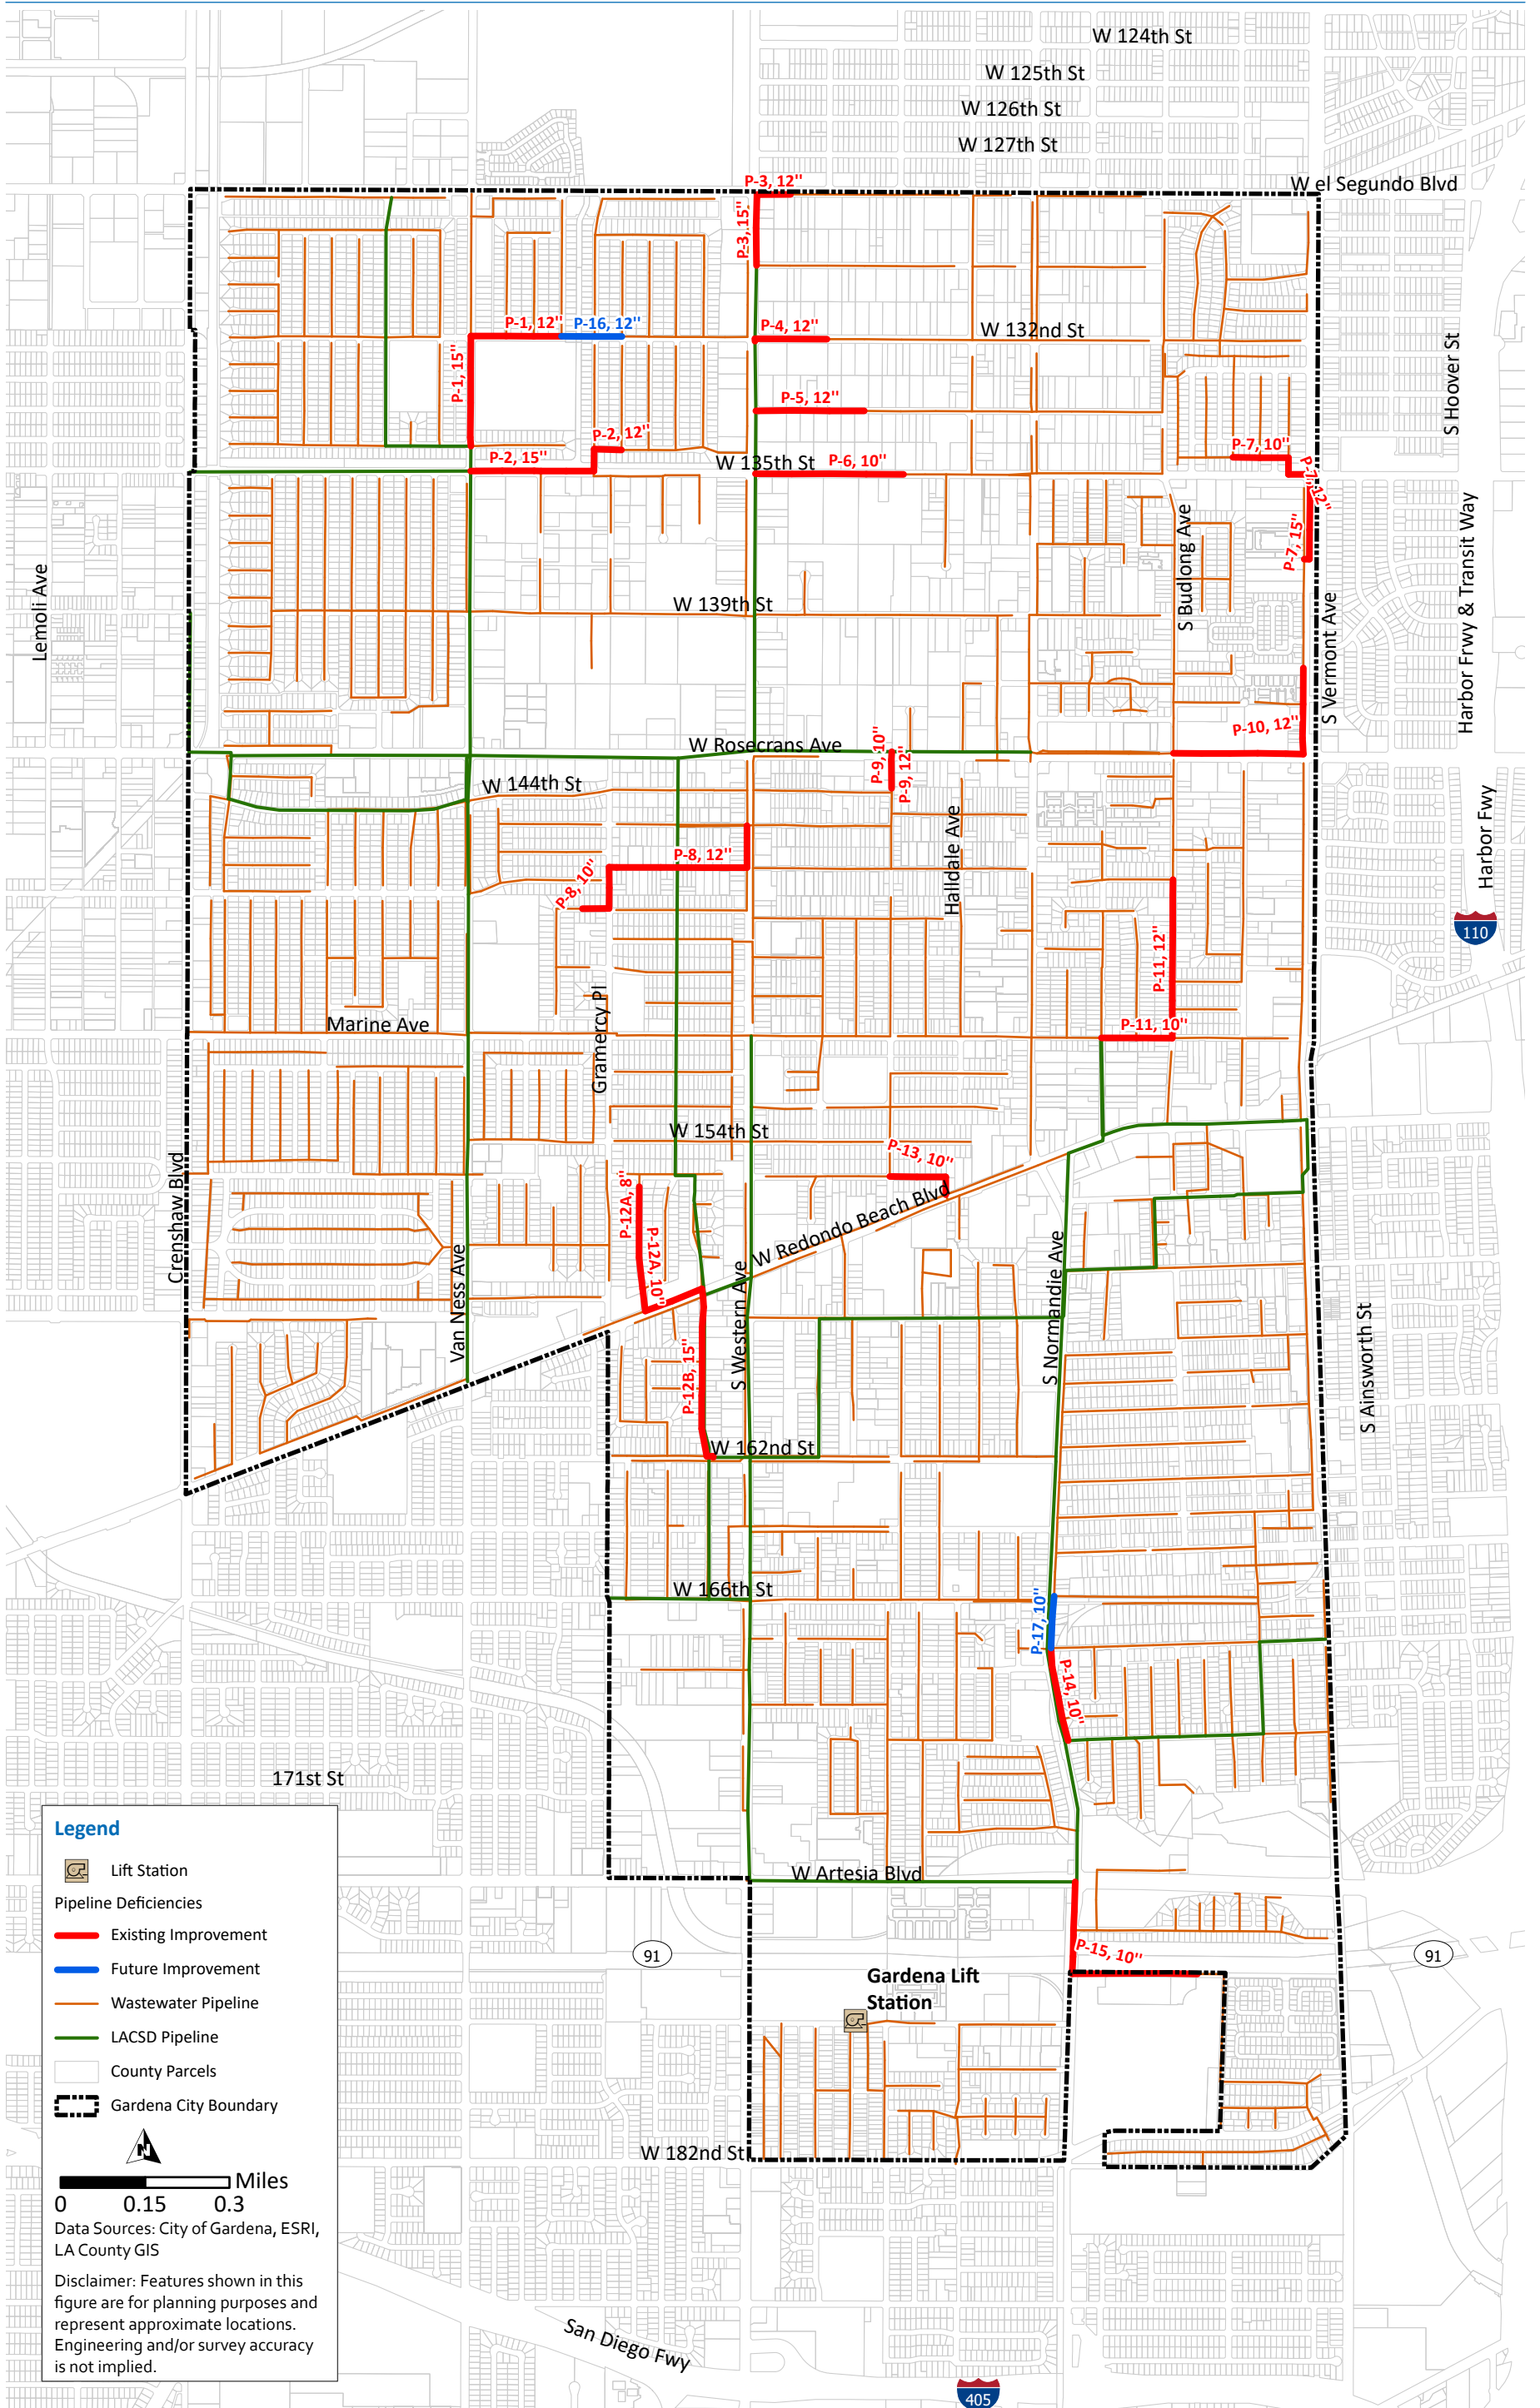
Figure ES.2 Recommended Improvements

Following the completion of the existing system analysis, 15 improvement projects were identified to mitigate existing system pipeline capacity deficiencies. The future system evaluation only identified two additional capacity deficiencies. The proposed capacity improvements are illustrated on Figure ES.2.

For the purposes of this study, it was assumed that a capacity deficiency sewer would be upgraded to a larger diameter, rather than combined with a new parallel sewer. The proposed improvements were sized for future 2045 conditions. The specific outlined improvements are detailed in Chapter 6. All improvements are based on maintaining the maximum flow depth criteria stated in Chapter 3.

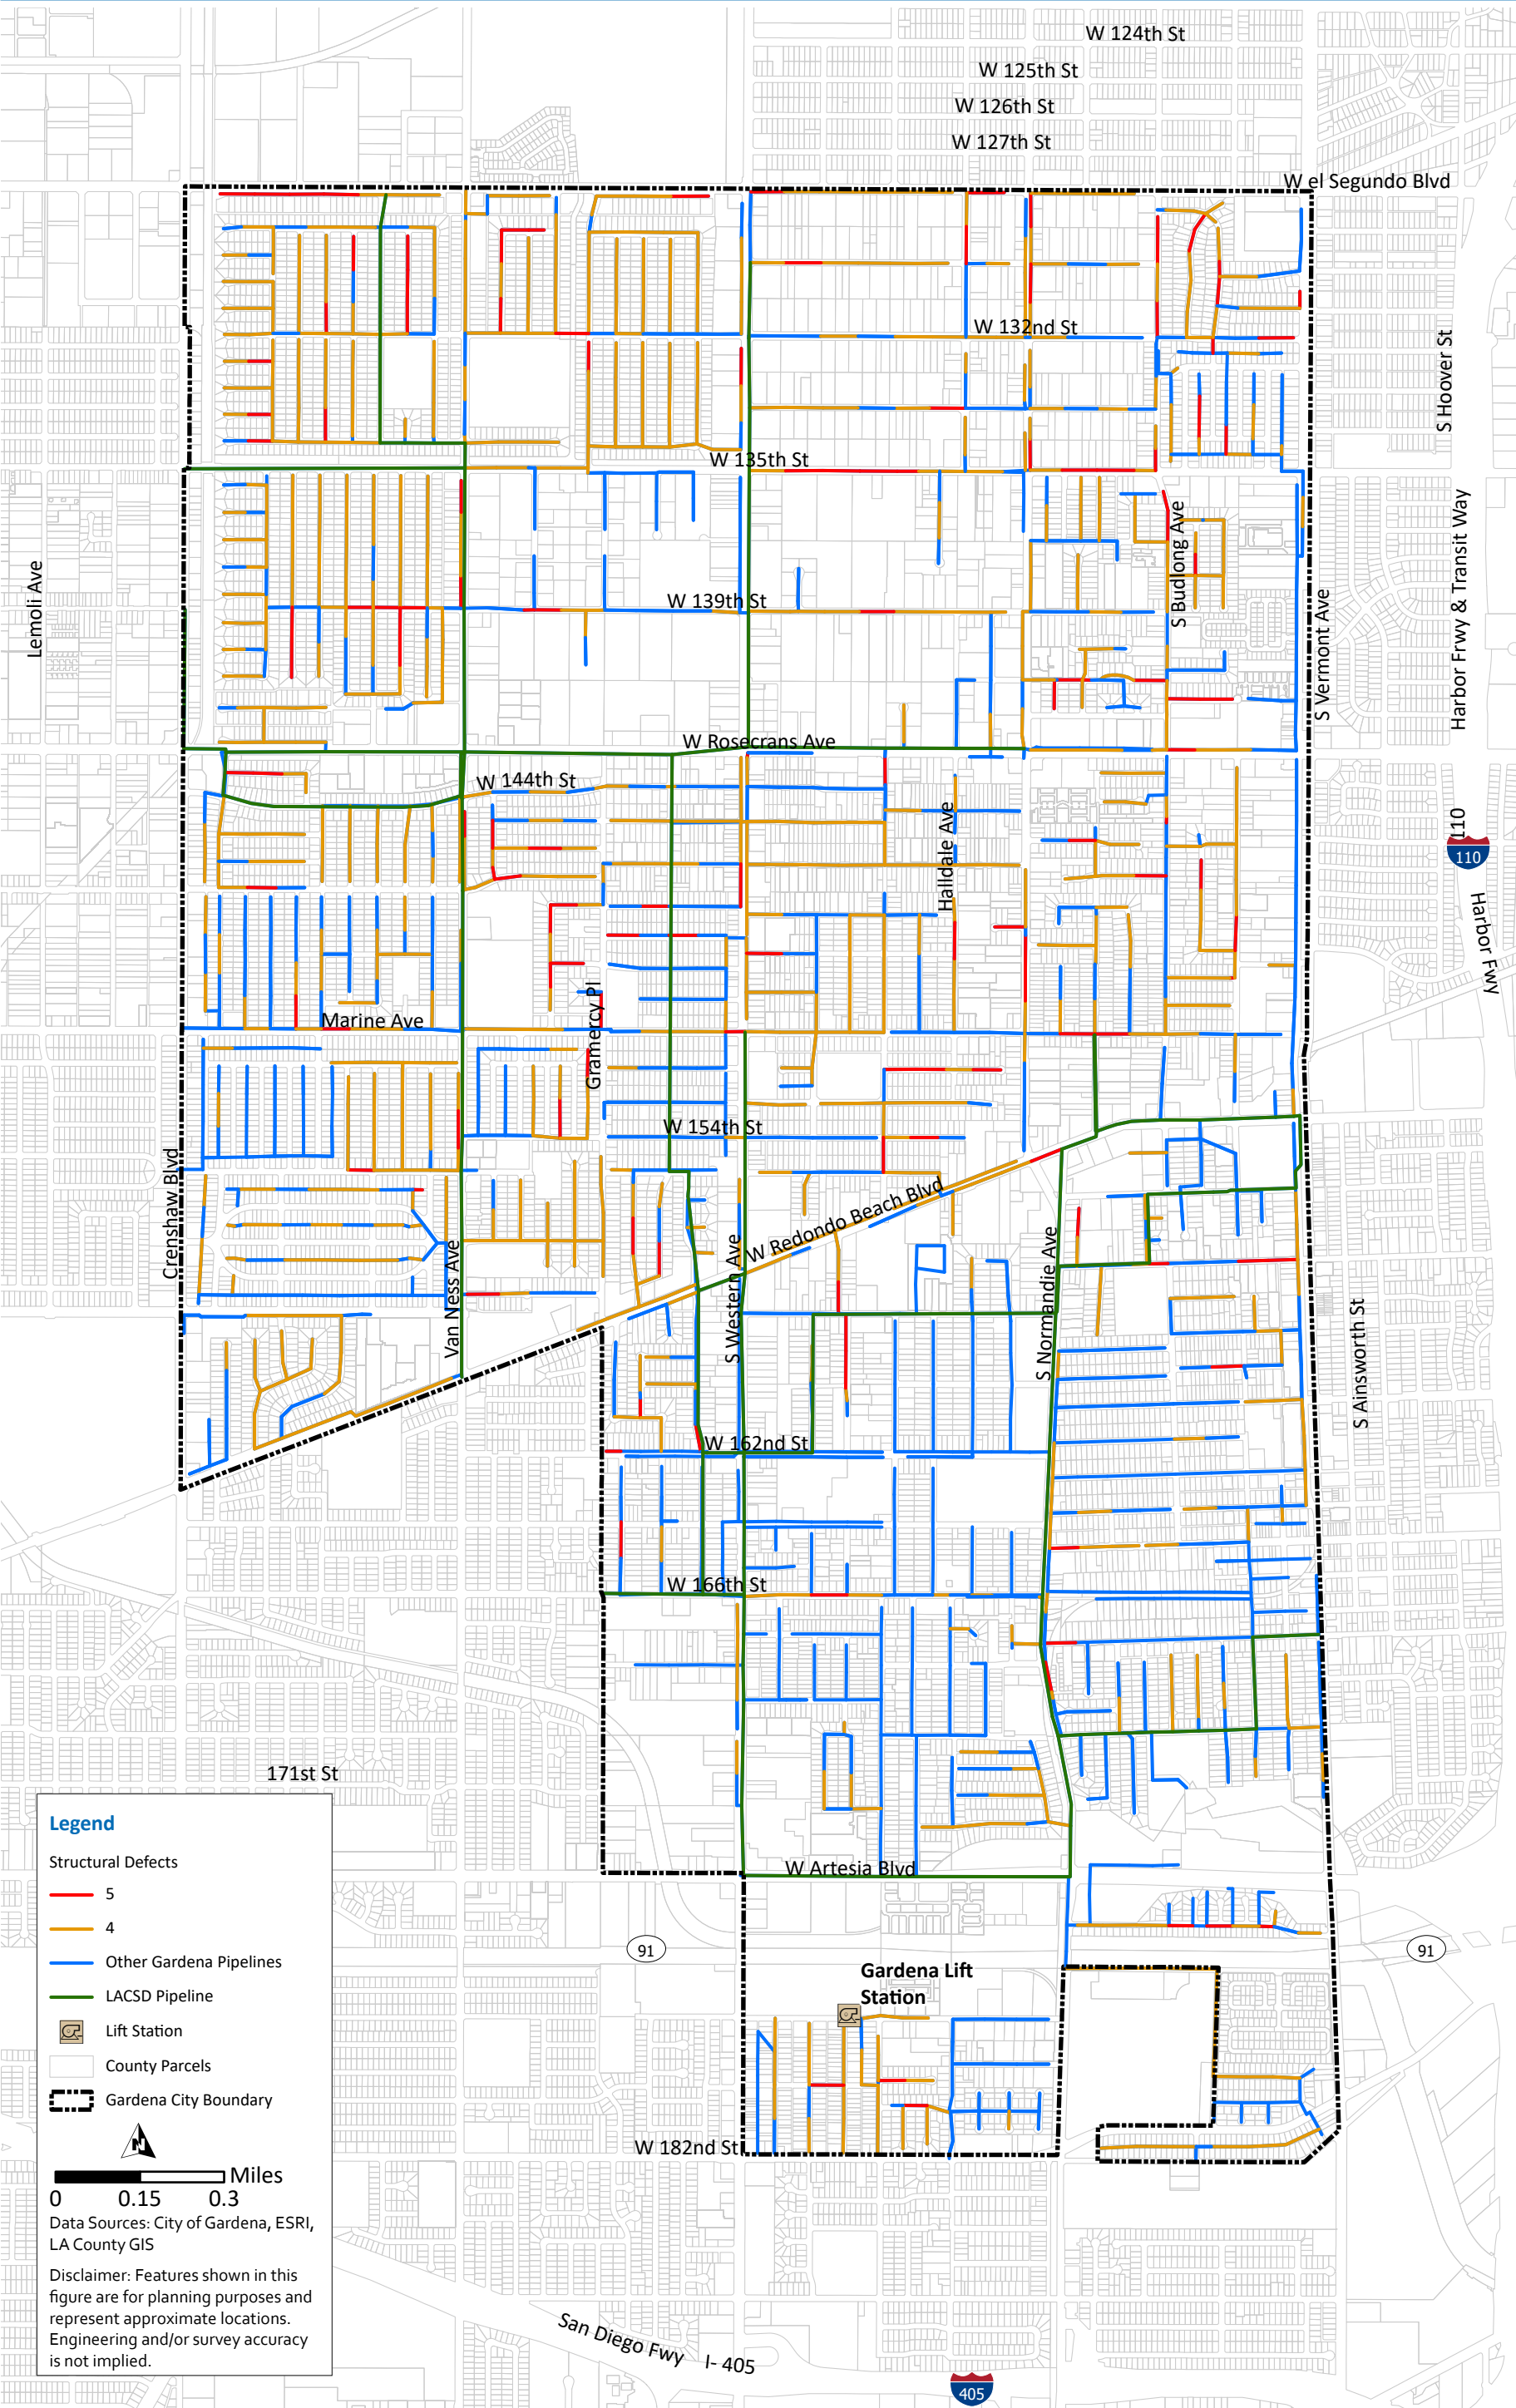
Figure 7.3 Structural Defects

- 141 reaches had one or more structural defects with a Condition Grade of 5.
- 791 reaches had one or more structural defects with a Condition Grade of 4.
- 7 reaches had O&M defects with a Condition Grade of 4.
- 76 reaches had O&M defects with a Condition Grade of 5.
- 58 reaches had Condition Grades 4 or 5 for both structural and O&M defects.

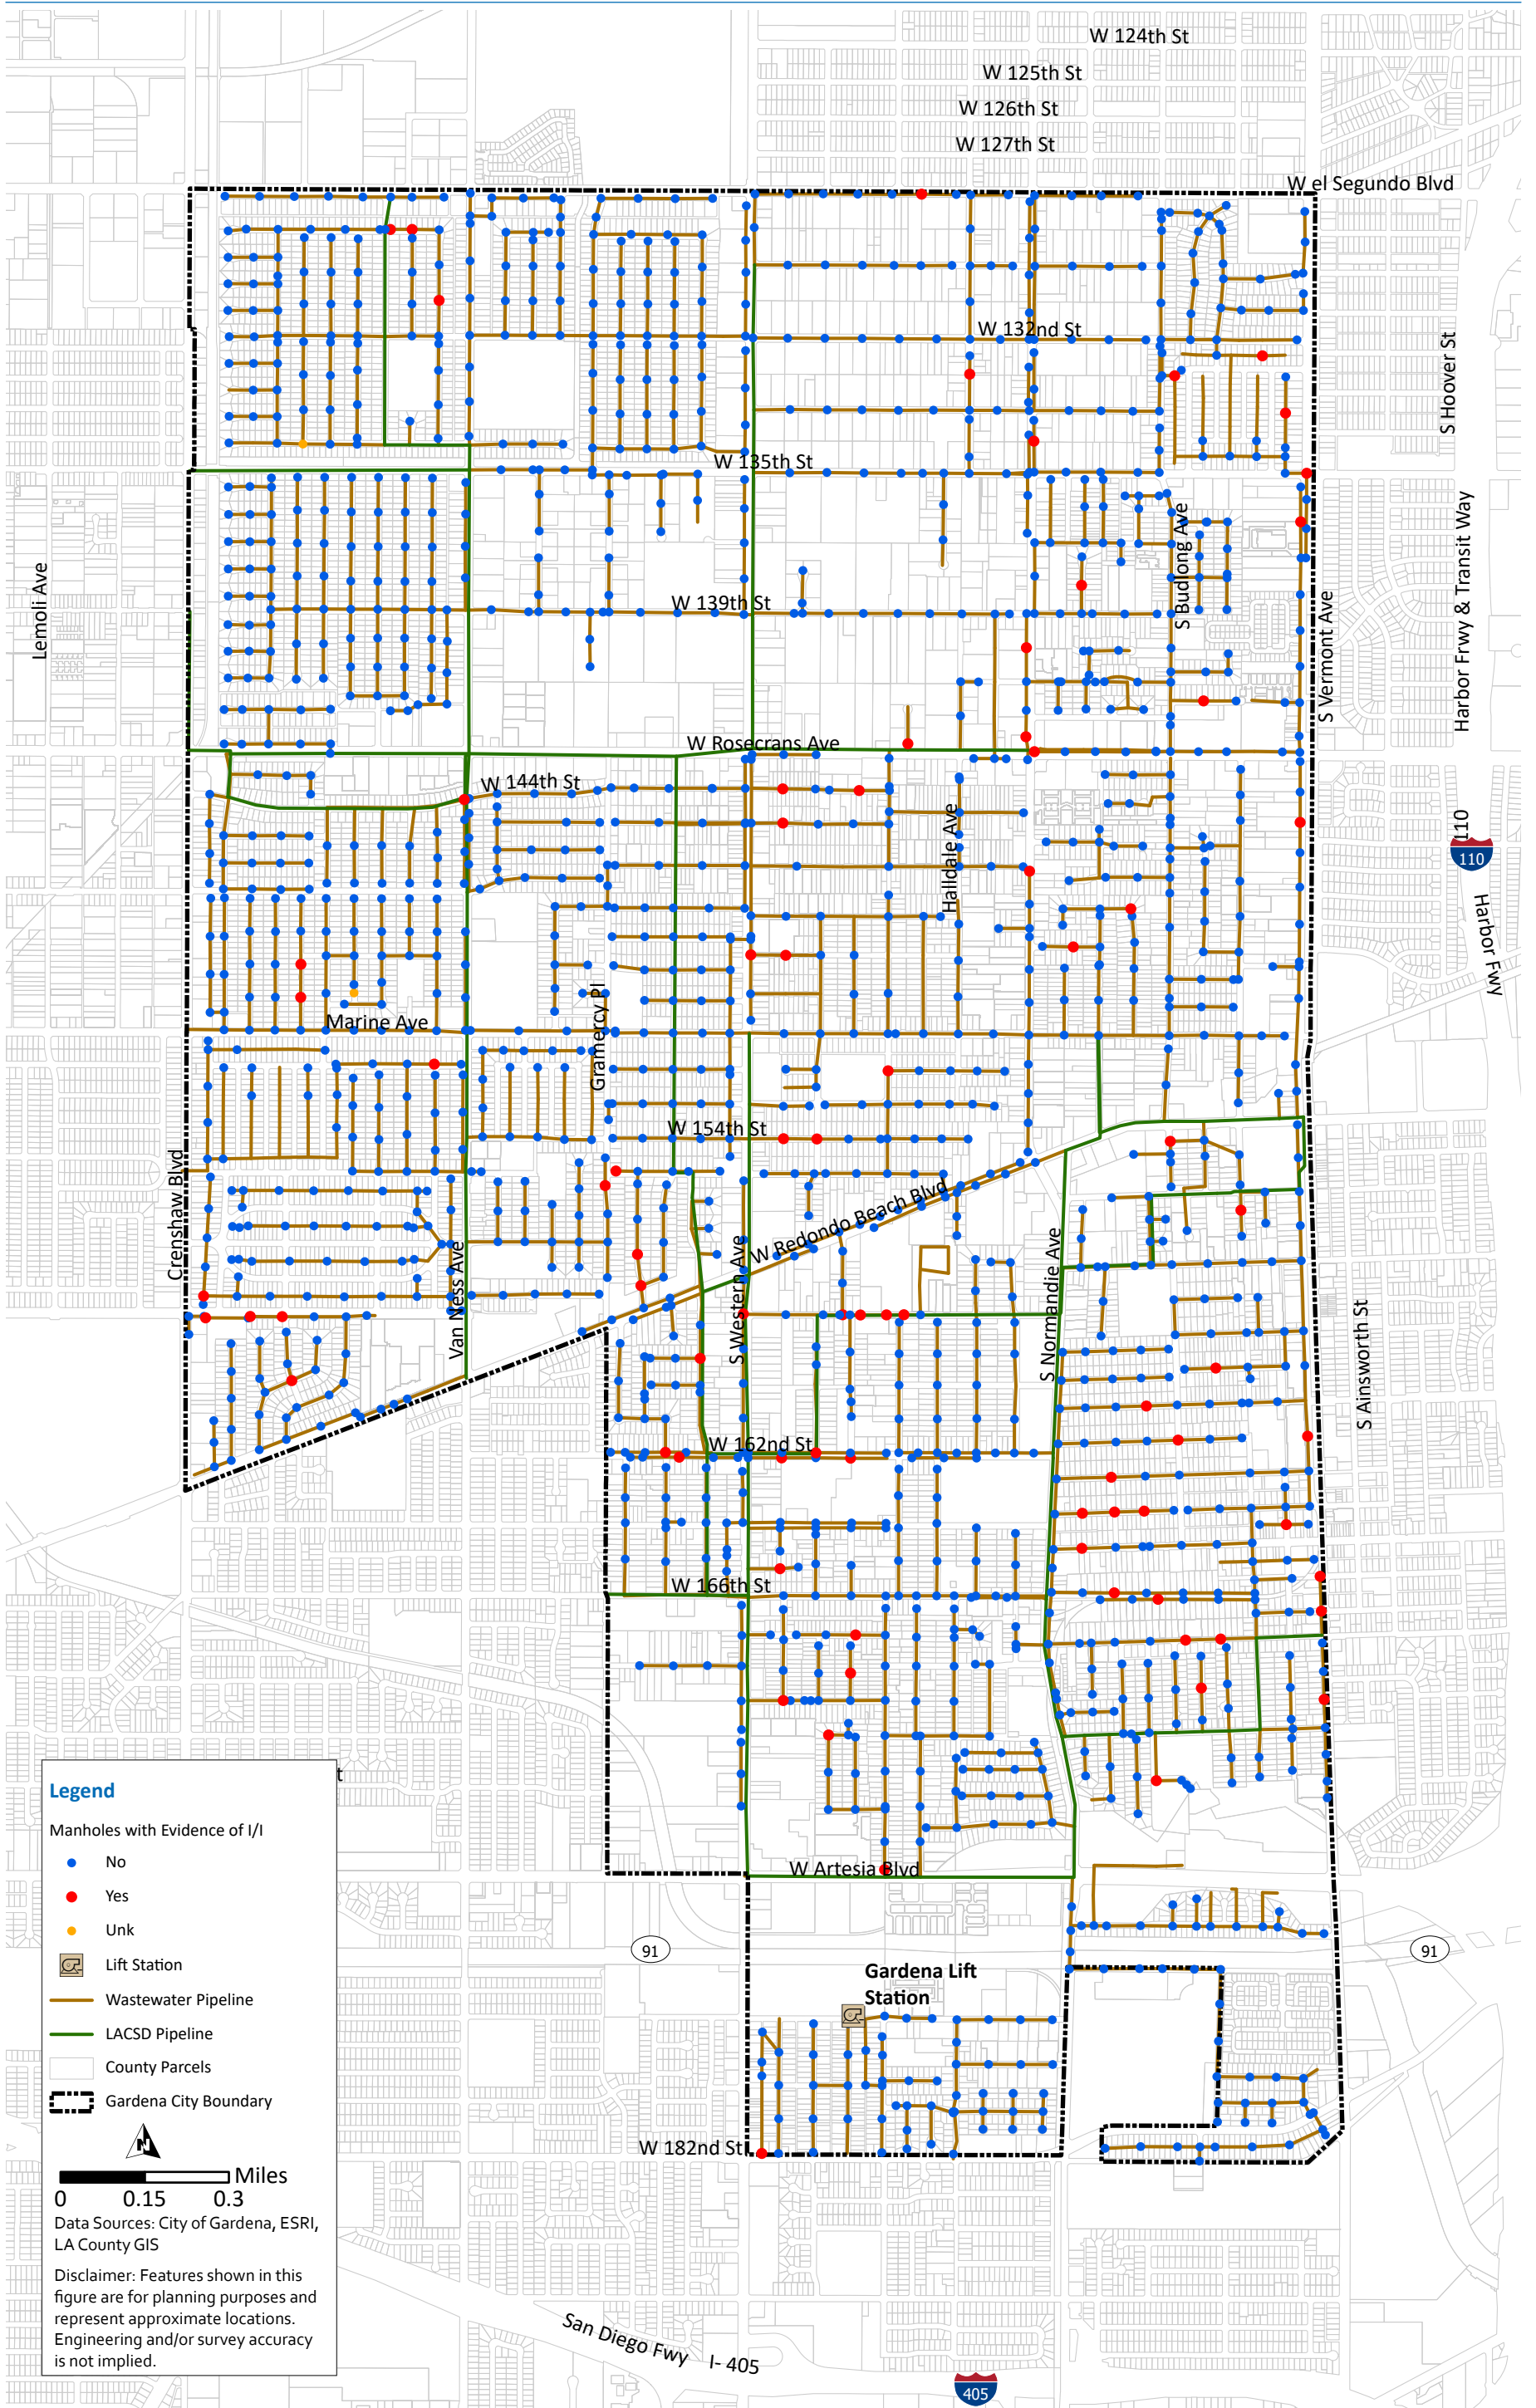
Figure 7.5 Manhole Inspection Results (Evidence of I/I)

- Approximately 5 percent of manholes inspected had evidence of I/I. Most of the manholes with evidence of I/I were marked as “Sound” for every condition category.

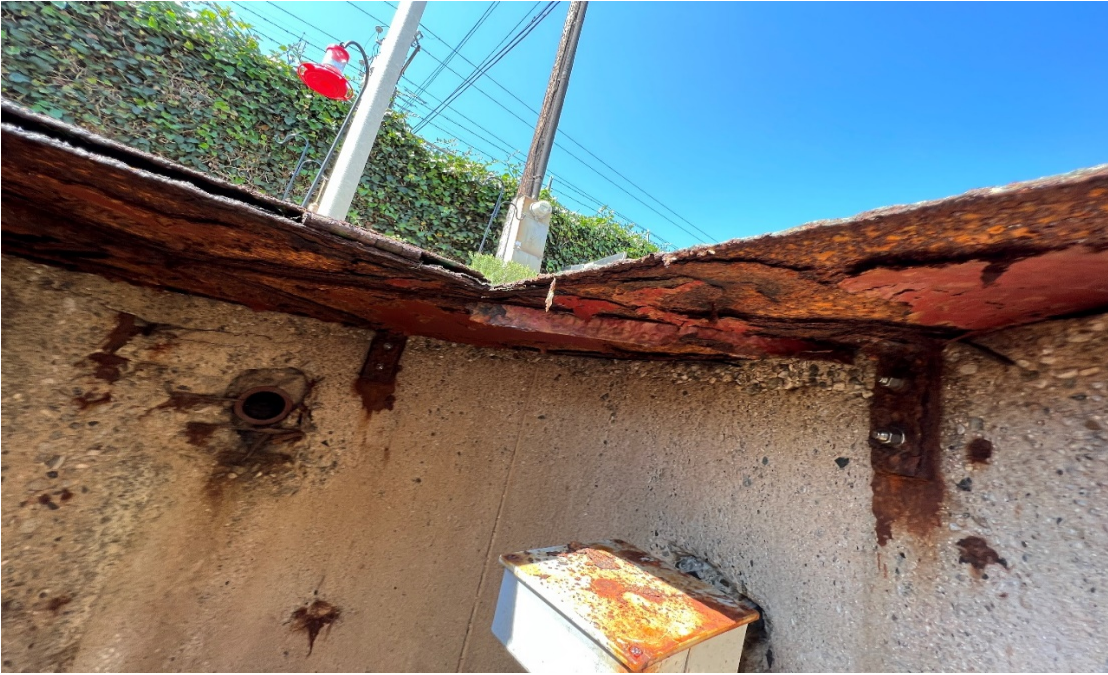
- Pipe supports in the wet well show corrosion and rust.
- The underside of the checkered steel plate as well as the support brackets are corroded (See Figures 1.4 and 1.5).

Figure 1.4 Corrosion at Underside of Checkered Steel Plate

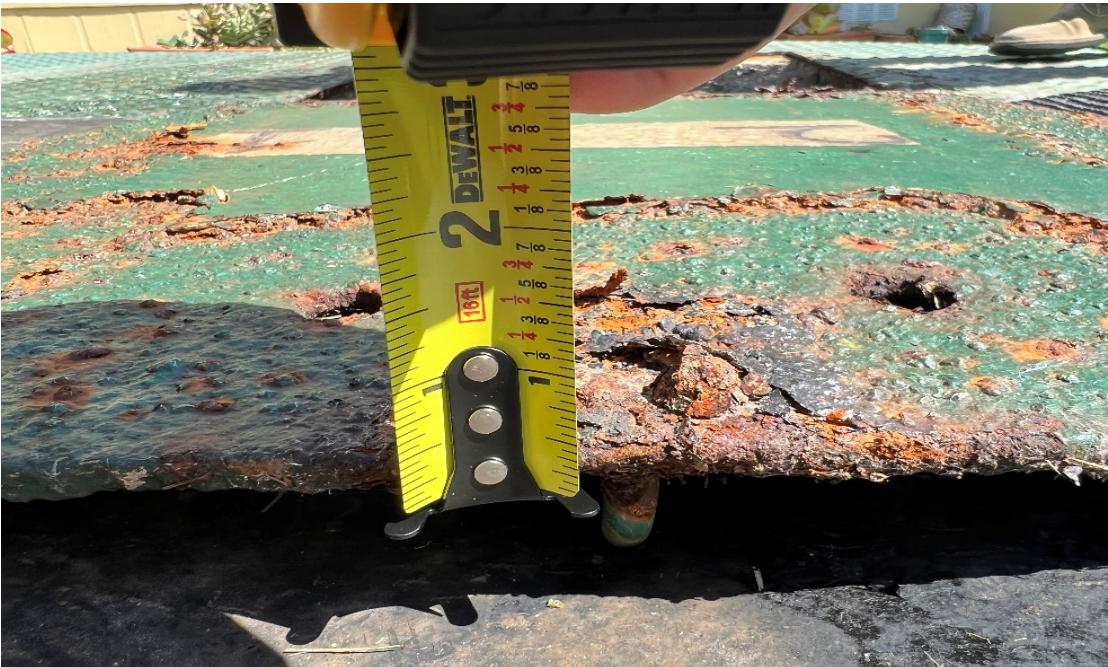
Figure 1.5 Corrosion at Underside of Checkered Steel Plate Hatch

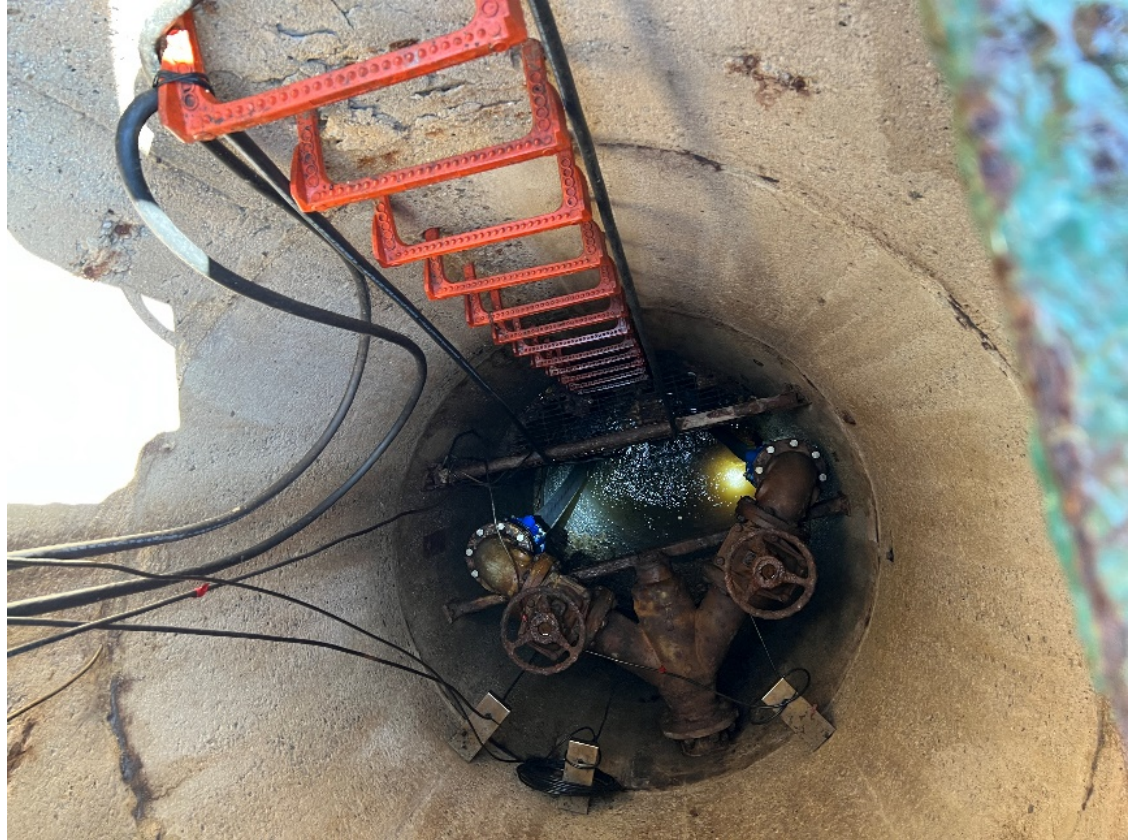
- The ladder rungs look to be in good condition (See Figure 1.6). Several rungs are embedded into concrete that is spalling. This could compromise the embedment and cause the rung to loosen and ultimately lose its capacity.
- From a distant observation, the lower platform and handrail appear to be in fair condition (See Figure 1.7). It was difficult to see any corrosion. There appears to be minor corrosion around the bracket connections to the concrete.
- There is no fall protection at the wet well.

Figure 1.6 Spalling Concrete Around Ladder Rungs

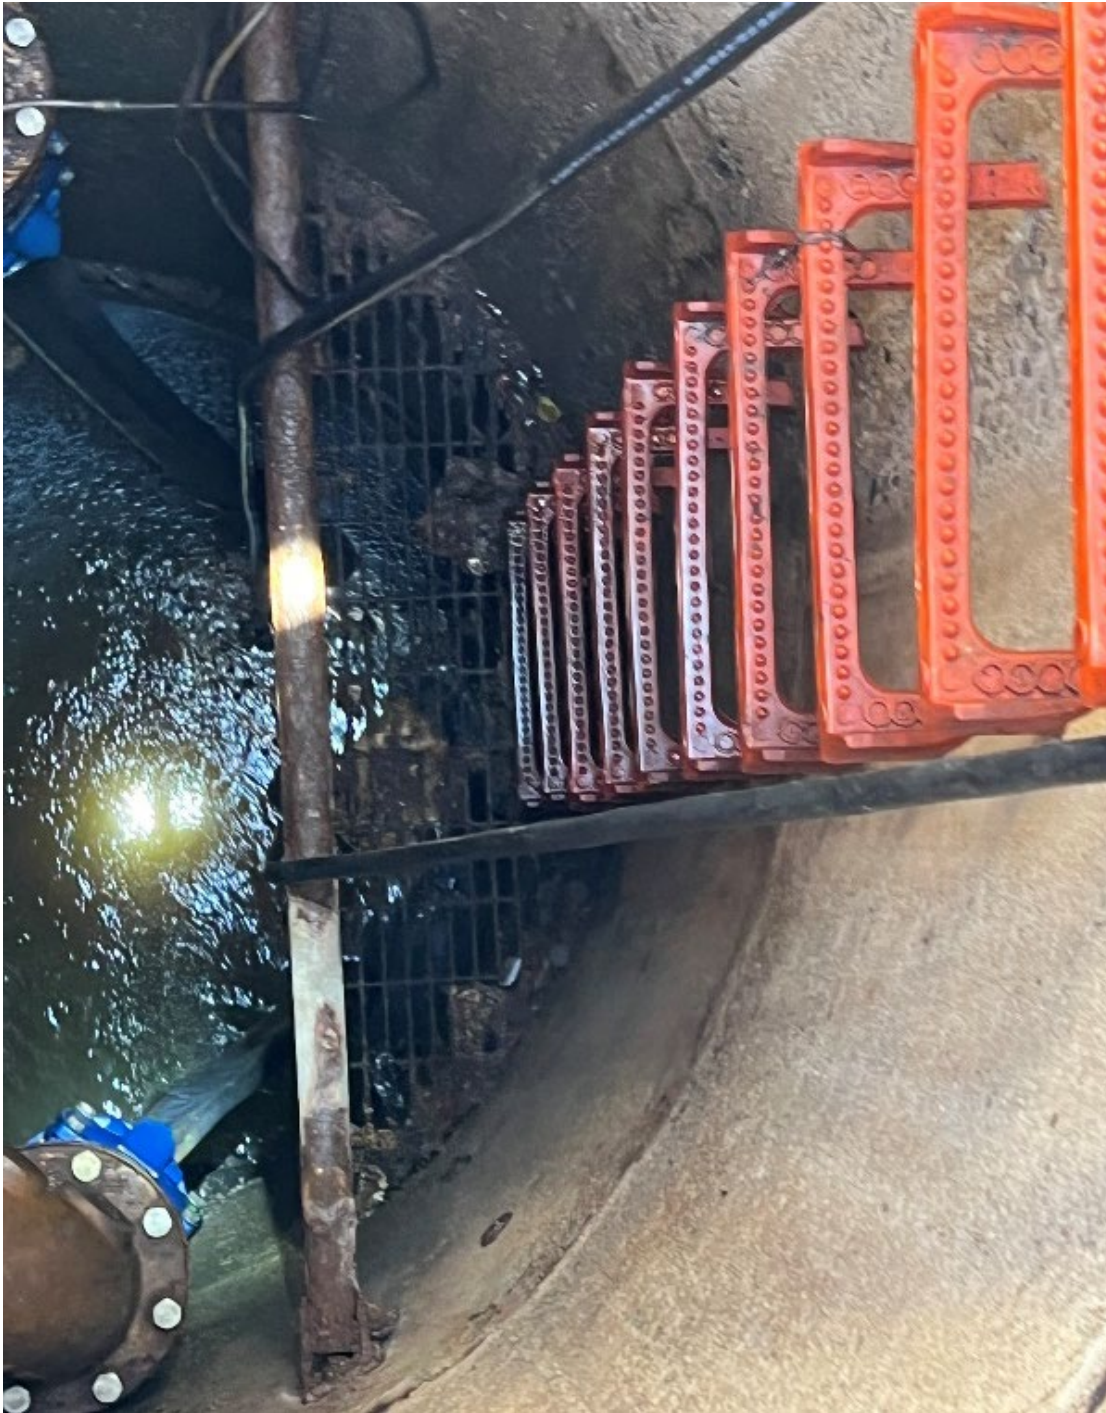
Figure 1.7 Buildup and Signs of Minor Corrosion Around Handrail and Platform Connection to Concrete

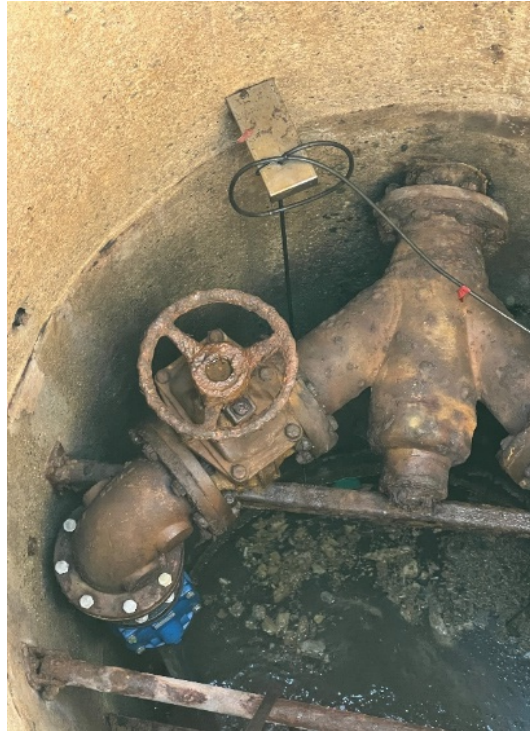
Image A

- The pumps and motors are two years old and are in good operating condition. The City has not had any previous capacity issues here.
- Wet well storage capacity appears to be sufficient to prevent excessive pump cycling.
- It was not possible to see the condition of all mechanical equipment within the wet well to confirm if corrosion was present (See Figure 1.8).
