**Phase I Environmental Site
Assessment
1515 West 178th Street,
Gardena, California**

Prepared for:
The Olson Company
3010 Old ranch Parkway,
Suite 100
Seal Beach, CA 90740

Prepared by:
Stantec Consulting Services Inc.
25864-F Business Center Drive
Redlands, California 92374

Project No.: 185803664

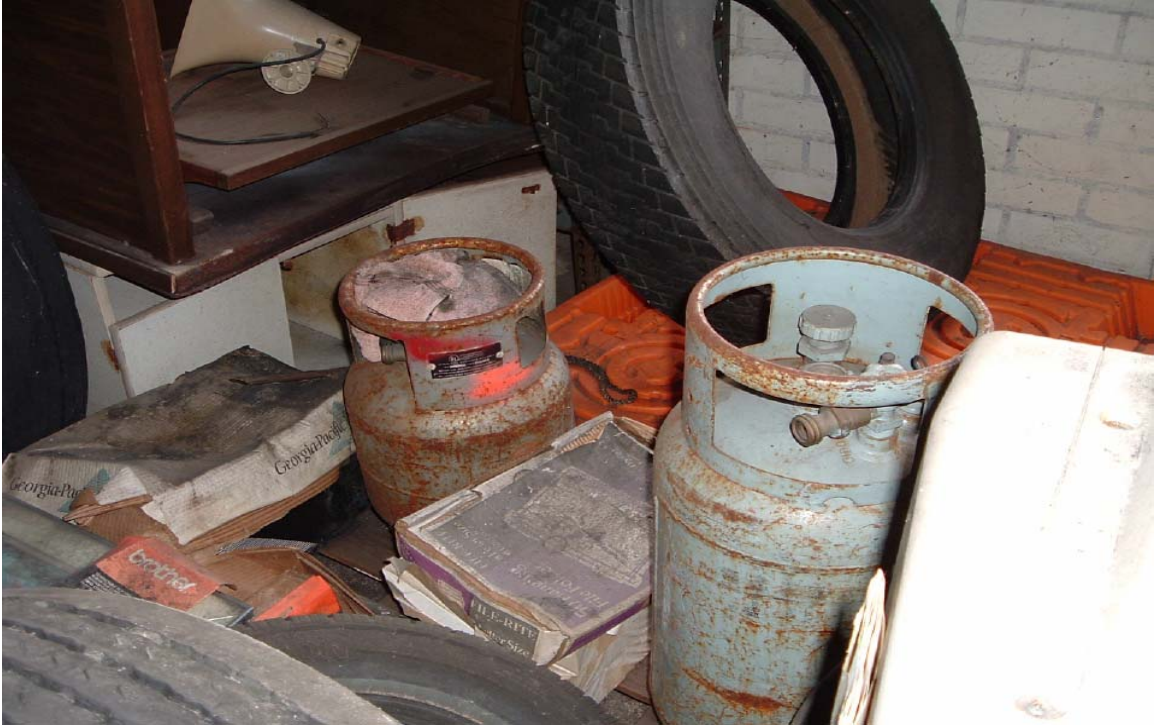
Photograph No. 7

An assortment of items (box files, empty gas bottles, worn tires, office furniture etc.) observed in the storage room located towards the southeast corner of the warehouse building.

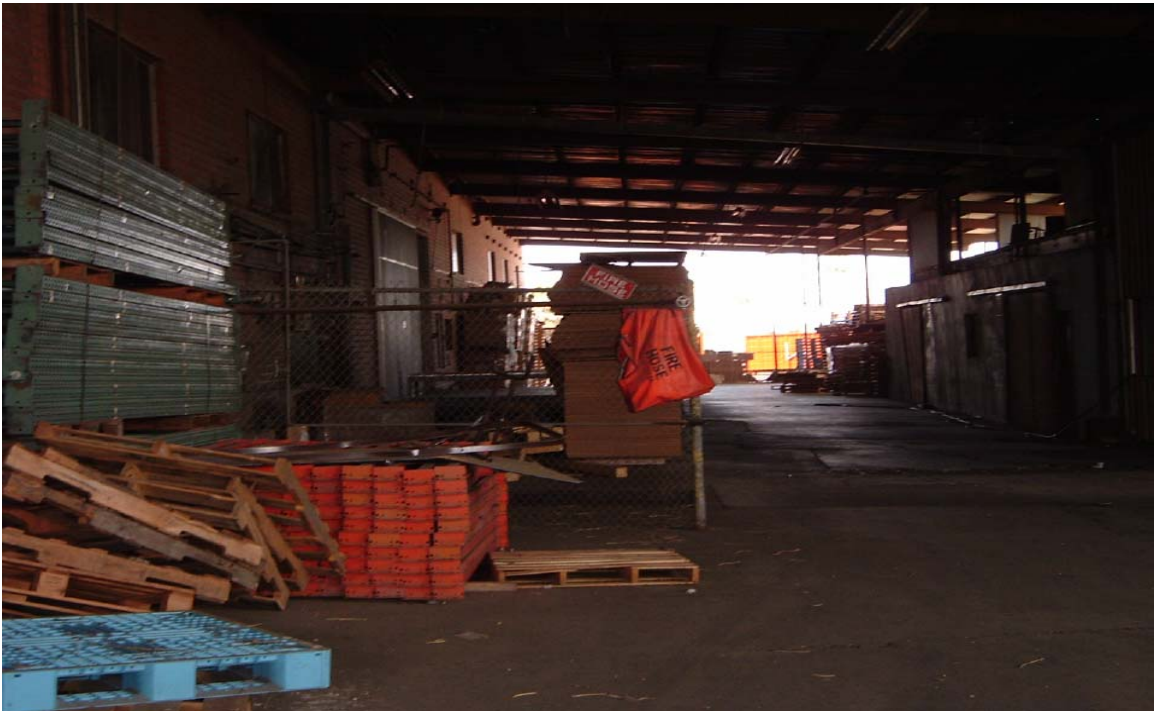
Photograph No. 8

View of storage area located in the northern portion of the warehouse building. The area is currently unused and reportedly the result of former manufacturing operations conducted at the Site.

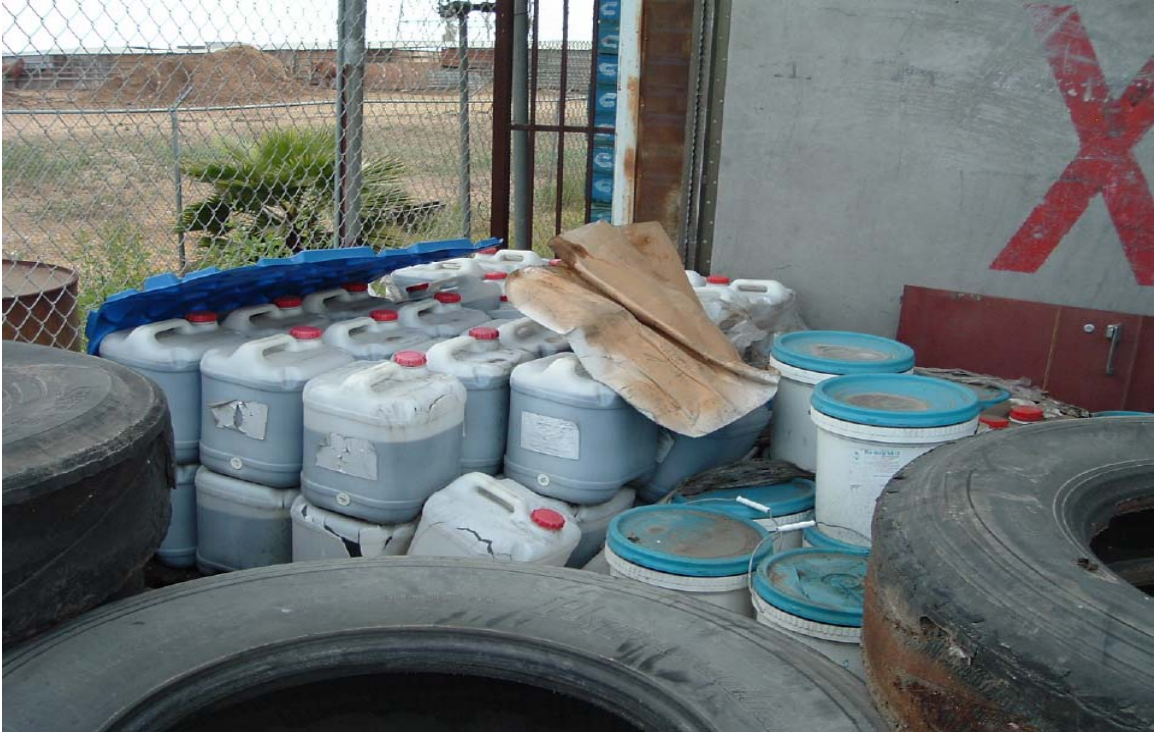
Photograph No. 9

View of pallets of damaged chemicals and worn tires stored towards the northwest corner of the warehouse building.

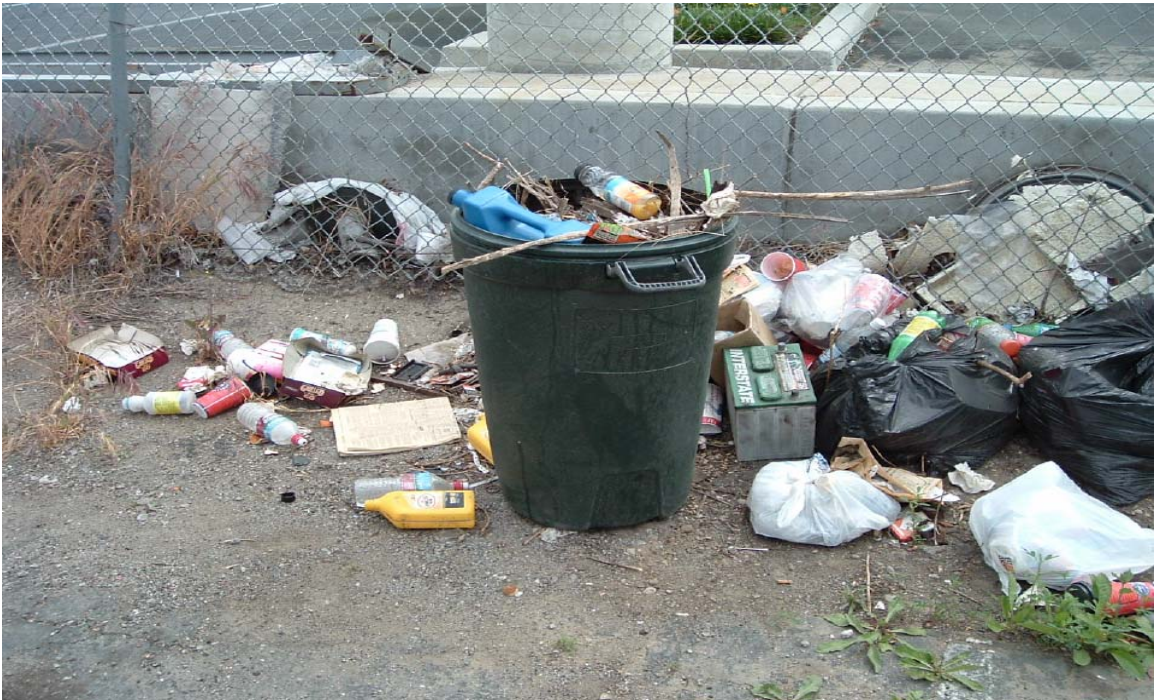
Photograph No. 10

View of trash dumped along the east boundary of the Site. Items include general household trash, batteries, worn tires and plastic oil containers.
