1515 W. 178th St
Gardena, CA 90248

Inquiry Number: 3341107.1s
January 28, 2013

The EDR Radius Map™ Report

SECOR 290 Conejo Ridge Avenue, Suite 200 Thousand Oaks, CA 91361 (805) 230-1266 / 230-1277 (Fax)	FOR: THE OLSON COMPANY PHASE I ESA POWER TRANS FREIGHT SYSTEMS, INC. 1515 West 178th Street Gardena, California		SITE LOCATION MAP		FIGURE: 1
	JOB NUMBER: 04OT.29213.41.001	DRAWN BY: R. Roman	CHECKED BY: L. Simons	APPROVED BY: L. Simons	DATE: 05/05/04

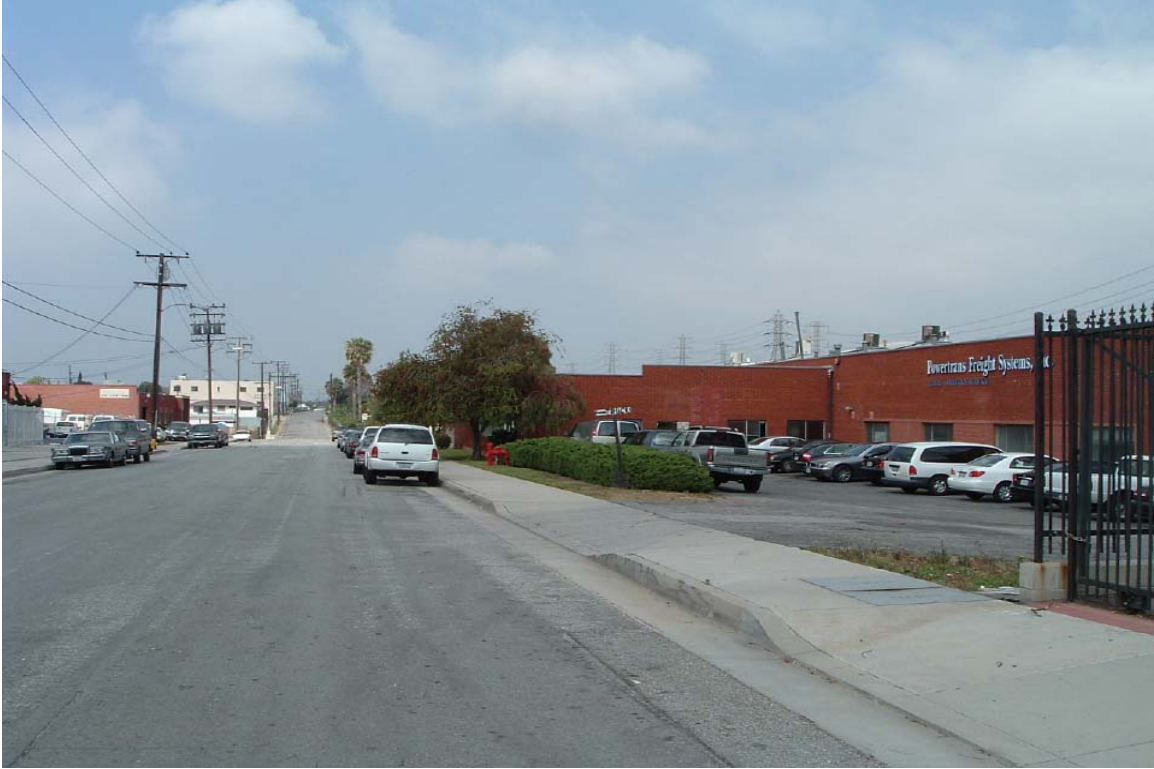
Photograph No. 1

View looking west along front entrance of Site (southern boundary) along West 178th Street

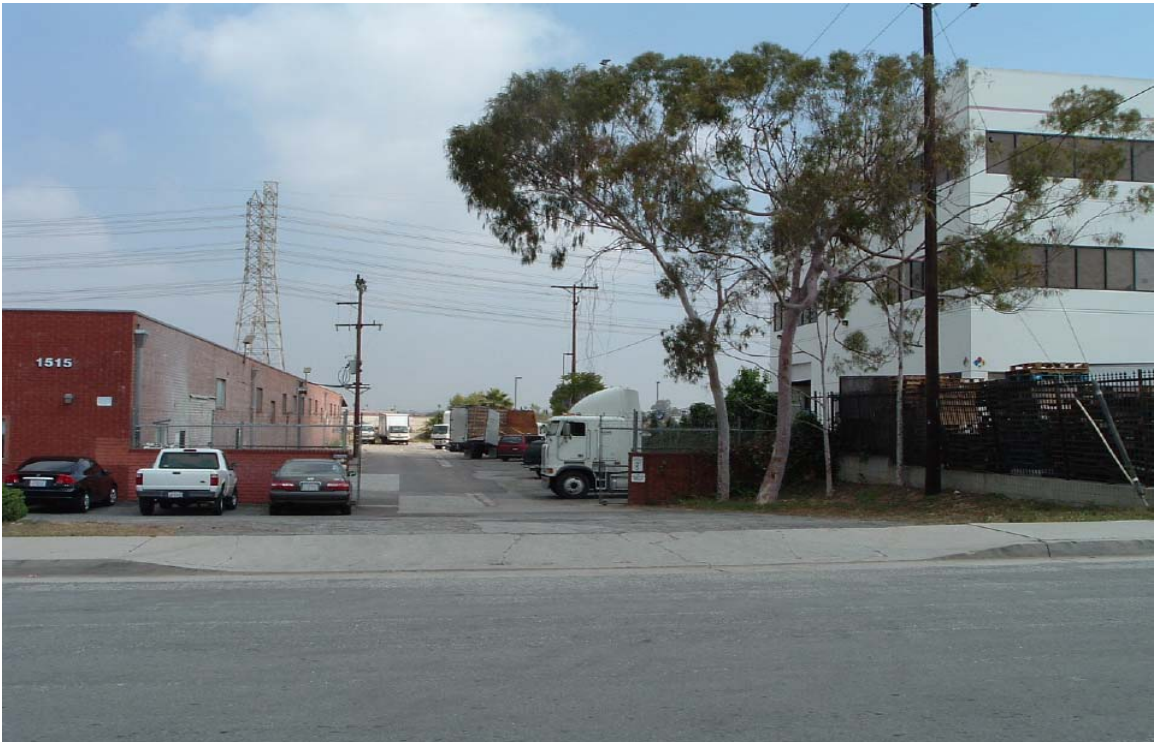
Photograph No. 2

View along east boundary of Site looking north.

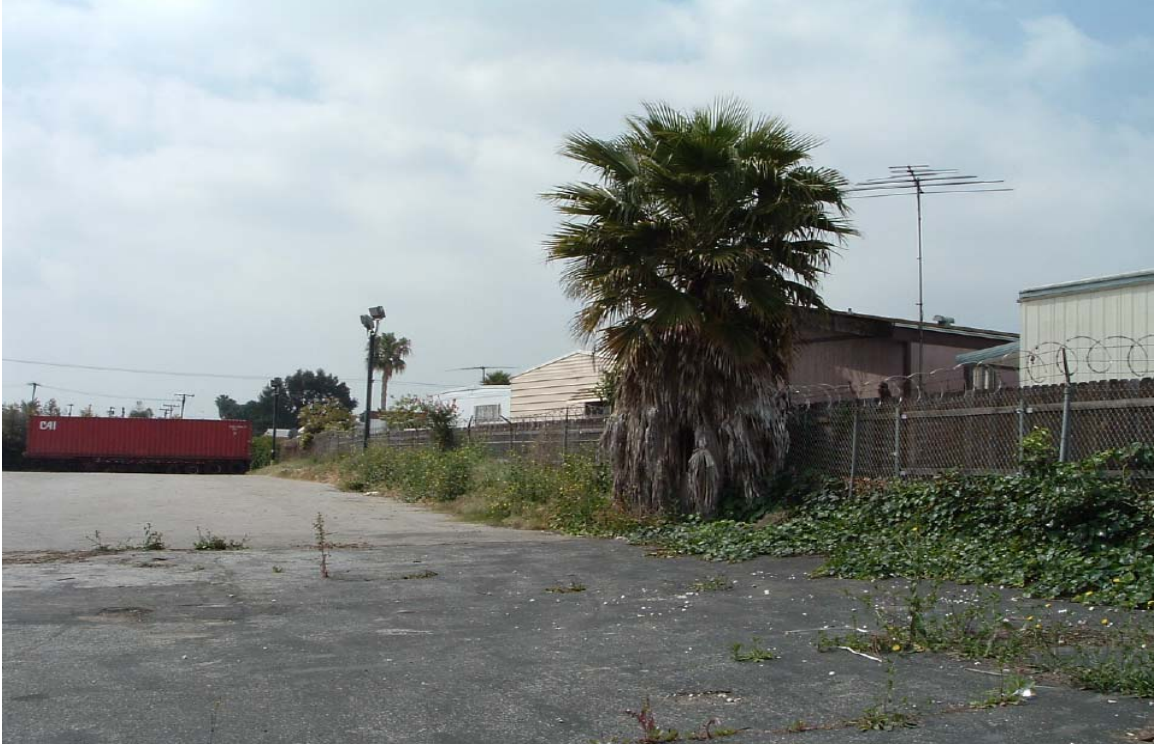
Photograph No. 3

View along west boundary of Site, looking southwest towards adjacent residential trailer home park

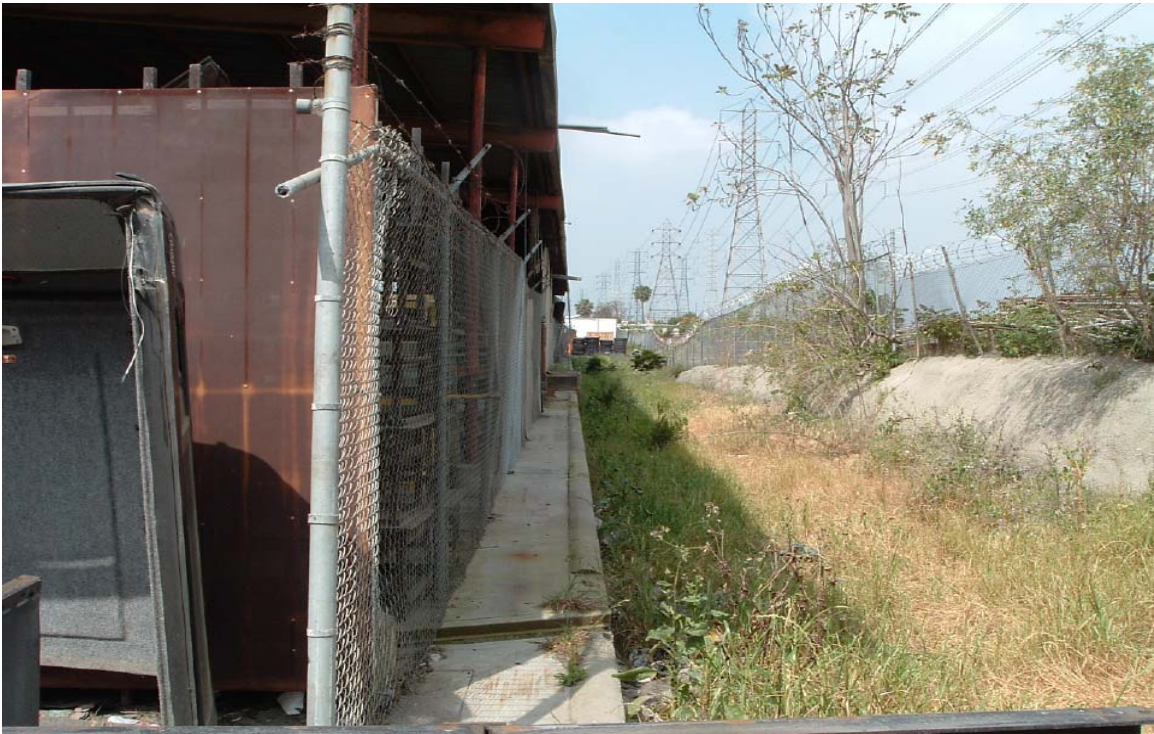
Photograph No. 4

View along the northern boundary of the Site (former railroad that trends east to west).

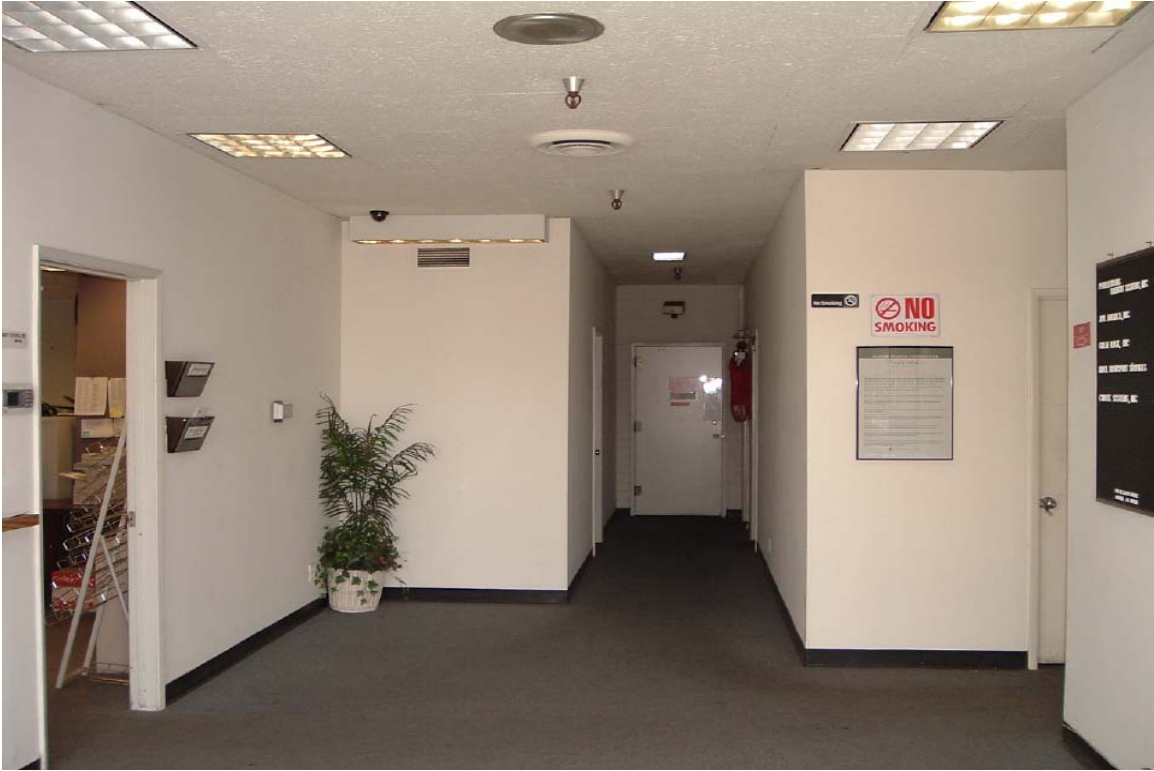
Photograph No. 5

View of main entrance to office area. Materials observed in this area are typical of the materials used in the office suites. The door in the background leads to the warehouse area.

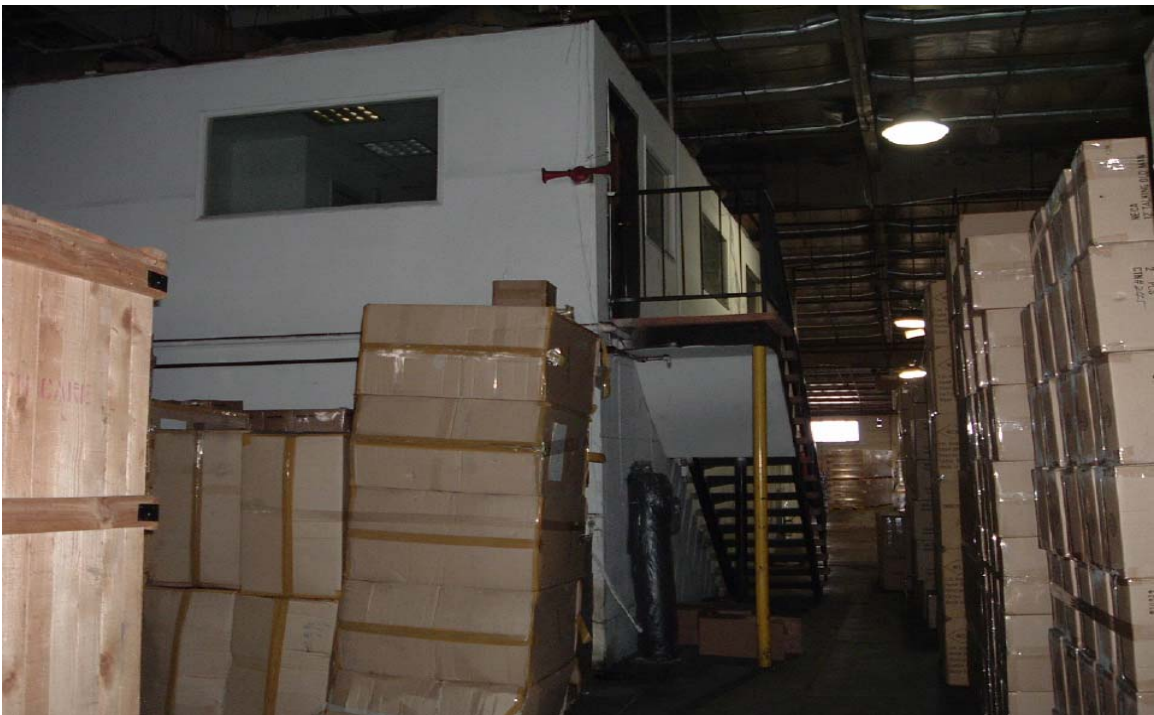
Photograph No. 6

View of central office building located in the warehouse. Rooms include a gym, kitchen, restrooms and general office space.

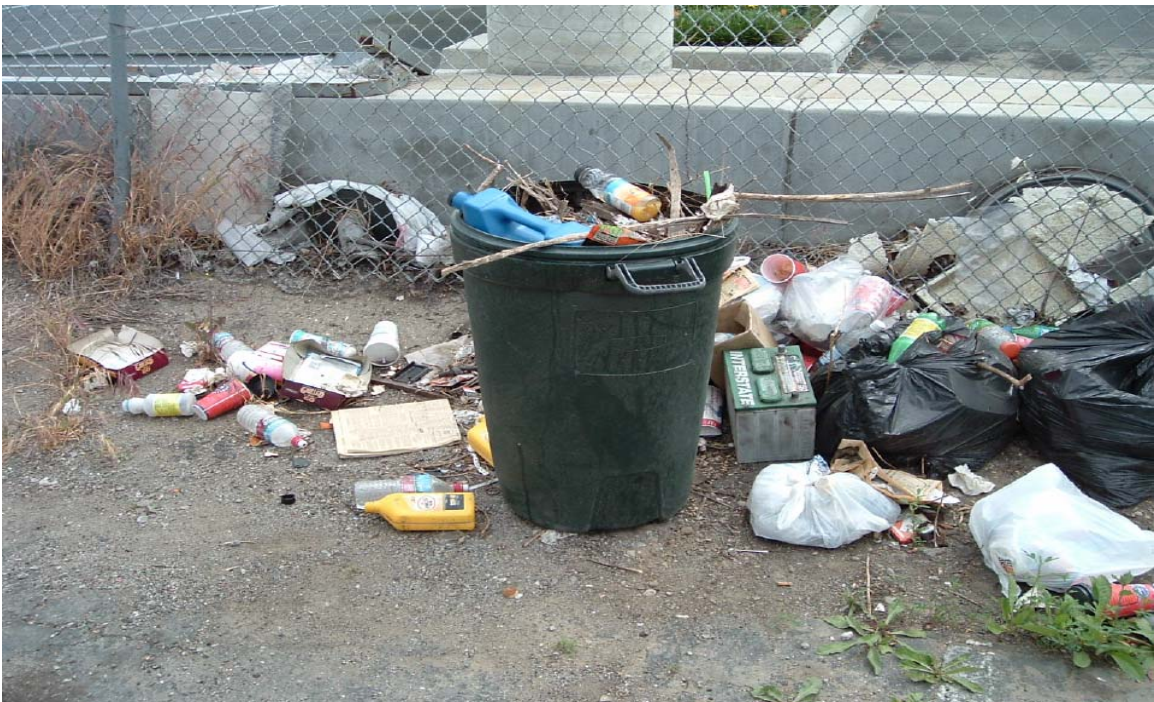
Photograph No. 10

View of trash dumped along the east boundary of the Site. Items include general household trash, batteries, worn tires and plastic oil containers.

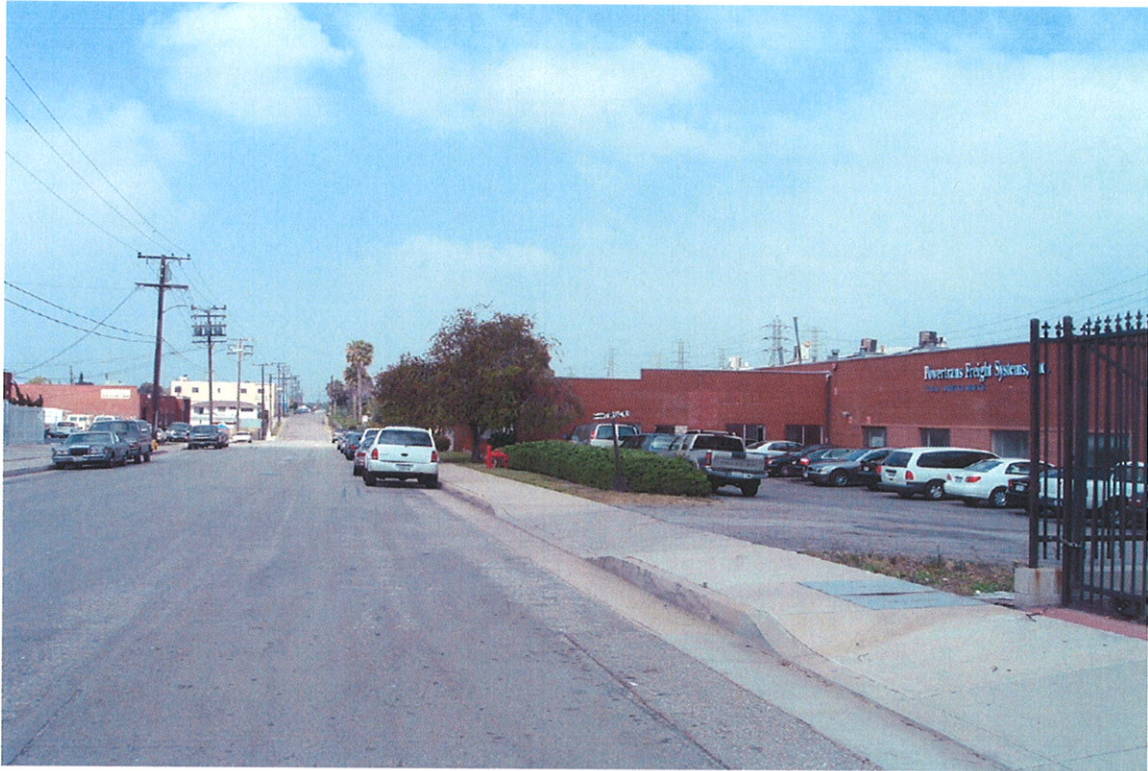
Photograph No. 1

View looking west along front entrance of Site (southern boundary) along West 178th Street

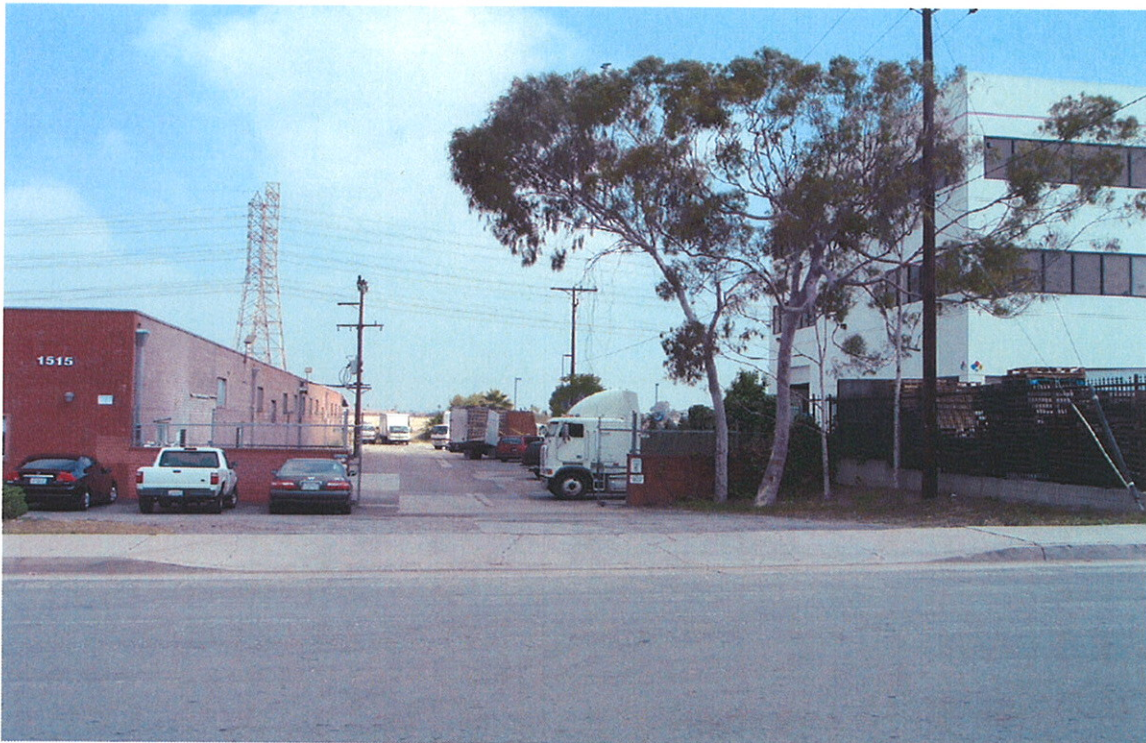
Photograph No. 2

View along east boundary of Site looking north.

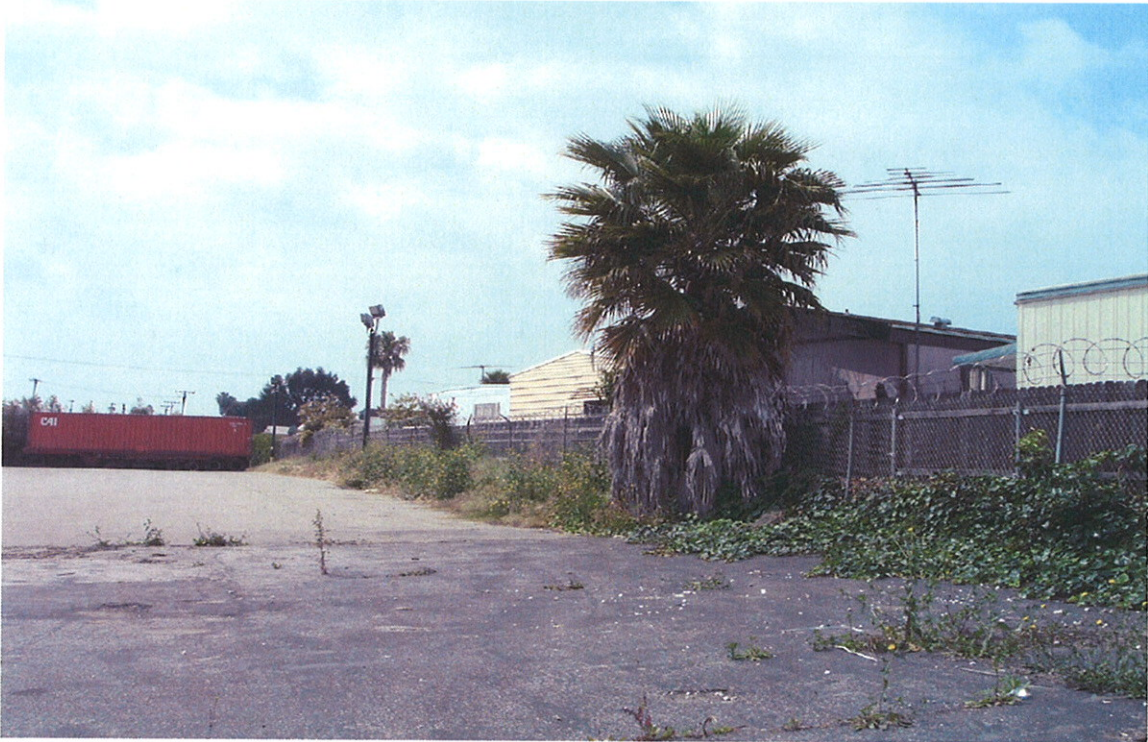
Photograph No. 3

View along west boundary of Site, looking southwest towards adjacent residential trailer home park

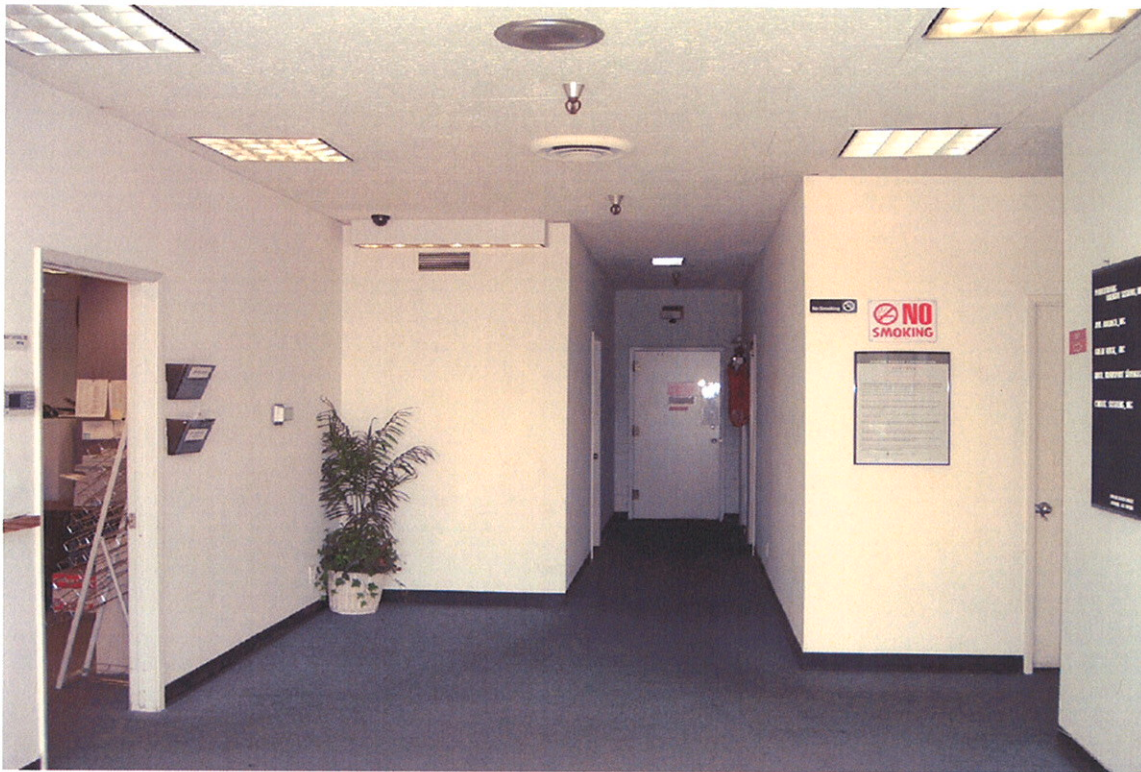
Photograph No. 5

View of main entrance to office area. Materials observed in this area are typical of the materials used in the office suites. The door in the background leads to the warehouse area.

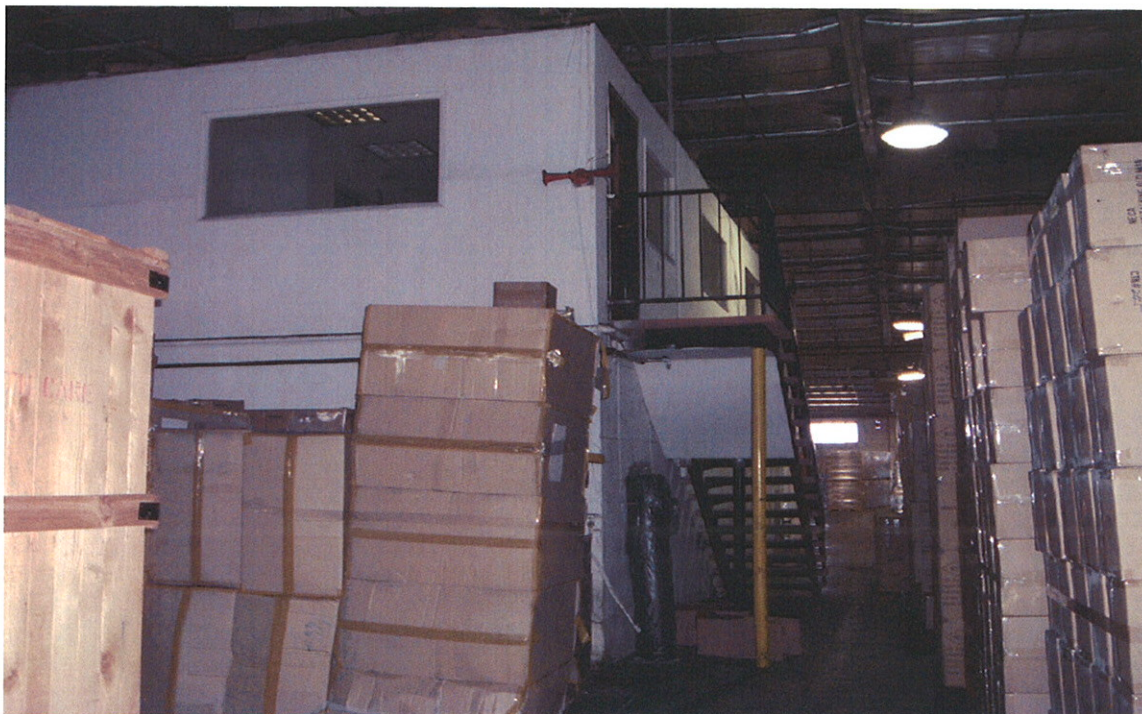
Photograph No. 6

View of central office building located in the warehouse. Rooms include a gym, kitchen, restrooms and general office space.

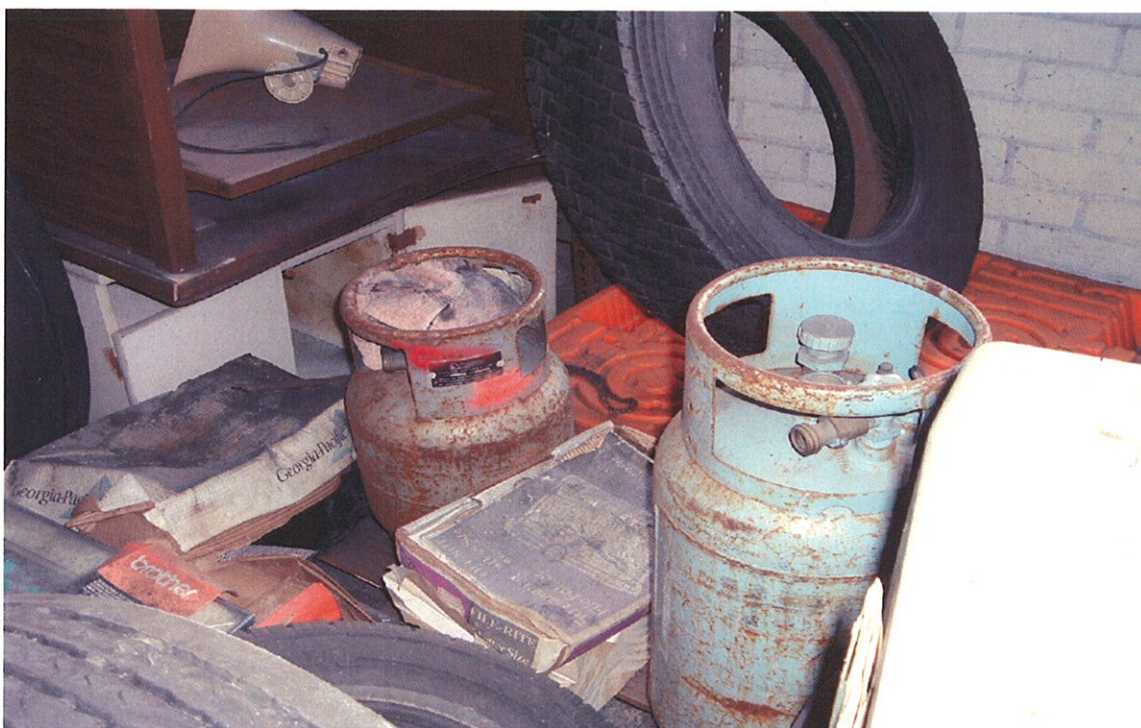
Photograph No. 7

An assortment of items (box files, empty gas bottles, worn tires, office furniture etc.) observed in the storage room located towards the southeast corner of the warehouse building.

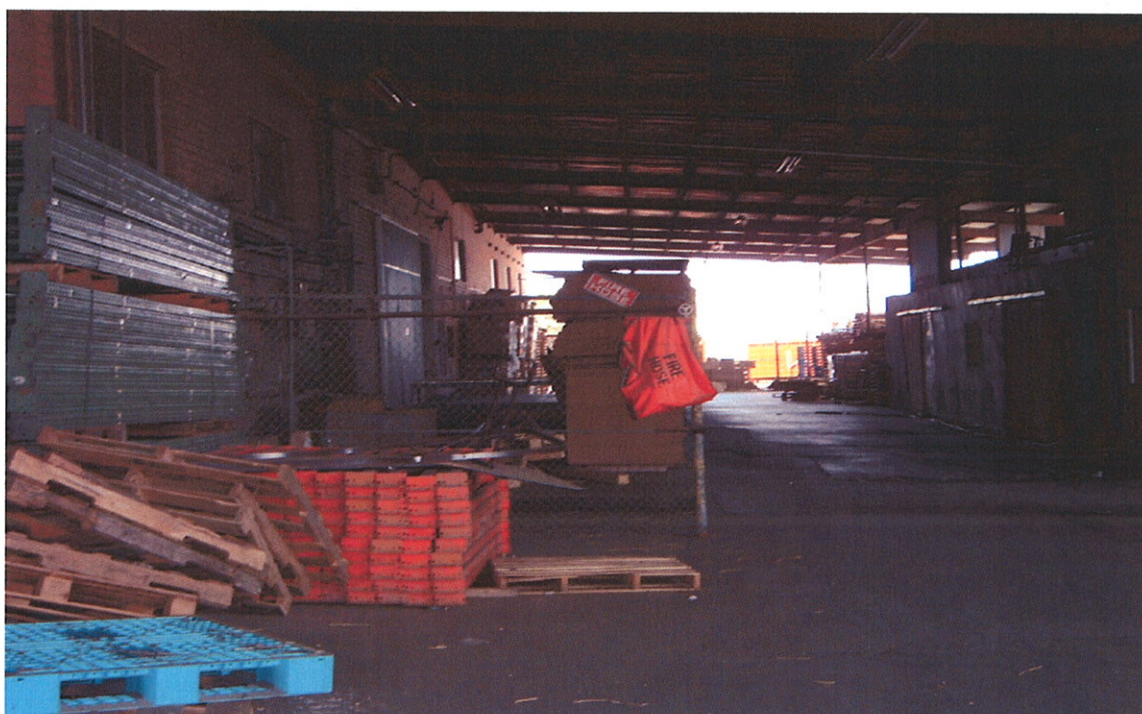
Photograph No. 8

View of storage area located in the northern portion of the warehouse building. The area is currently unused and reportedly the result of former manufacturing operations conducted at the Site.

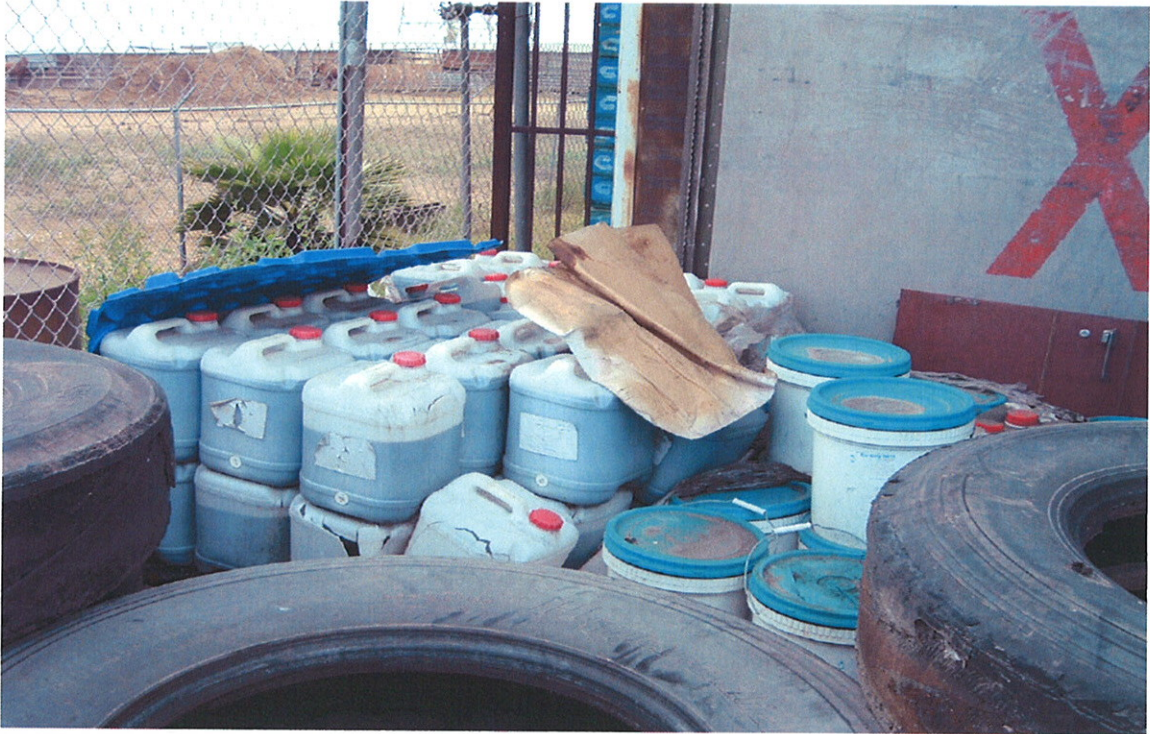
Photograph No. 9

View of pallets of damaged chemicals and worn tires stored towards the northwest corner of the warehouse building.

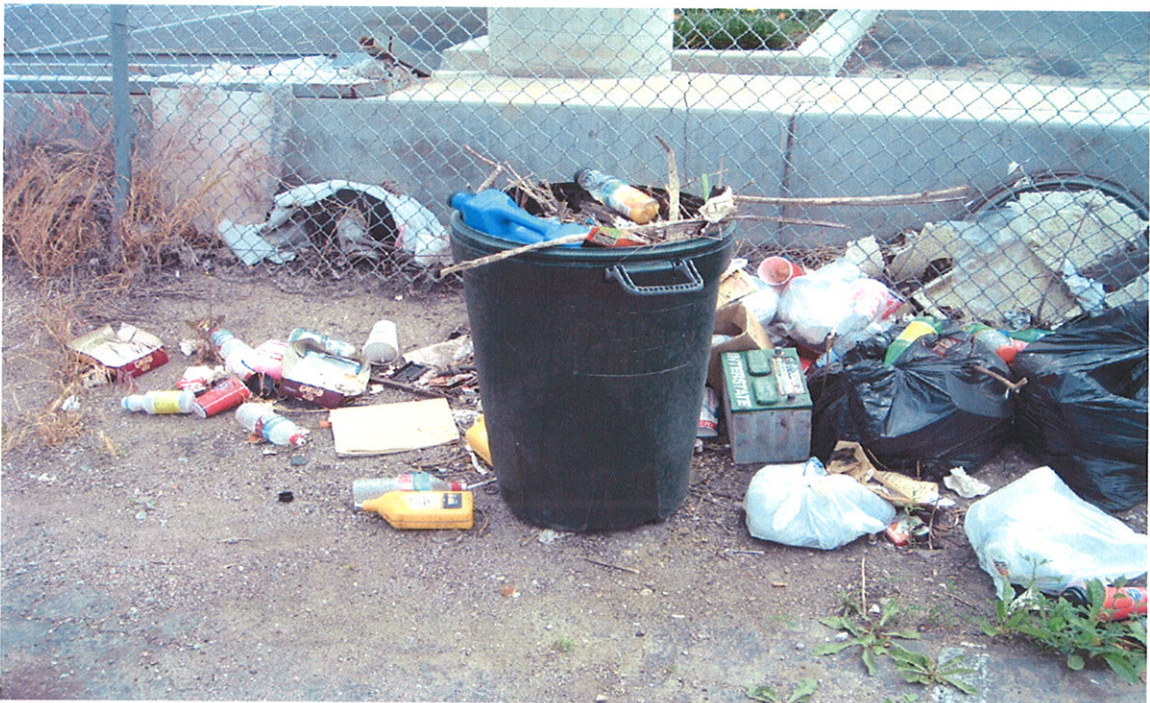
Photograph No. 10

View of trash dumped along the east boundary of the Site. Items include general household trash, batteries, worn tires and plastic oil containers.
