CITY OF GARDENA PARKS AND RECREATION MASTER PLAN APPENDIX

2024

Appendix Table of Contents

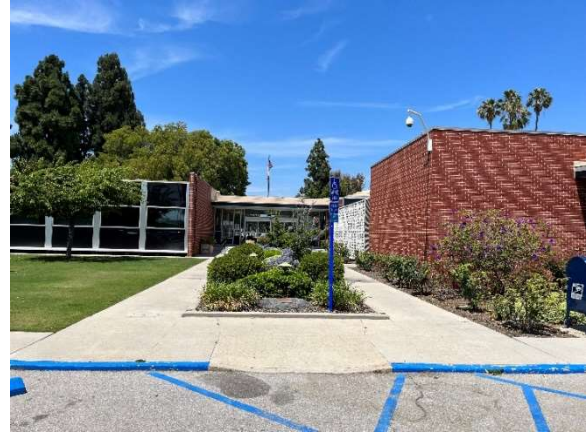
City Hall Main Entry

In general, the City Hall site is level and allows access throughout. There is an accessible walkway from the public sidewalk on the south side to the building. Additionally, there are direct paths of travel between City Hall, Nakaoka Community Center and the Gardena Police Department.

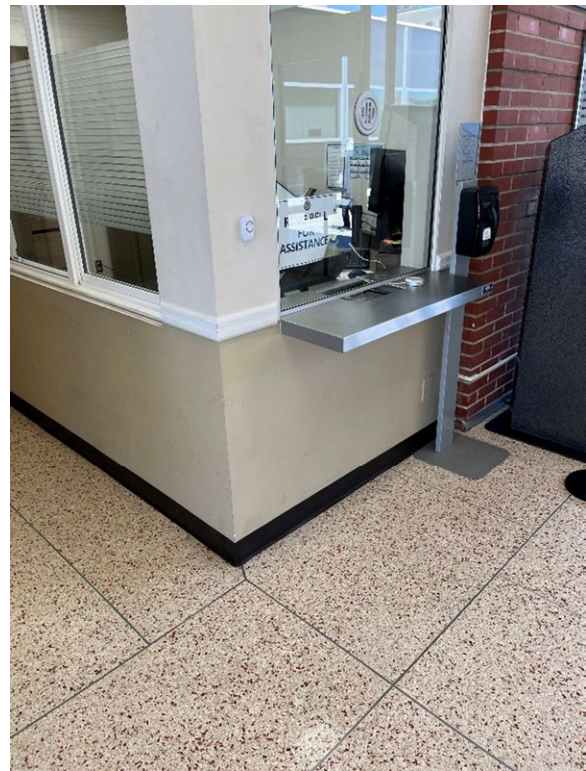
City Hall Reception Counter

The reception/service counter was inspected and found to provide an accessible space for the public to utilize. While the depth of the knee space is slightly less than the code requires for front approach, there is ample room for side approach to the transaction counter.

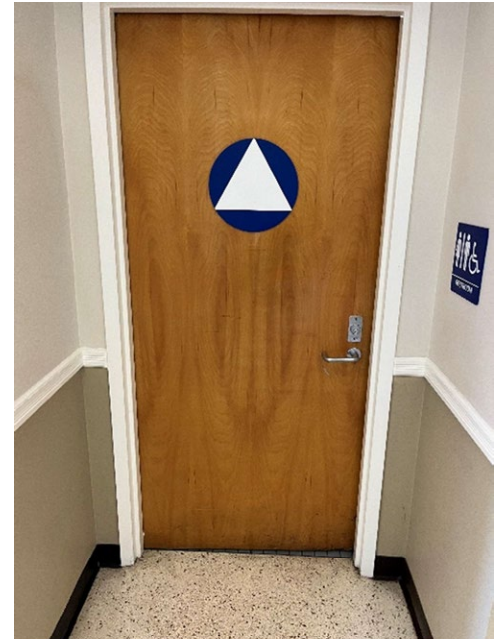
Restroom 1 Entry

1. Entry door does not have adequate side clearance on the push side of the door.
2. Entry door requires closing speed adjustment and door operating pressure adjustment.
3. The lavatory is too close to the side wall.
4. The soap and paper towel dispensers are mounted too high.
5. The toilet is too far from the side wall.
6. The side grab bar at the toilet is too close to the rear wall.
7. The toilet paper dispenser requires relocation to a location below the side grab bar.
8. The coat hook is mounted too high.

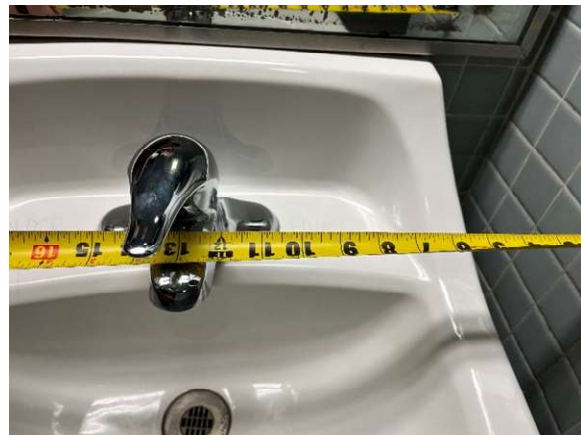
Lavatory offset

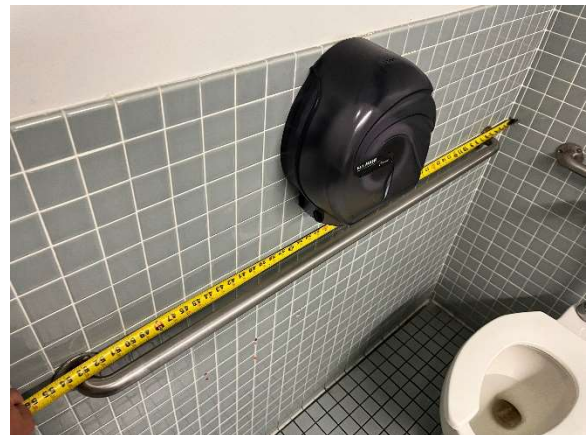
Toilet Paper Dispenser location

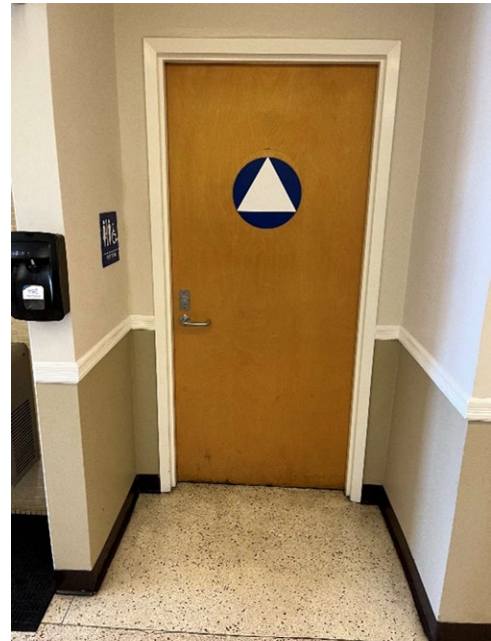
Restroom 2 Entry

1. Entry door does not have adequate side clearance on the push side of the door. There is a wall shelf located within the required clear space on the pull side of the door which should be removed.
2. Entry door requires closing speed adjustment and door operating pressure adjustment.
3. The lavatory is slightly within the minimum distance from the side wall.
4. The soap and paper towel dispensers are mounted too high.
5. The side grab bar at the toilet is too far from the rear wall.
6. The rear grab bar at the toilet is not centered properly above the centerline of the toilet.
7. The toilet paper dispenser requires relocation to a location below the side grab bar.

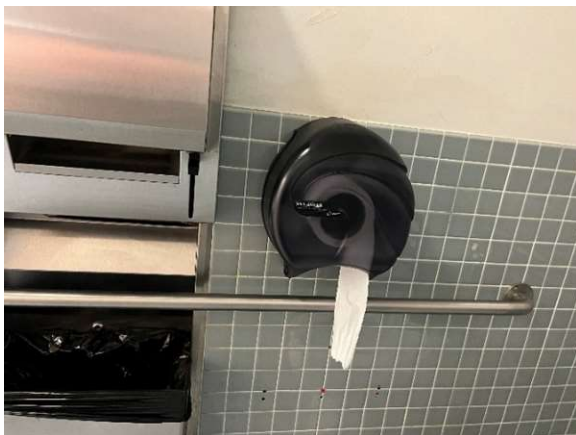
Toilet Paper Dispenser location

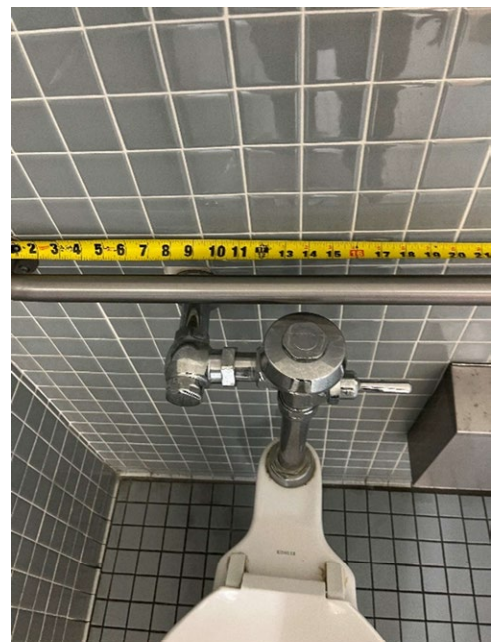
Rear Grab Bar location

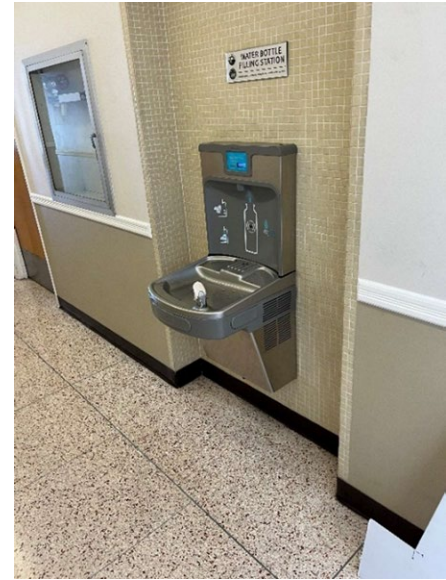
Drinking Fountain 1

This drinking fountain appears to be a newer model Elkay unit that includes a water bottle filling station. In general, this drinking fountain is compliant, however, drinking fountain rails should be added on either side of the alcove to protect the visually impaired from walking into the unit.

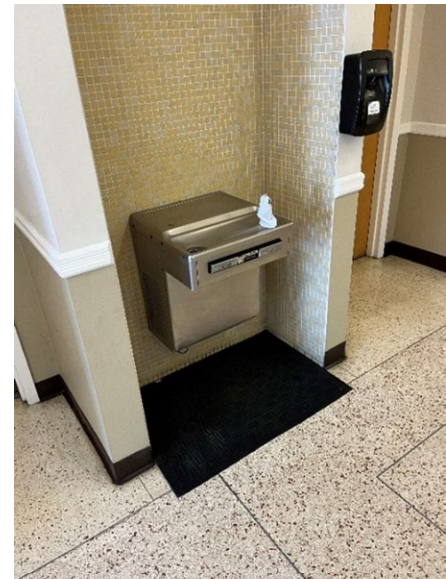
Drinking Fountain 2

This drinking fountain appears to be an older unit and is currently not in operation. The alcove is slightly out of compliance, requiring approximately 1" depth increase to meet the alcove requirement. Since Drinking Fountain 1 is an upgraded unit with a water bottle filling station, it is recommended that this unit be replaced and mounted to meet the requirement for a standing drinking fountain.

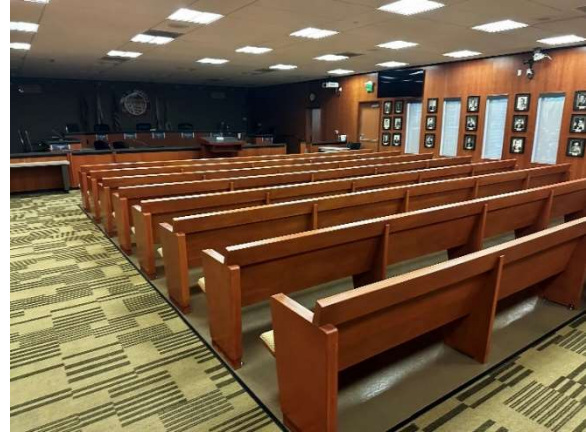
Council Chambers Seating Area

While there are no dedicated wheelchair spaces within the public area, the entire floor is level and the walk aisles on either side are over 6 feet wide. This allows for accessible seating on either side of the room throughout the public gallery space.

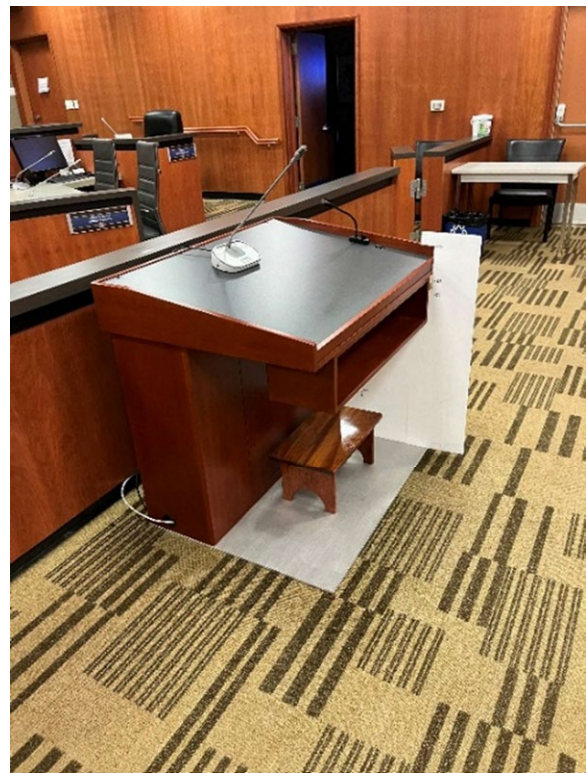
Council Chambers Public Podium

The public podium was inspected for accessibility and the adjustable height top can be lowered to 34", providing an accessible surface. There is limited knee space provided under the unit for front approach, however, side approach is achievable as the entire space surrounding the unit is unobstructed and clear.

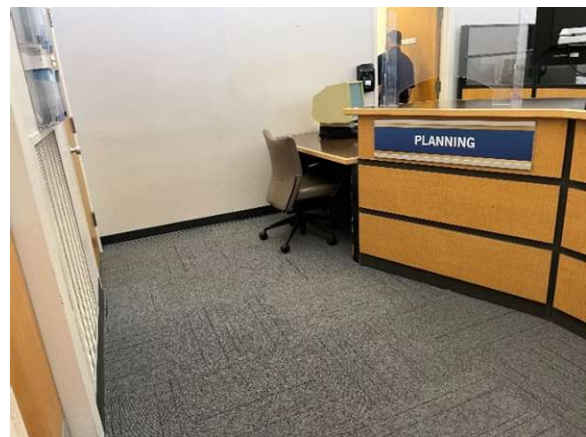
Accessible Planning Station

The service counter is located on the far right side of the public space. It provides adequate accessible space for business.

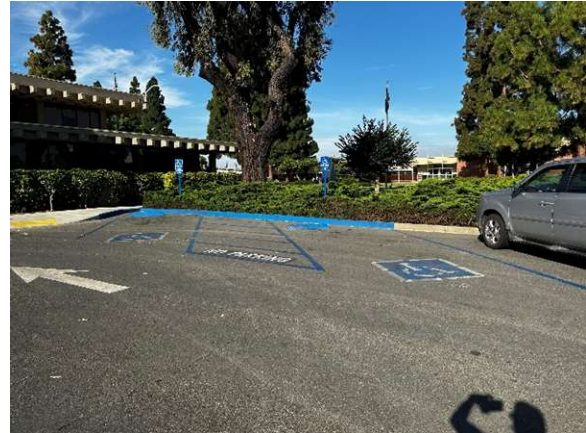
Nakaoka Community Center Accessible Parking

- The top landing has non-compliant slopes
- The counter slope at the bottom of the curb ramp is too steep
- The transition between the curb ramp and the adjacent asphalt is too steep.

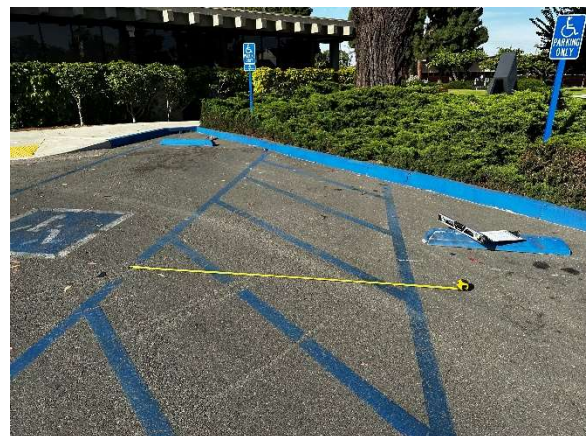
7'-5" wide access aisle

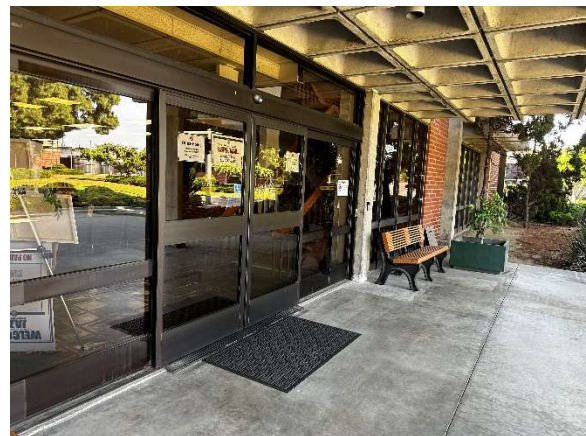
Main Entry Door

The main entry door is a double automatic sliding door system facing the greenbelt area to the west of the building. In general, it is a compliant entry. However, there are unsecured floor mats on either side of the door which should be removed or secured.

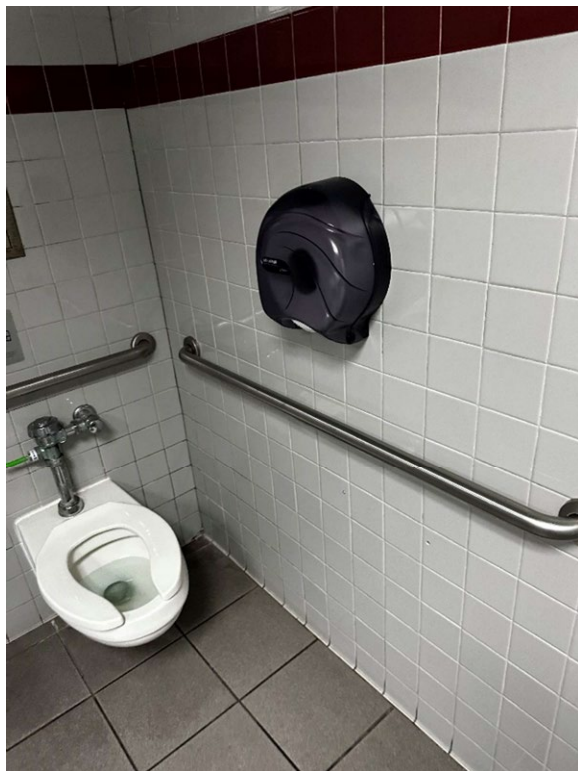
Toilet paper dispenser incorrectly located

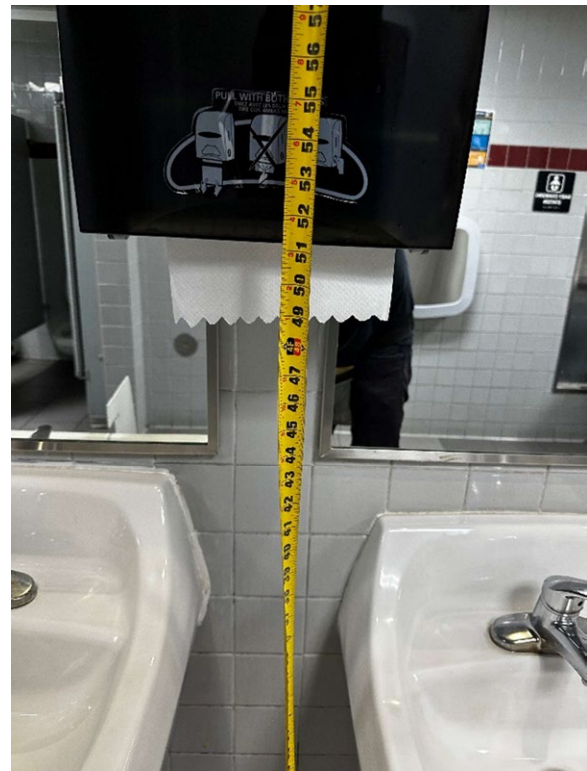
Dispenser height too high

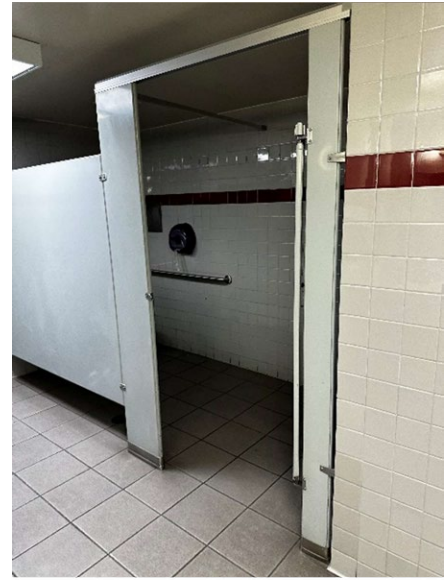
First Floor Women's Restroom Toilet

- Minor door operation adjustments required
- Missing entry signage
- Minor modifications required at the lavatories
- Missing pipe insulation at sinks
- Dispensers at incorrect heights
- Toilet compartment is too narrow
- Minor modifications at accessible toilet compartment required
- Toilet is centered too far from side wall

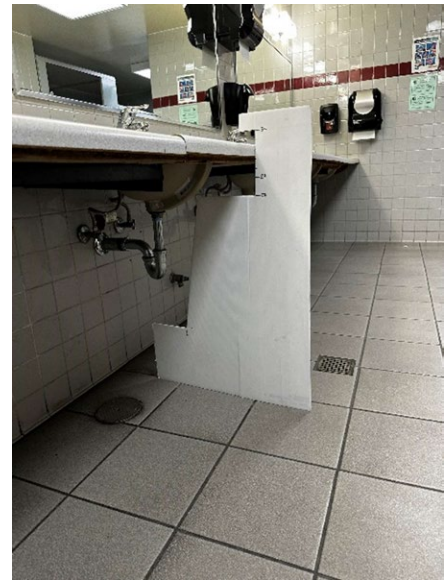
Missing insulation on pipes

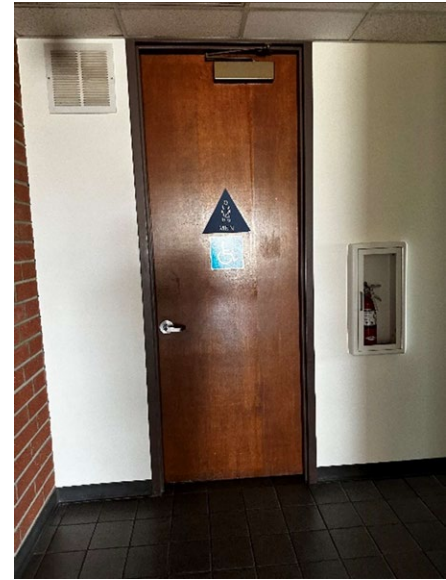
Second Floor Men's Restroom

The second floor men's restroom is a multiple occupant facility located along the hallway. It includes two sinks, two urinals and multiple toilets, including one accessible toilet compartment. In general, access into the restroom is acceptable. However, there are multiple elements requiring modification including the following:

- Minor door operation adjustments required
- Missing entry signage
- Minor modifications required at the lavatories
- Dispensers at incorrect heights
- Toilet compartment is too narrow
- Minor modifications at accessible toilet compartment required
- Toilet is centered too far from side wall
- Incorrect rear grab bar

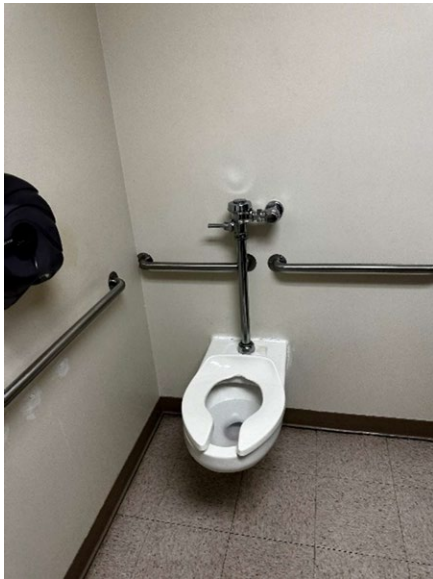
Non-Compliant Rear Grab Bar

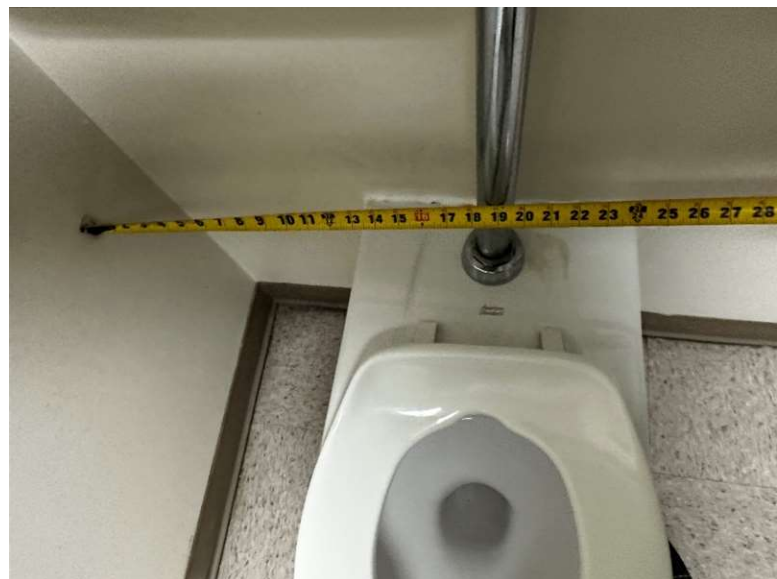
Toilet centered too far from side wall

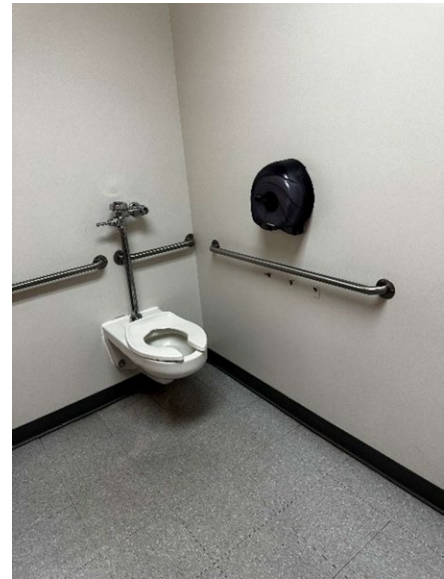
Second Floor Women's Restroom

The second floor women's restroom is a multiple occupant facility located along the hallway. It includes two sinks and multiple toilets, including one accessible toilet compartment. In general, access into the restroom is acceptable. However, there are multiple elements requiring modification including the following:

- Minor door operation adjustments required
- Missing entry signage
- Minor modifications required at the lavatories
- Dispensers at incorrect heights
- Toilet compartment is too narrow
- Minor modifications at accessible toilet compartment required
- Toilet is centered too far from side wall
- Incorrect rear grab bar

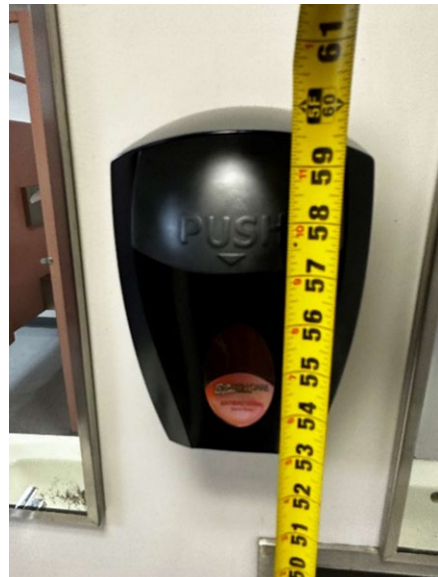
Accessory mounting heights too high

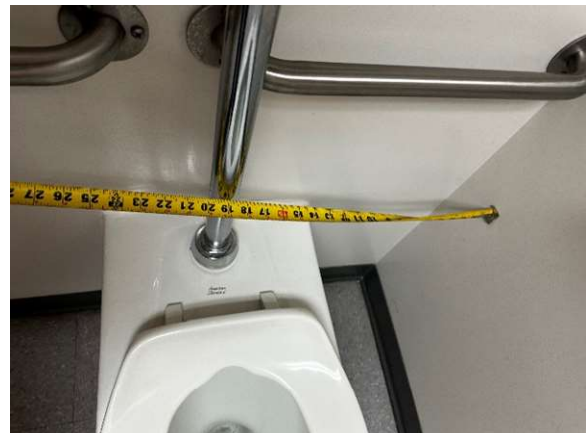
Toilet centered too far from side wall

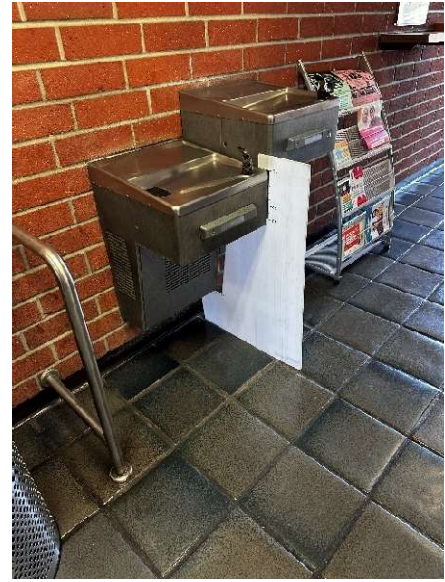
There is a public drinking fountain located at the rear of the building near the parking lot entry. It is currently not operational. Inspection was limited to dimensional clearance requirements.

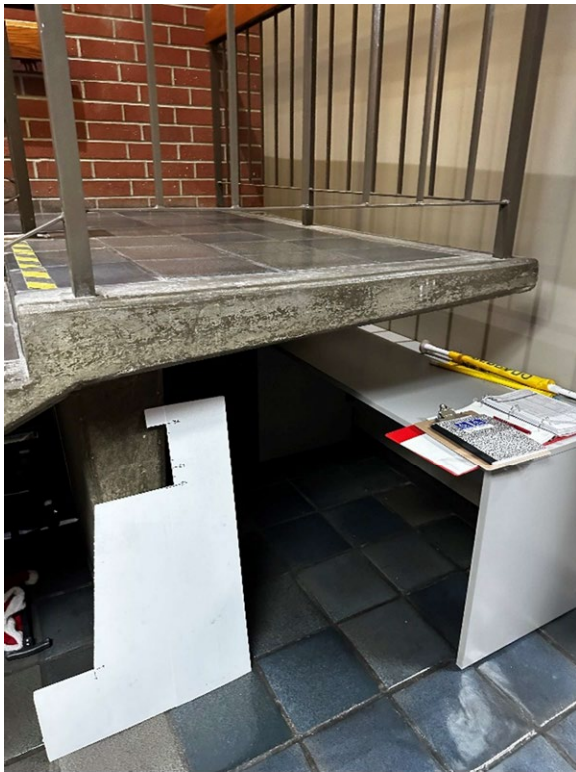
Non-compliant clearance under stair landing

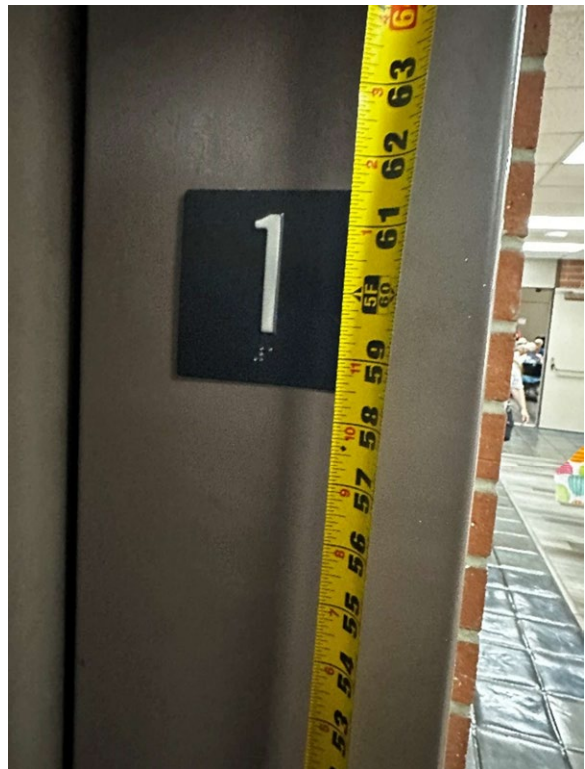
- Incorrect jamb signage at first floor (missing STAR)
- Closing timing adjustments required

Incorrect Jamb Signage at First Floor Landing

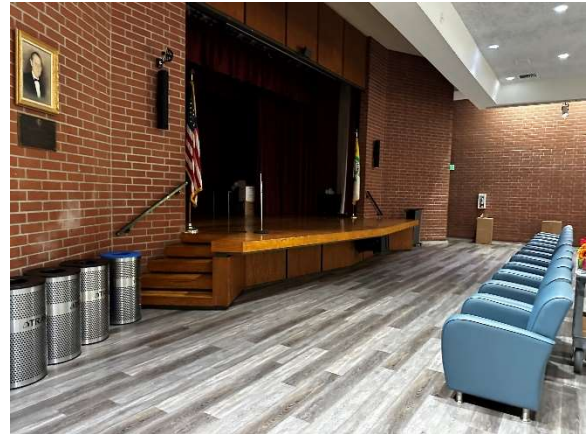
Auditorium

There are stairs at either side of the stage. These stairs have handrails on the wall side only and taper from wide at the bottom to narrow at the top. To meet accessibility, these should be removed and rebuilt with compliant widths and handrails.

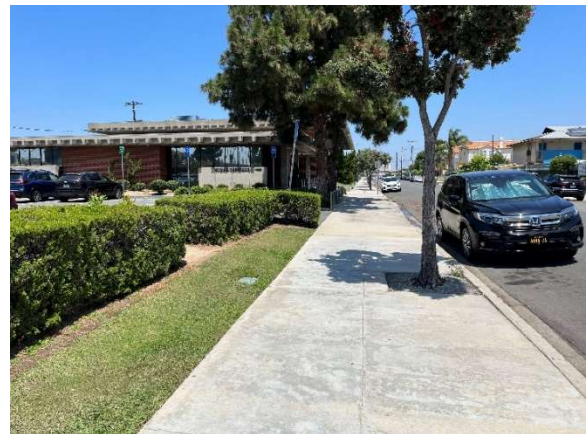
Public Sidewalk at W. 162nd Street

The primary path of travel to the gymnasium and office entrances is along the public sidewalk via a ramp and stair at each entry. Since the sidewalk is part of the public right of way, the city should regularly inspect, maintain and repair any uneven cracks, broken or heaving concrete along the accessible path of travel.

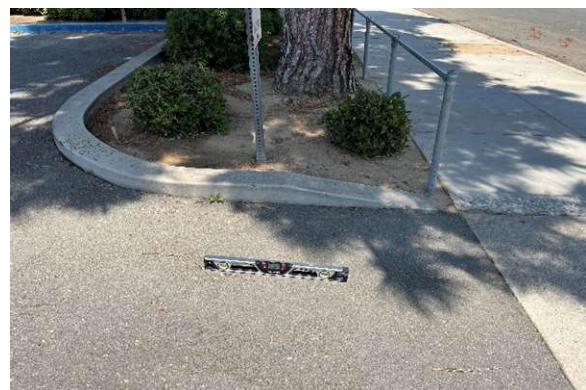
This building is located directly adjacent to the public sidewalk along W. 162nd Street. There are separate entrances to the gymnasium and office space. The parking lot is just to the south of the building. There is no compliant accessible route from the parking lot to the building entrances. See Parking section below for complete details.

Non-compliant Path of Travel from Parking Lot

- Restriping to compliant width.
- When restriping, ensure all diagonal hatches are provided at compliant maximum spacing.
- Repainting NO PARKING at entry end of aisle.
- Providing a compliant path of travel to the public sidewalk and continued path of travel to both the gymnasium and the office space.

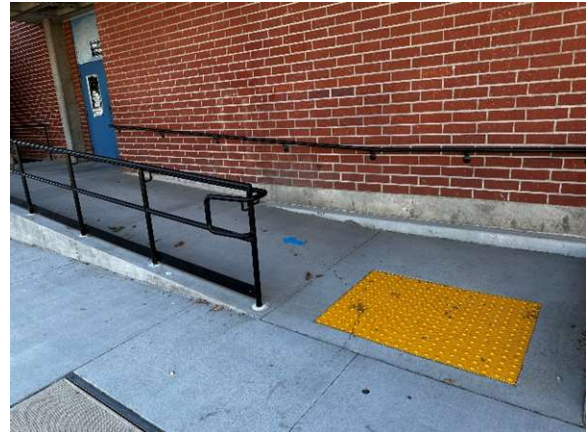
Gym Entry Ramp

- The lower landing has non-compliant slopes
- The ramp cross slope is too steep
- The detectable warnings at the bottom of the ramp are not required. This is not an interface with a hazardous vehicular way

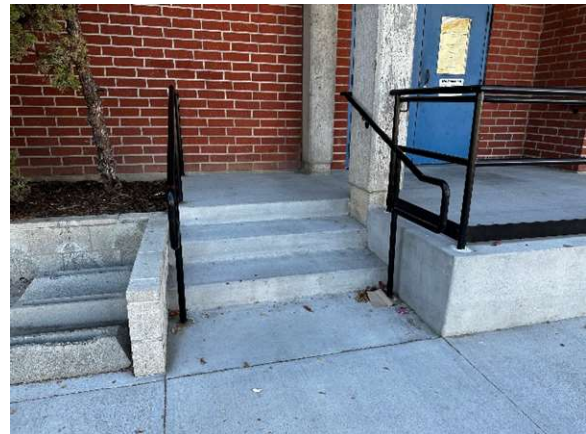
Gym Entry Stairs

- The bottom landing slope is slightly too steep
- The handrail extensions are too short
- The contrasting stripes at the stair nosings are missing

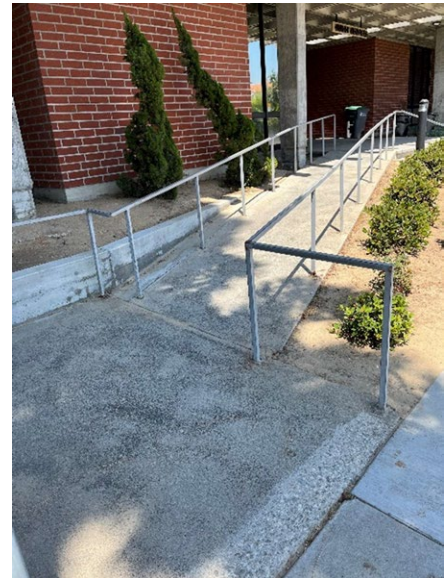
Office Entry Ramp

See DOOR2 Checklist for complete details.

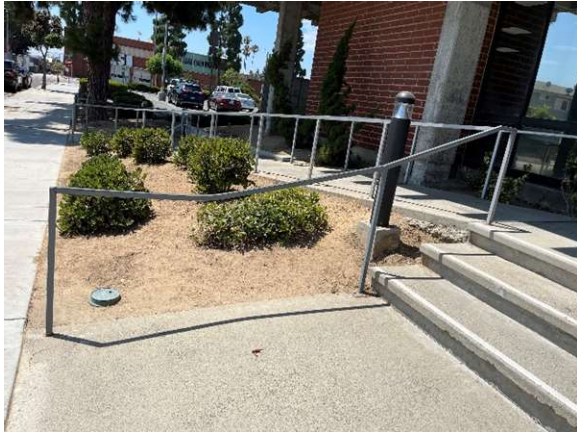
Office Entry Stairs

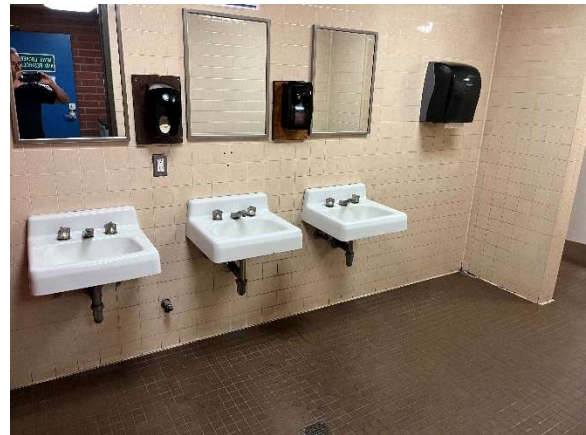
Both gym restrooms are severely non-compliant and require major renovation to provide require accessibility. Key areas in need of replacement include:

- Inadequate restrooms signage.
- Marginally accessible lavatories.
- No accessible toilet compartments.
- No accessible urinal in the men’s restroom.

Men's Restroom Lavatories

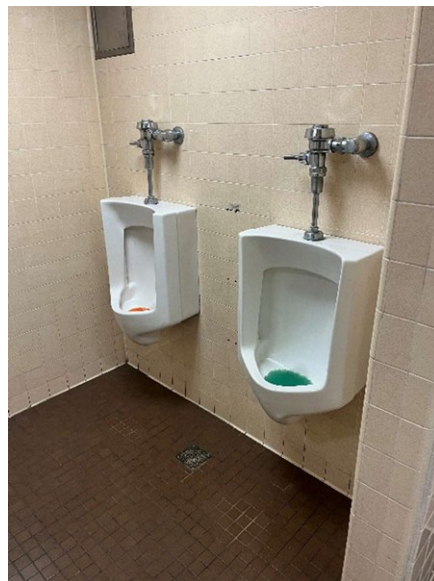
Non-compliant Urinals

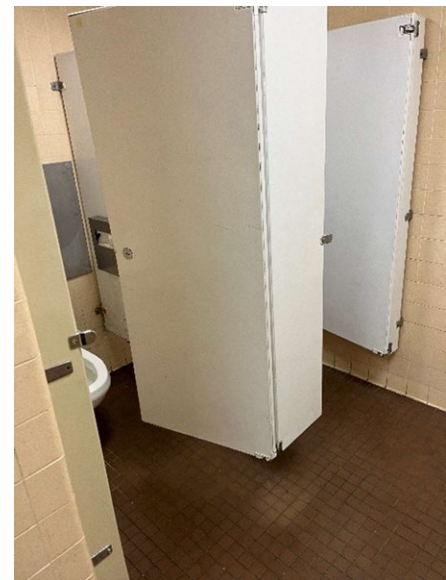
Men's Toilet Compartments

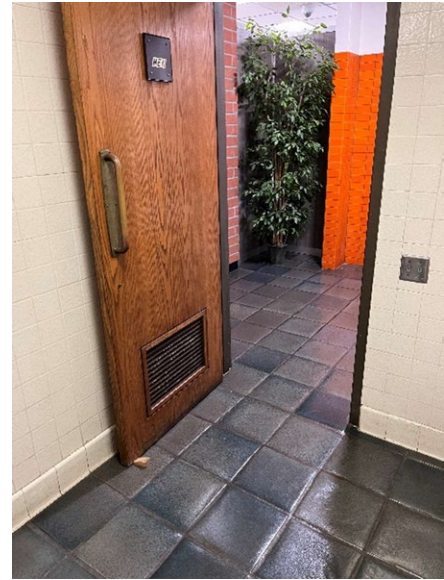
- Inadequate entry signage
- Entry door is too narrow
- Door operation requires adjustments
- Lavatories mounted slightly too low
- Lavatory accessories mounted too high
- Urinal controls too high
- No accessible toilet compartment

Men's Restroom Entry

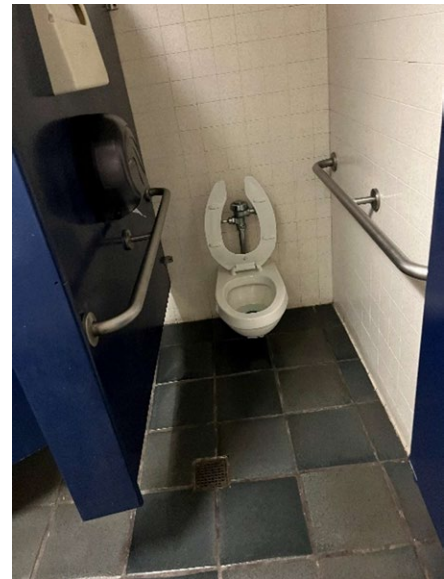
Men's Toilet Compartment

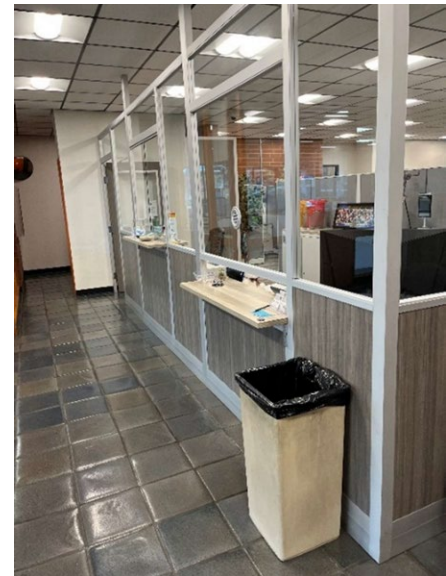
In the office public lobby, there are both a high and low service counter. The lower counter is fully accessible and no repair work is required.

Reception Counter

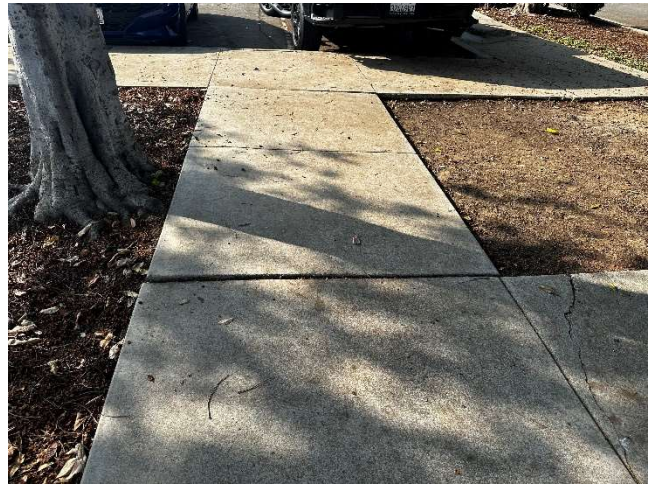
Heaving Concrete Walkway

In general, accessibility is provided throughout the park. However, there are walkways along the perimeter of the basketball courts that have non-compliant cross slopes and/or damaged concrete should be repaired or replaced. A full civil engineering site survey should examine walkway slopes and areas requiring replacement.

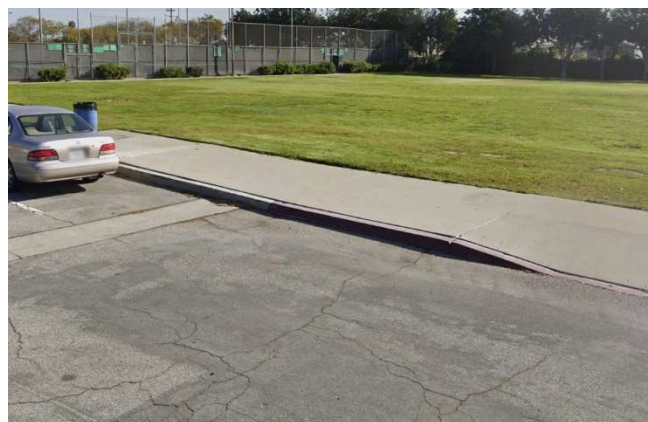
Concrete Walk adjacent to Sports Field

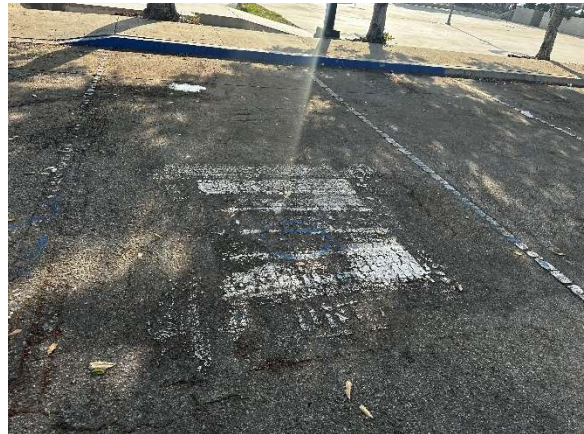
Parking Space 1

- Complete restriping and marking at parking space and access aisle
- Installation of signage
- Minor repairs to slopes at access aisle
- Repaving of parking space and access aisle
- Removal and replacement of curb ramp with compliant installation.

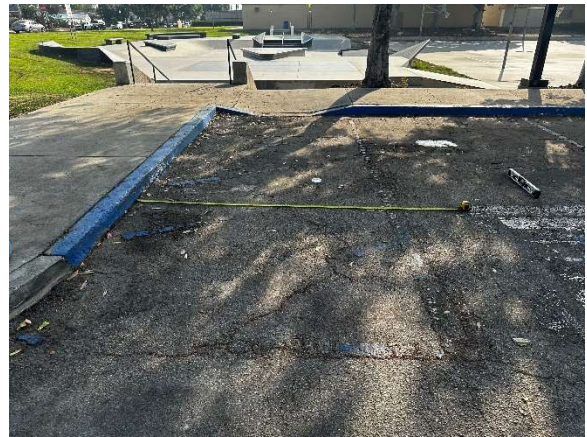
Access Aisle 1

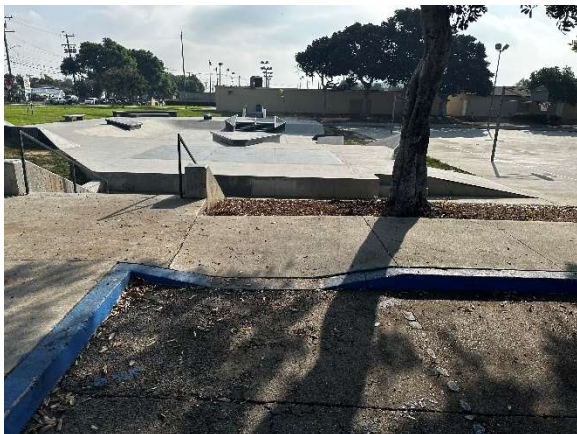
Non-compliant Curb Ramp 1

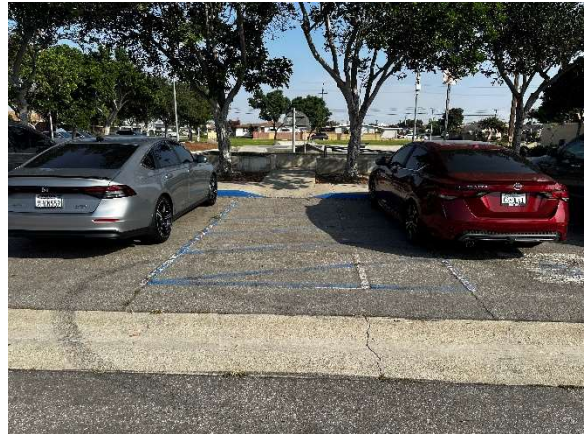
Parking Spaces 2 & 3

- Complete restriping and marking at parking spaces and access aisle
- Installation of required signage. If Van accessible space is included, add correct sign
- Minor repairs of slopes at front of spaces and access aisle
- Remove and replacement of curb ramp and modify top landing to connect to accessible path of travel

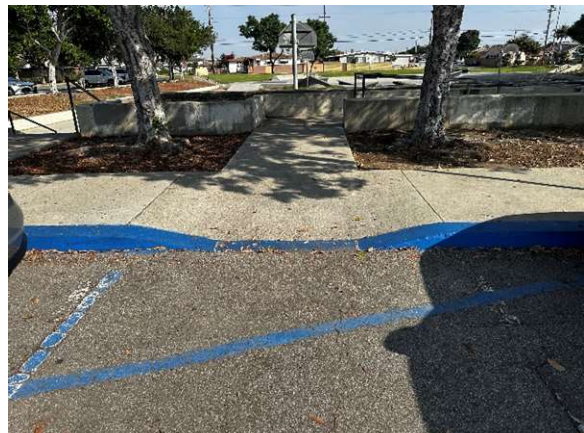
Curb Ramp at Parking Spaces 2 & 3

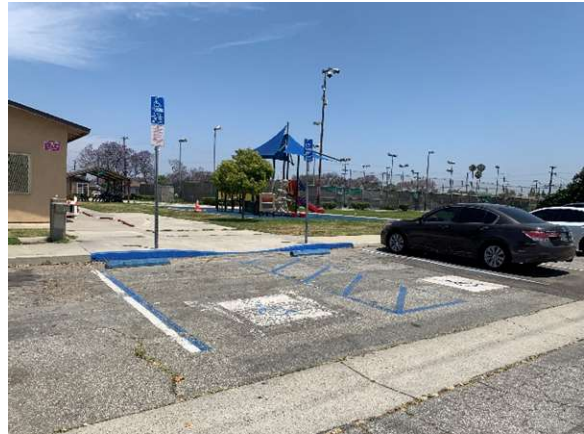
Parking Spaces 4 & 5

- Complete restriping and marking at parking spaces and access aisle
- Minor slope correction required at Parking Space 5
- Modify transition between curb ramp and access aisle
- Add detectable warnings at bottom of curb ramp.

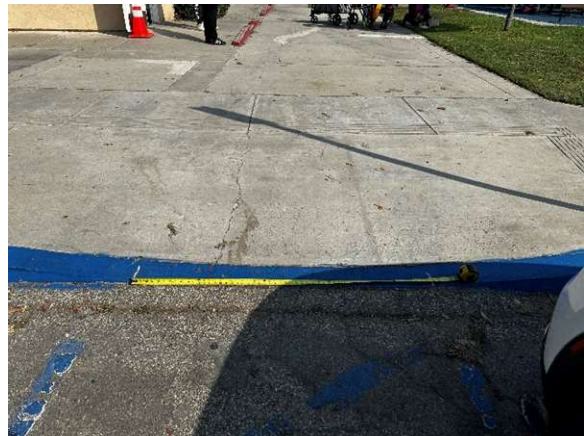
Curb Ramp at Parking Spaces 4 & 5

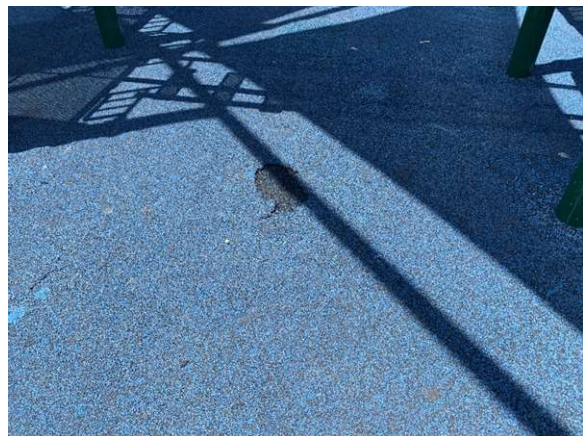
Rubberized Surface Damage

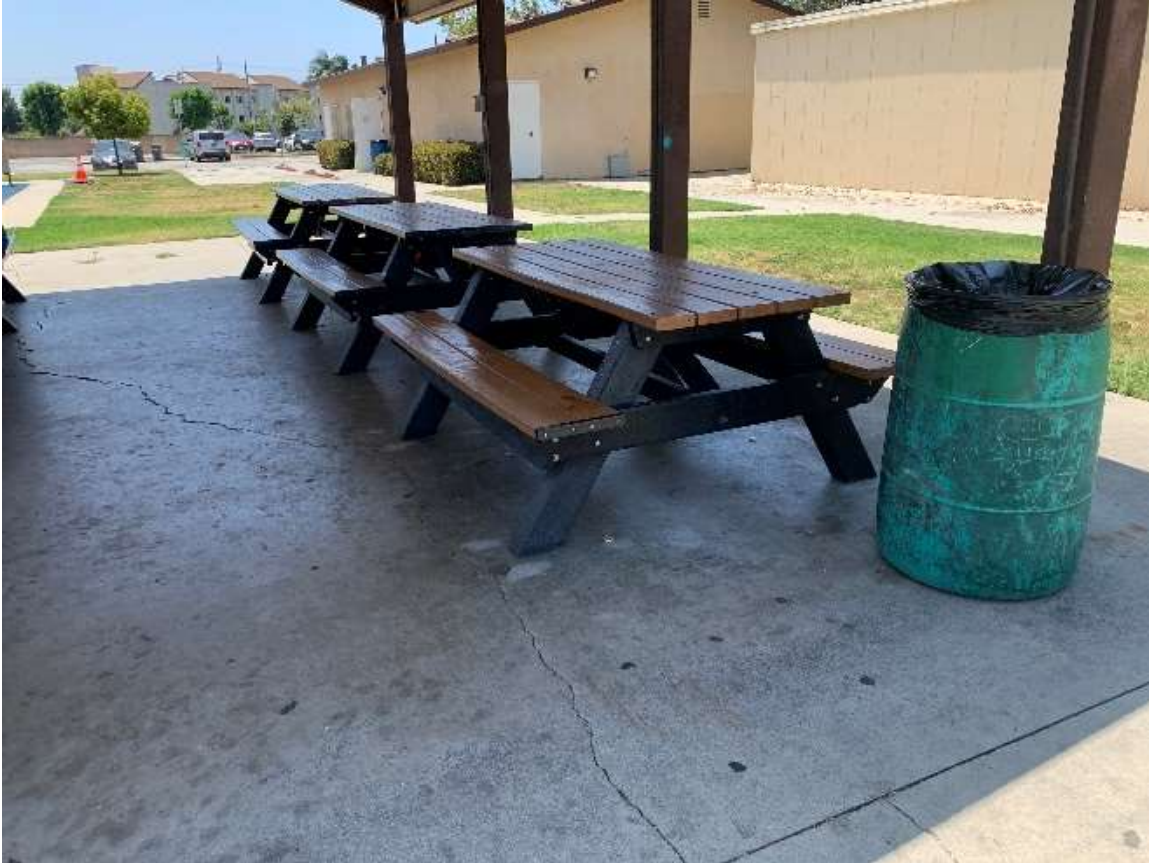
There is one covered picnic area provided at this park with six 6-person picnic tables. The ground surface is entirely concrete and is fully accessible. However, there are no accessible picnic tables provided. A minimum of 5% of the total seating should be accessible. Based on the total number of seating provided there should be a minimum of 2 accessible seating locations.

Covered Picnic Area

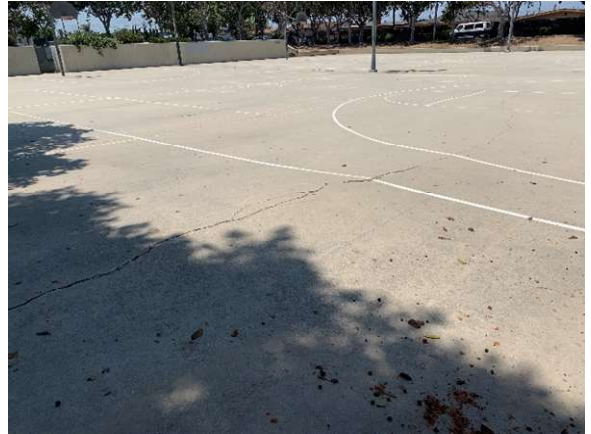
Additionally, there is significant cracking and heaving within the concrete area of play. Repair of the basketball court surface should be planned.

Cracked Basketball Courts

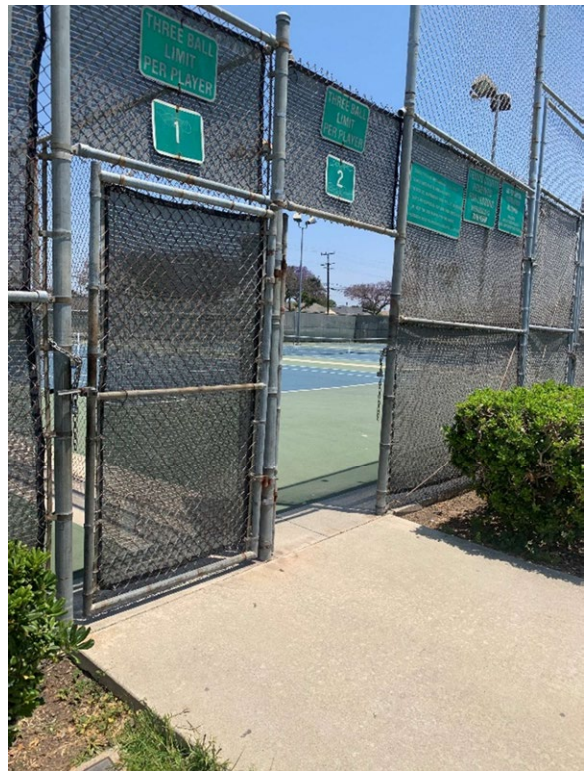
The latches on the entry gates are centered at 54" above the ground surface. Additionally, the latches are difficult to operate. It is recommended that the gate latches be replaced with compliant latches within acceptable reach ranges.

Tennis Court Gate

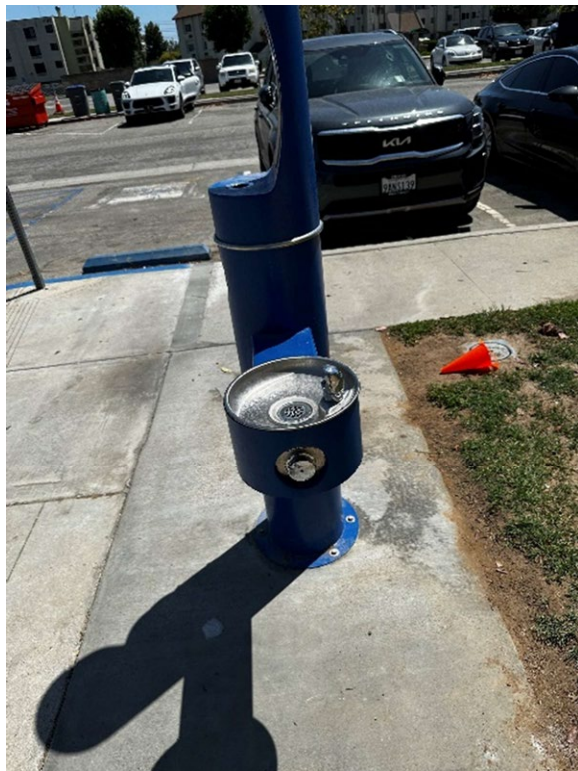
There is one recently installed drinking fountain and water bottle filling station. This station meets accessibility requirements and is a replacement for the original non-compliant drinking fountain (shown below). No repair work is required for the new unit.

New Drinking Fountain and Water Bottle Filling Station

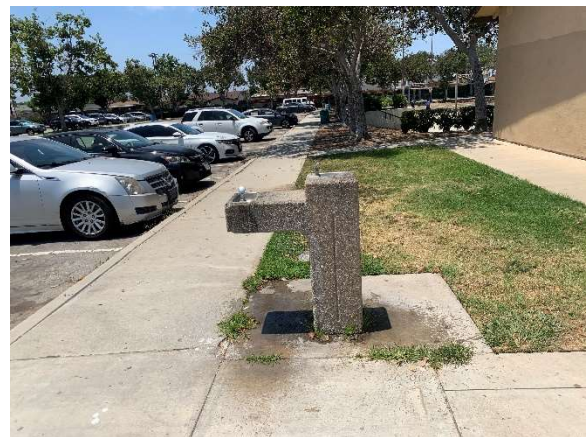
Original Drinking Fountain (recently replaced)

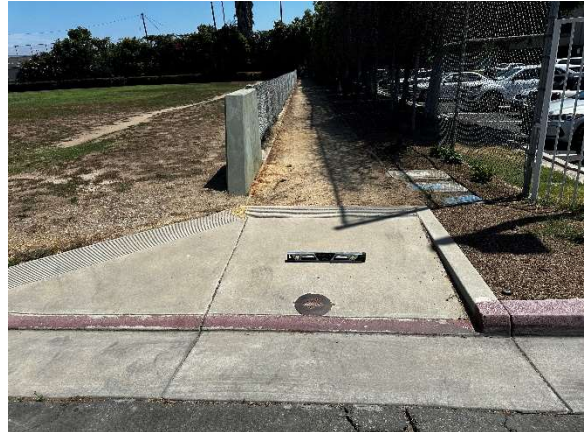
The slopes of the existing curb ramp are compliant. However, there is no compliant top landing. The concrete ends at the top of the ramp with an abrupt drop to the dirt pathway. Additionally, the bottom of the ramp exits directly into the vehicular way and does not connect to any pedestrian route. There are no detectable warnings at the bottom end of the curb ramp. It is recommended that a new concrete walkway is added from the area of the curb ramp leading to Johnson Park along the western edge of the sports field. When adding a new walkway, an upper concrete landing of the curb ramp should be installed.

Curb Ramp Approach

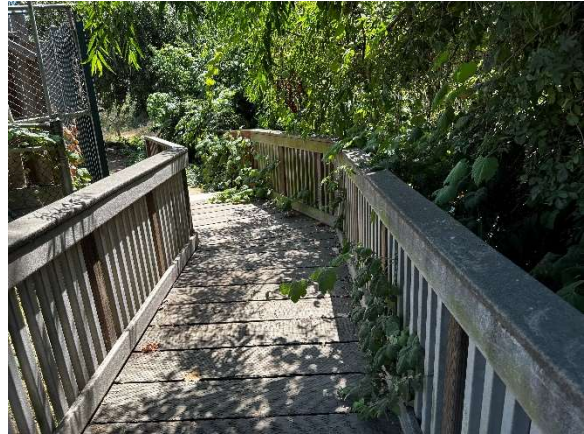
Entry Bridge

- Install compliant handrails on both sides of the bridge with 12" minimum extensions.
- Compliant landings should be included at both ends of the bridge. Top landings must be 48" long and bottom landings must be 72" long.
- Infill the plank gaps that are greater than $\frac{1}{2}$ " in width.

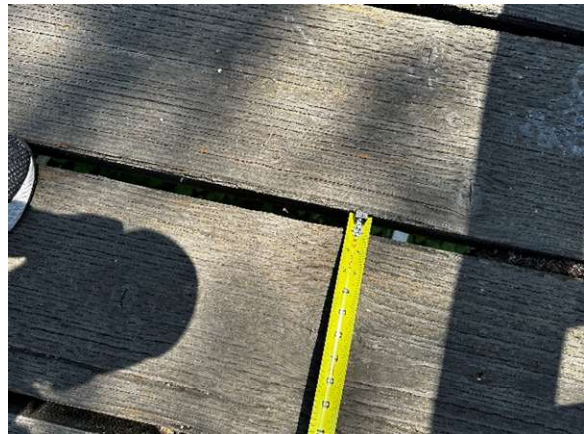
Typical Bridge Plank Gaps

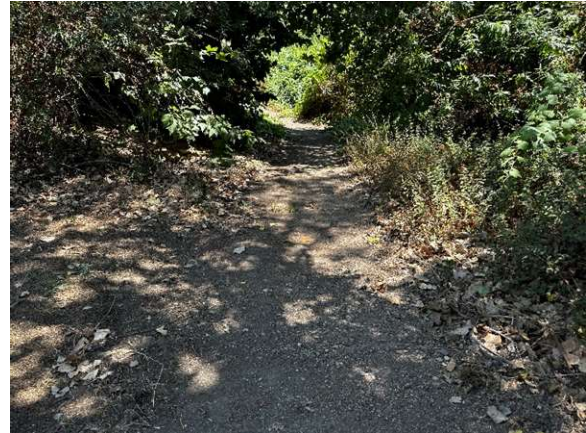
In general, all pathways marked in green on the Wetlands map should be cleared to provide 48” wide walkways. Uneven or rutted surfaces in these areas should be regraded and compacted. Signage should be included throughout the Preserve at all junctions to identify the recommended accessible path of travel.

Narrow Path on West Side

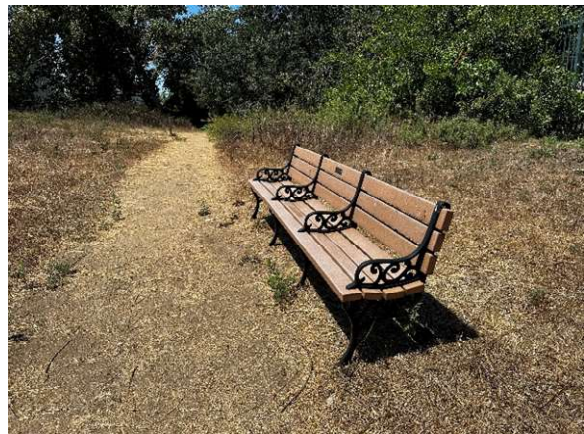
There are several benches located throughout the Preserve along the existing pathways. Where feasible, adjacent level spaces that are 36” wide by 48” deep should be created for wheelchair users.

Pathway Bench

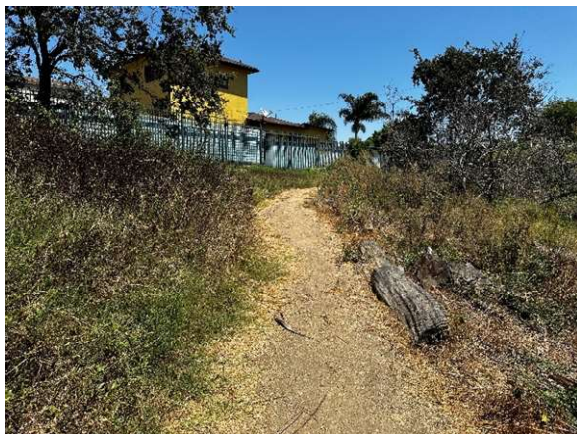
Steep Path on North Side beyond the Overlook

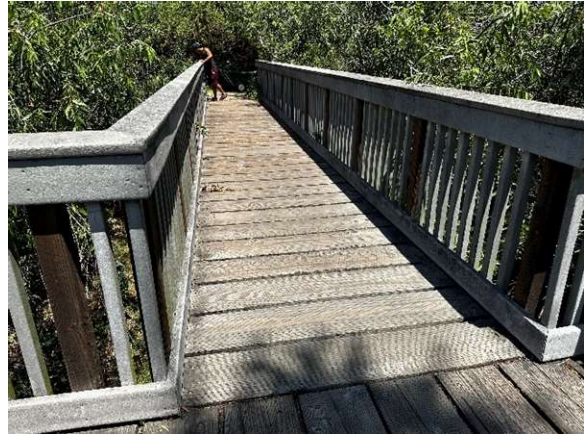
The bridge to the Overlook viewing area is generally accessible. The walking surface has slopes less than 5% and is in good condition. There is a bench provided at the Overlook and there is adequate turning radius space within the deck area. Similar to the Entry Bridge, there are gaps in the planks as wide as 1". These should be modified to gaps no greater than ½" wide.

There are guardrails at all areas of the Overlook Bridge and viewing area that are 42" high, meeting compliance requirements for drop-offs greater than 30" high.

Bridge to Overlook
