CITY OF GARDENA PARKS AND RECREATION MASTER PLAN APPENDIX

2024

Appendix Table of Contents

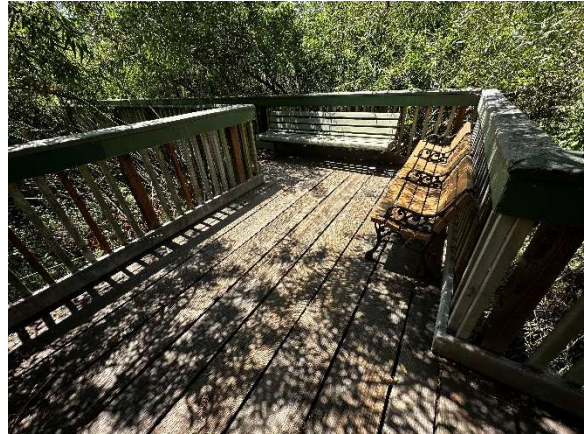
The Zigzag bridge is on the most accessible route to the Amphitheater and Educational Center areas. It is generally accessible and provides a level route across the wetlands area below. Similar to the Entry Bridge and Overlook, the walking planks have gaps up to 1" wide. These should be modified to ½" maximum. The ground at the entry end of the bridge has degraded and does not provide a level transition. The surface should be leveled and stabilized to provide a smooth level pedestrian path.

The guardrails on either side of the bridge are 42" high, meeting compliance requirements for drop-offs greater than 30" high.

Zigzag Bridge

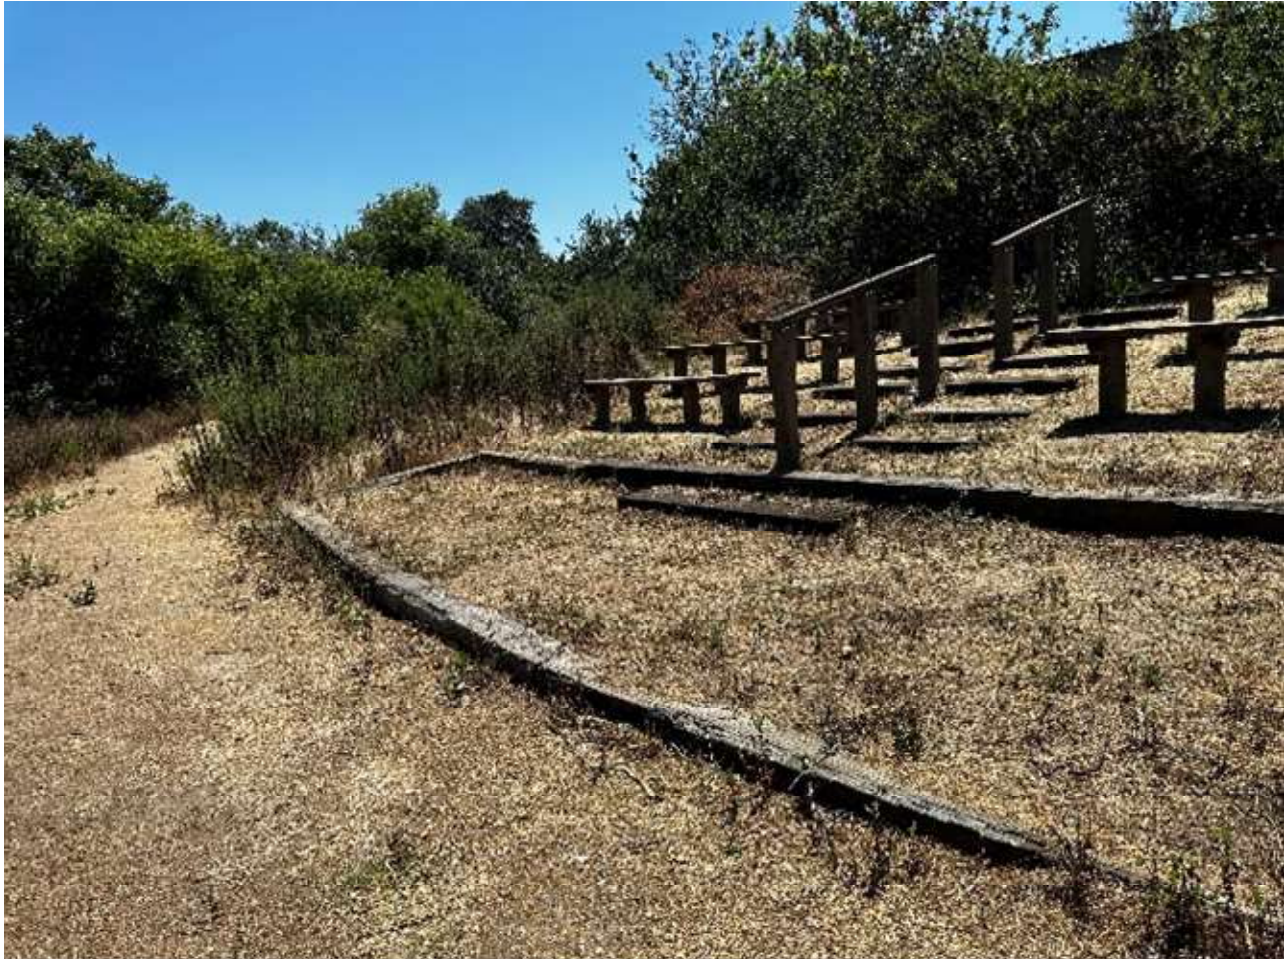
The amphitheater is a relatively minimally improved space for outdoor gatherings and presentations. There are no dedicated seating areas for wheelchair users. While wheelchair users could be seated along the walkway area, a dedicated space for wheelchairs with a companion bench should be considered to improve accessibility.

Amphitheater

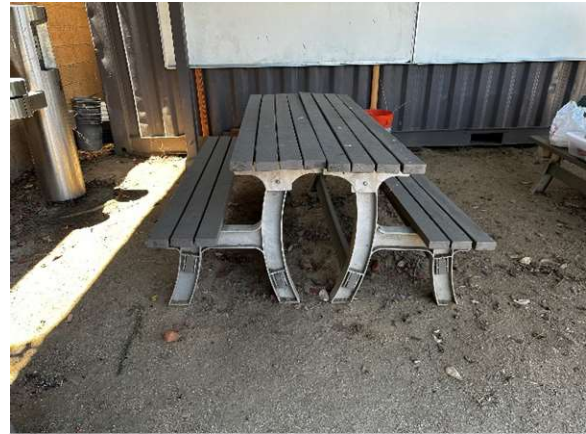
There are two picnic tables located at the covered area. Neither table have a dedicated wheelchair space and takes up much of the hard surface area. Additionally, the table blocks clear access to the water bottle filling station unit provided at the back of the gathering area. It is recommended that a clear pathway be created to provide access to the water bottle filling station. At least one of the tables should be replaced with one that provides an accessible area on one end and be placed on the accessible route.

Picnic Table

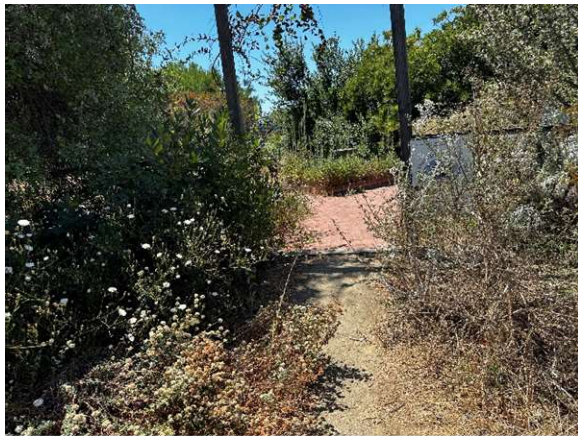
Mother Nature’s Backyard entry is overgrown and has uneven surfaces. Inside the area much of the walking surface is brick and provides an acceptable route. However, the entry route should be cleared and the transition from the dirt path to the brick path should be leveled to eliminate this barrier.

Mother Nature’s Backyard Entry

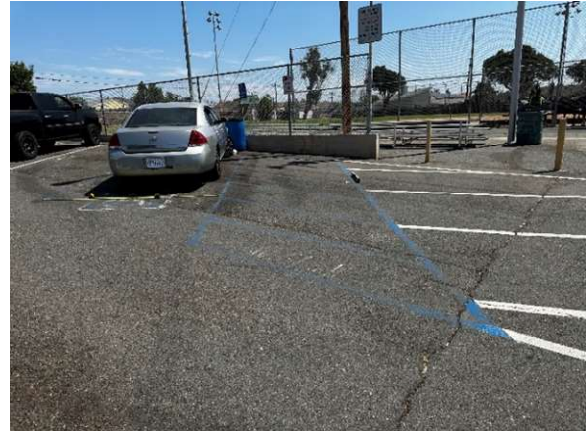
Parking Space 1

The parking lot associated with Freeman Park is strictly street-loaded along Cimarron Way. There are a total of 13 parking spaces including one accessible parking space and adjacent access aisle. In general, the parking area and route to the park include significant cross and running slopes which exceed the maximum allowable.

This is the only accessible parking space provided and is located at the far right end of the parking area. Among this parking space's deficiencies, the slopes at this parking space are significantly out of compliance.

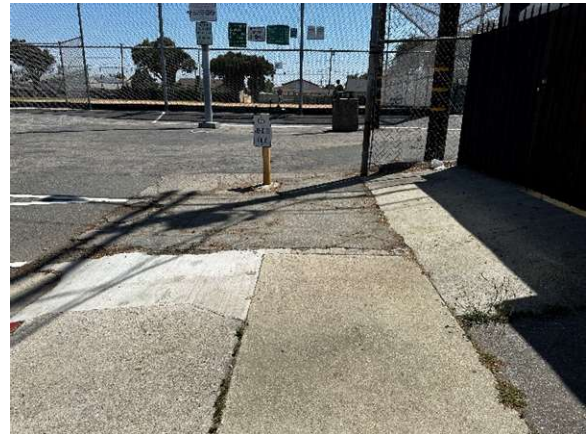
There is inadequate pedestrian access into the park at the end of W. 154th Place. Additionally, there is a short site stairway with no handrails leading from Parron Avenue into the park on the south side. The walkway from the stair into the park stops after several feet and does not provide adequate access. This walkway should be extended into other walkways within the park.

Sidewalk Entrance at 154th Place

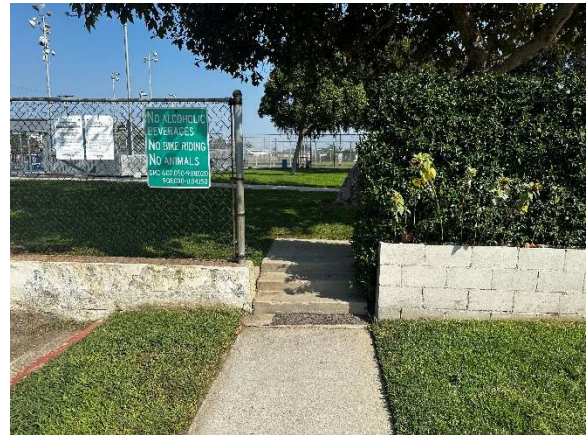
There is a pedestrian entrance to the park at the north end of Parron Avenue. This concrete walkway enters the park with a non-compliant stair. The sidewalk ends abruptly at the top landing and does not connect to any accessible path within the park. Handrails should be added to the stair and the concrete path should be extended to other paths within the park.

Sidewalk Entrance at Parron Avenue

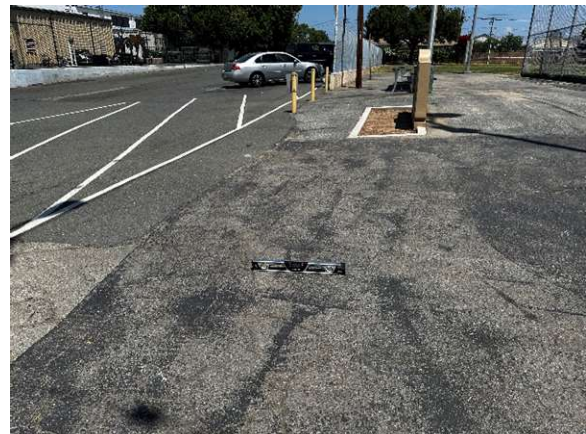
The pedestrian route from the accessible parking space is not defined and has non-compliant cross slopes. Similar to the path of travel at 154th Place, a new accessible path that is clearly identified should be created. This work should be in conjunction with modifications to the accessible parking that creates a level surface. See Parking section in this report.

Pedestrian Route from Accessible Parking

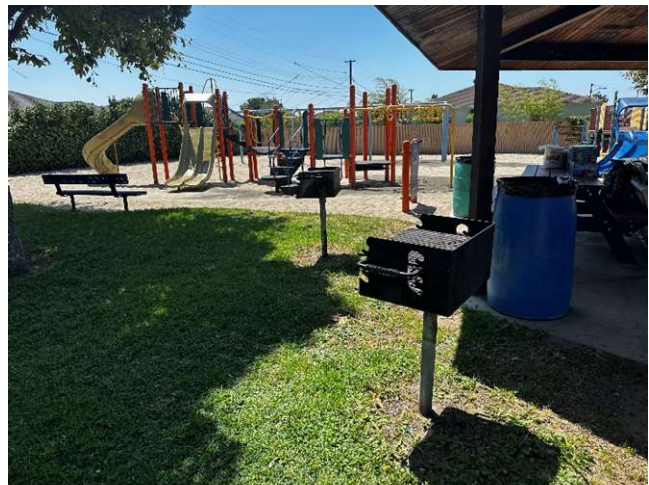
Barbeques

Adjacent to the picnic area, there are two barbeque grills. The path to the barbeques includes an uneven grass area. Neither barbeque adequately meets accessibility standards. It is recommended that at least one barbeque is replaced with an accessible unit and a compliant access route be provided.

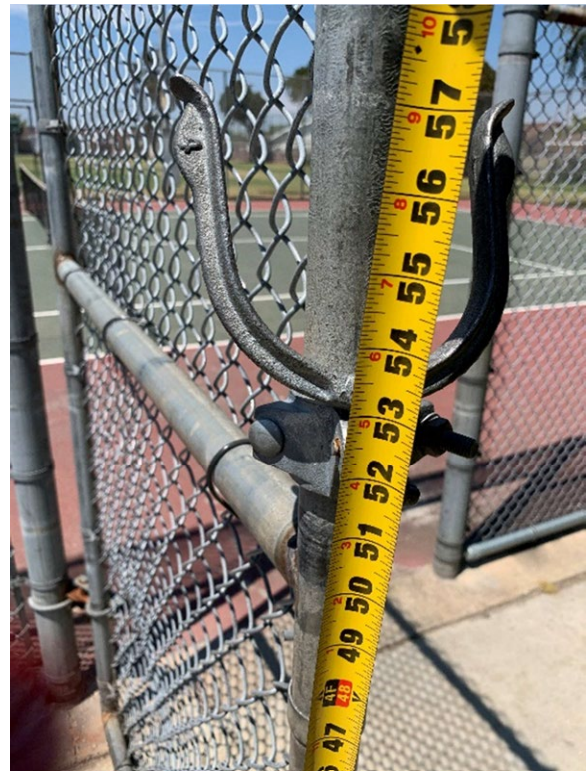
There is one tennis court provided in this park. The exterior walkway to the court is level and accessible. Interior walkways around the court are also accessible and require no modifications. However, the entry gate hardware is mounted too high and is difficult to operate and should be replaced.

Tennis Court Gate Mechanism

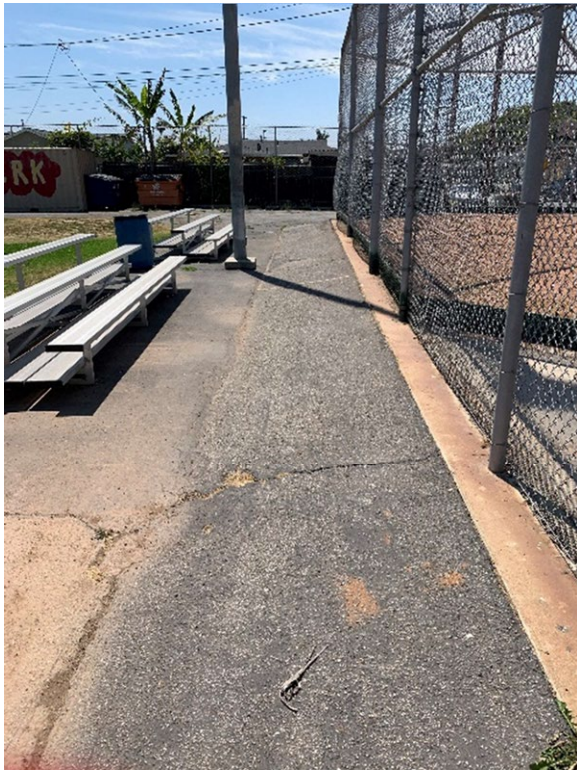
There are small bleachers on either side of the field. While there is adequate paved surface adjacent to both bleachers, the walking surfaces have steep cross slopes, limiting accessibility to each location. Significant asphalt modification is required to provide adequate spectator access on both sides of the field.

Right Field Bleachers

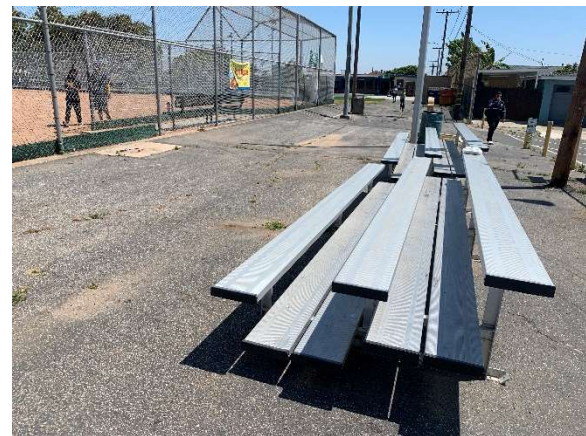
Left Field Bleachers

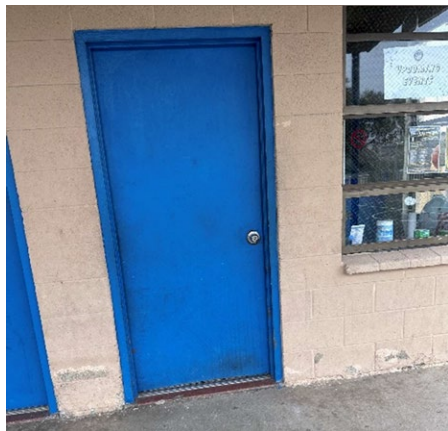
The office door has a non-compliant knob which should be replaced with lever hardware.

Office Door

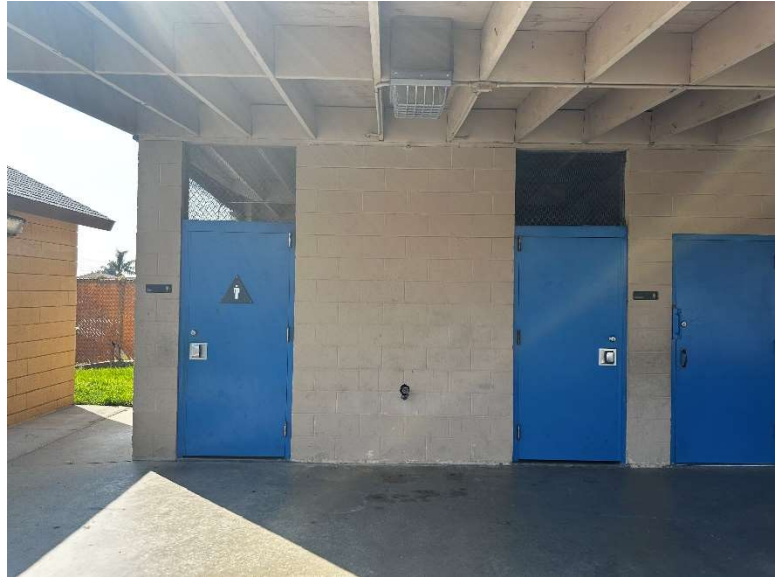
There are two restrooms within the public building. Upon inspection, neither restroom is nearly compliant. Modifications to provide full access would be extensive. However, the standalone restroom building adjacent to these restrooms provides greater access (with minor modifications as listed below). The two gender-specific restrooms should be upgraded with new compliant restroom signage and additional signage identifying the standalone restroom as the accessible facility.

Gender-Specific Restroom Doors

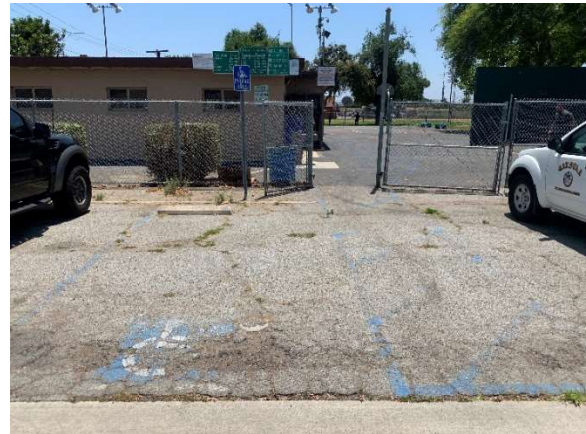
The sole accessible parking space and adjacent access aisle are in extremely poor condition. The striping is nearly gone and the pavement is in need of full replacement.

Existing Accessible Parking Space

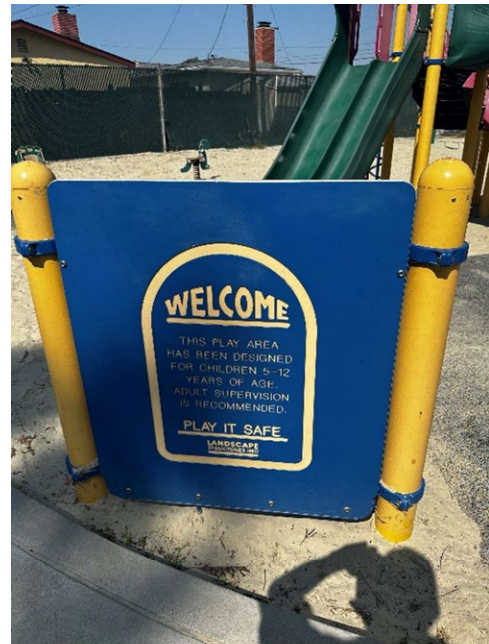
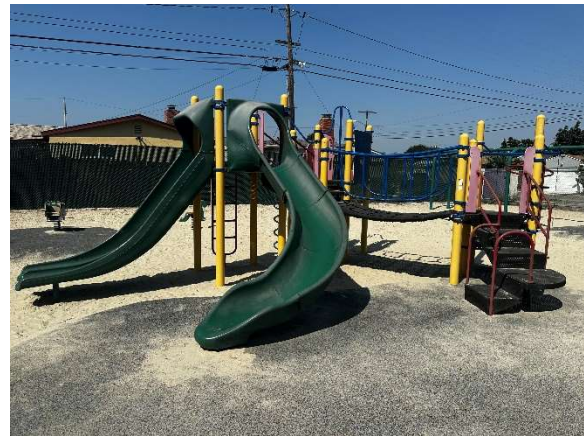
Play Structure

The large play structure is designed for children 5 to 12 years old. It includes two slides. It is in satisfactory condition.

There is a stairway within the play structure leading from the transfer platform. The stairway width is approximately 24" with 8" risers. Handrails are provided on both sides at approximately 24" above the riser nosings. Handrails are 1" in diameter. The structure stair assembly should be considered access compliant.

In general, this play structure is in acceptable condition and meets accessibility requirements and does not require replacement.

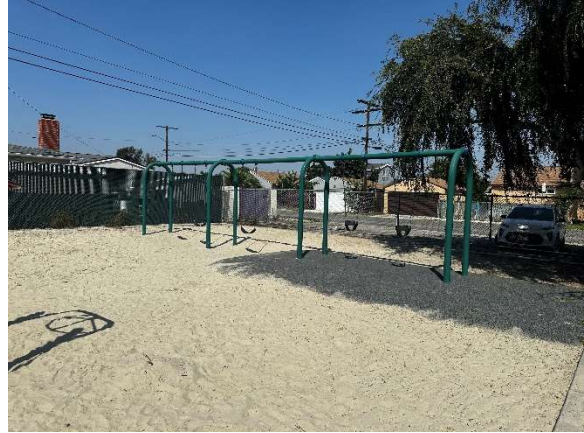
Swing Set

The swing structure includes two bucket swings and three belt swings. The bucket swings are mounted over the padded rubberized surface and the three belt swings are mounted over sand. This meets the requirements for accessibility at the swings.

In general, the swing set is in acceptable condition and meets accessibility requirements and does not require replacement.

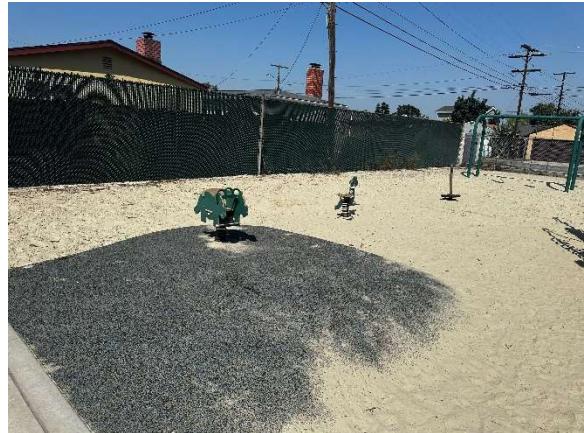
Play Equipment

There are three freestanding play equipment elements including two spring riders and a post platform. One of the spring riders is mounted on the rubber surface and the other rider is mounted in the sand area. The post platform is mounted in the sand area. All are in satisfactory condition and meet accessibility requirements and do not require replacement.

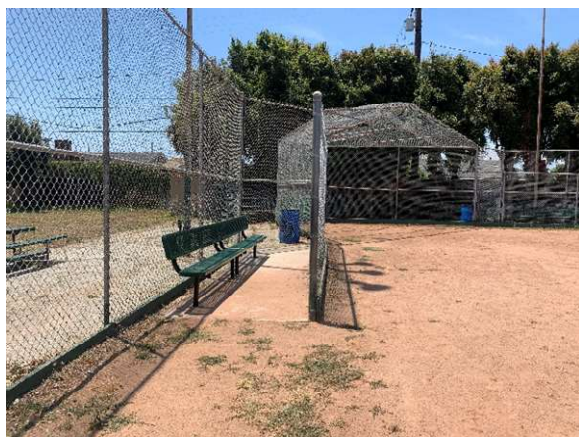
Dugout Seating

The existing dugouts on both sides of the infield have concrete surfaces. However, neither dugout has an adjacent level space for a wheelchair occupant to sit adjacent to the benches.

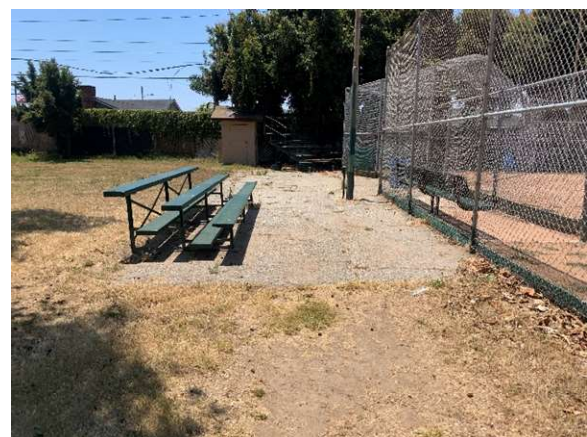
Bleachers

The bleachers at the baseball field are mounted on existing asphalt surface, which is in poor condition. Additionally, there are no accessible pathways to the spectator area.

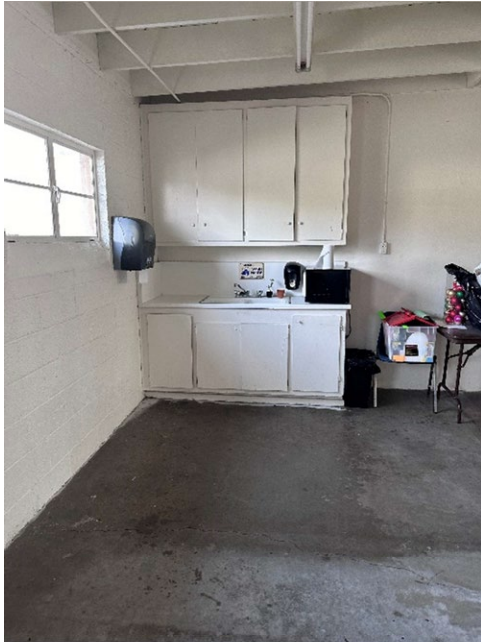
Cabinetry

In general, the assembly rooms meet access compliance requirements. However, there is a cabinet with a sink in the smaller assembly room. This cabinet and sink should be replaced with a compliant installation. This includes a counter no higher than 34" with a sink is equipped with compliant faucets.

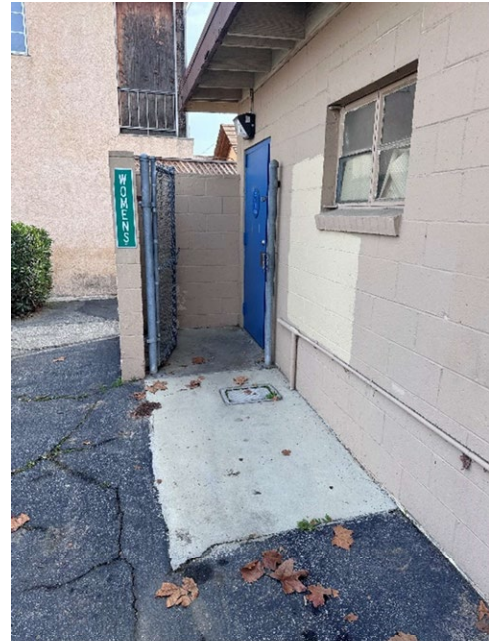
Women's Restroom Entry

The women's restroom faces the street-side of the property. Access into the space is limited due to the concrete block screen wall that encroaches into the required clear space. This should be removed and replaced so a 60" landing approach is provided. Additional required improvements to this restroom include the following:

- Adjustment of door closing speed and operating pressure,
- Modification of restroom signage,
- Adjustment of the lavatory height and offset from side wall,
- Insulation of under-lavatory pipes,
- Relocation of lavatory dispensers,
- Adjustment of toilet compartment closing mechanism and installation of handles on both sides of door,
- Modification of toilet location to provide 48" clear in front of bowl,
- Installation of compliant grab bars in accessible stall,
- Relocation of toilet paper dispenser.

Based on the current restroom configuration, it may be advisable to remove the toilet partition and create a single occupant restroom.

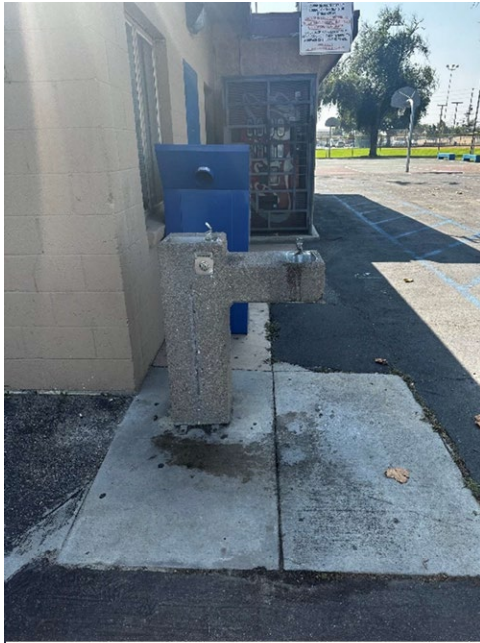
Drinking Fountain

There is one old-style concrete drinking fountain located near the park entry and adjacent to the community building. While it meets most of the dimensional requirements for accessible drinking fountains, it is recommended that the unit be replaced with a new high/low drinking fountain with water bottle filling station.

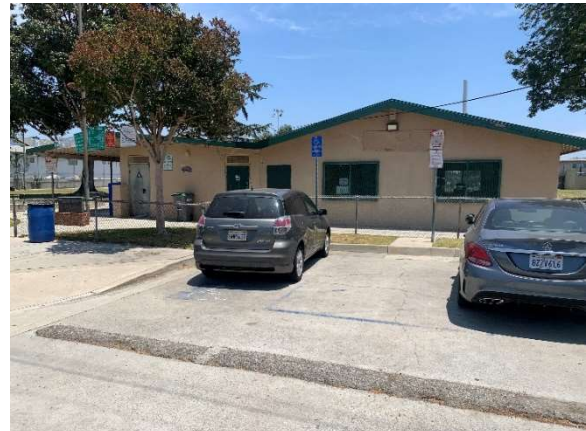
Accessible Parking Space

There is one accessible parking space and access aisle located along Halldale Avenue. A curb ramp is located to the left of the parking space providing a path of travel from the parking to the sidewalk and into the park. The parking paving surface is in satisfactory condition, however there is a speedbump installed along the street frontage which could encroach into the path of travel from the access aisle to the curb ramp to the left of the parking space.

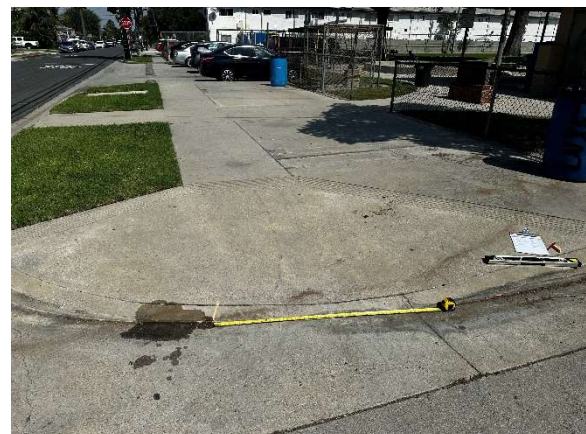
Curb Ramp adjacent to Parking

The existing curb ramp connects the parking path of travel to the public sidewalk that enters directly into the park.

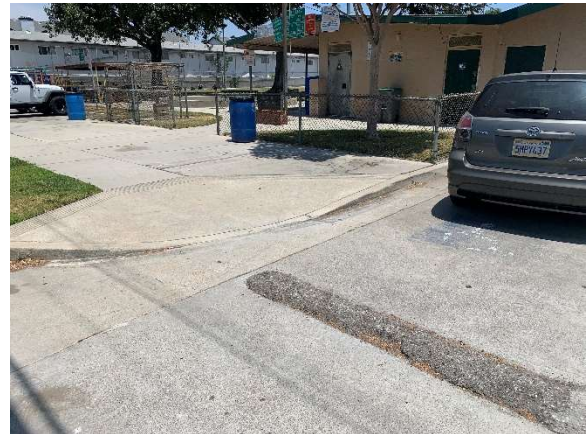
Halldale Avenue Pedestrian Entry

Pathways along the Halldale Avenue side of the park are in acceptable condition and provide continuous walkways between all activity areas. However, there is no accessible path provided to the baseball/softball seating area or the basketball half court.

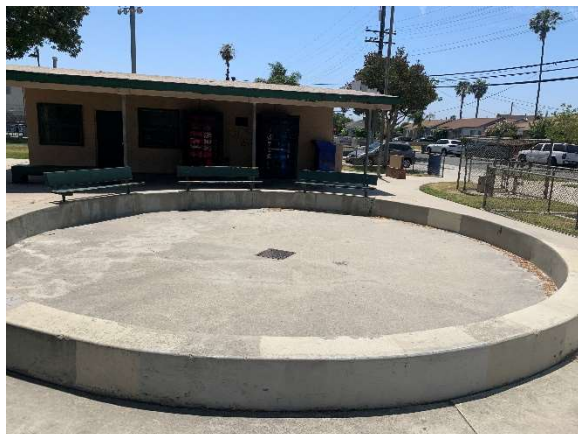
Circular Concrete Bench

There is also a circular concrete bench in the main park area. Surfaces around this feature are compliant. However, there is no access route provided into the center surface. It is unclear what the original intent was for this feature. Access improvements should be considered.

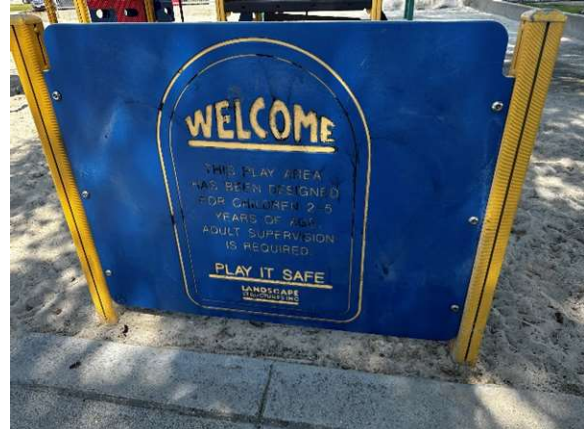
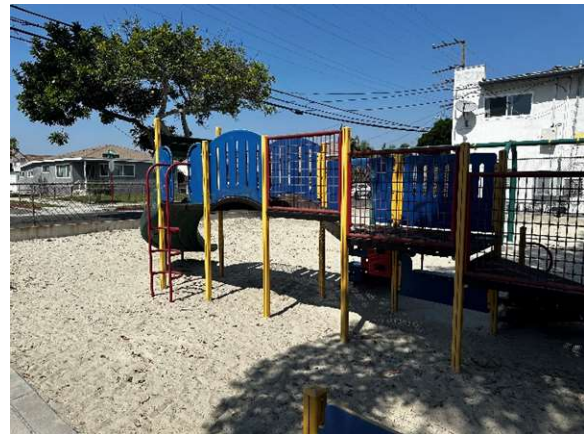
2 to 5 Year Olds Play Structure

The play structure also includes one transfer platform located on the padded rubberized material. The top of the platform is 15" above the ground surface (compliant). The flat surface is greater than 24" wide by 14" deep (compliant).

There is a stairway within the play structure. The stairway width is approximately 24" with 8" risers. Handrails are provided on both sides at approximately 24" above the riser nosings. Handrails are 1" in diameter. The structure stair assembly should be considered access compliant.

In general, this play structure is in acceptable condition and meets accessibility requirements and does not require replacement.

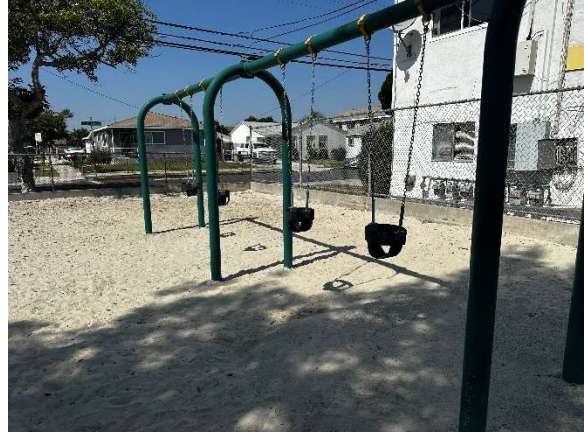
Young Children's Swings

The existing swing set includes four bucket-style swings. Three of the swings are located in the sand area and one is located over the padded rubberized material. There is a compliant accessible path of travel provided from the rest of the park to this location.

In general, this swing set is in acceptable condition and meets accessibility requirements and does not require replacement.

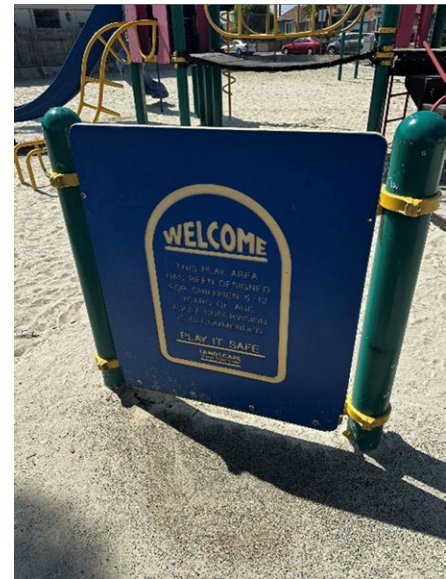
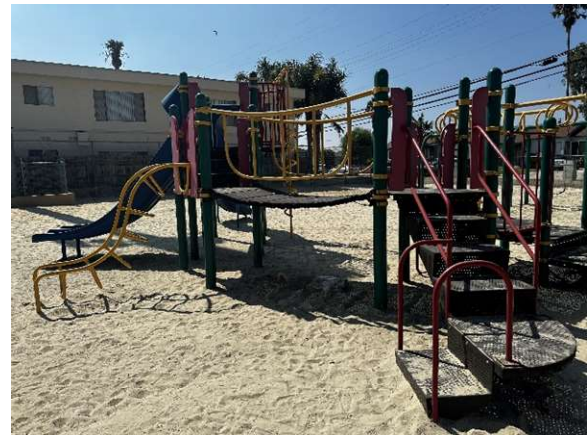
5 to 12 Year Olds Play Structure

The play structure includes 4 ground level play components areas and 4 elevated play components. These include the following:

- Ground Level
 - Climbing Ladder
 - Rings
 - Curving Ladder
 - Suspended Wheel
- Elevated
 - Double Slide
 - Curved Slide
 - Bridge
 - Spiral Pole

Based on four elevated play components, a minimum of one accessible ground level play component is required. The suspended wheel is the only ground level play component that is located on the padded rubberized material and is considered accessible.

In general, this play structure is in acceptable condition and meets accessibility requirements and does not require replacement.

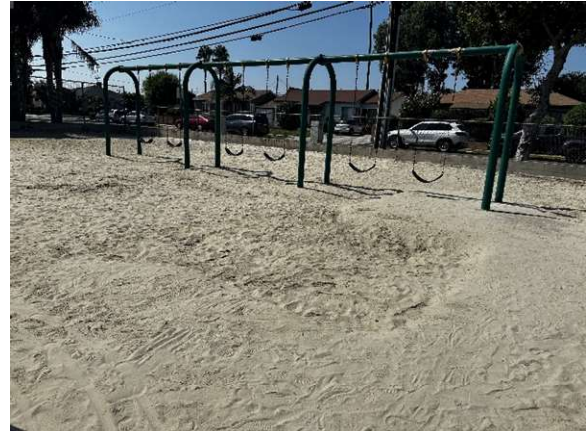
Older Children's Swings

In general, this swing set is in acceptable condition and meets accessibility requirements and does not require replacement.

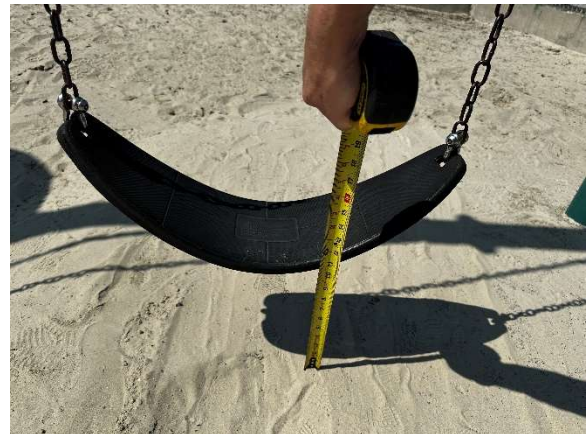
Accessible Swing

The padded rubber material below the accessible swing has significant wear showing. The surface should be repaired to provide a level surface under the swing.

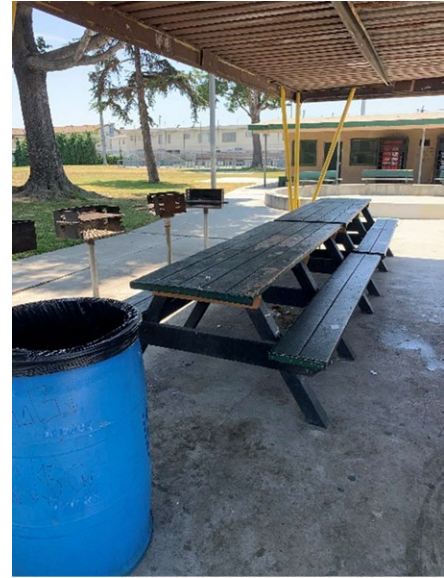
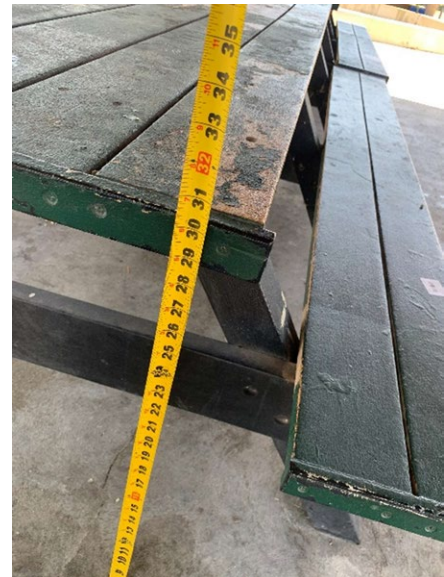
Picnic Table Clearances

There is one covered picnic area located within the park. There are four traditional wooden picnic benches that can accommodate approximately 24 to 32 persons. While the vertical table heights are compliant, there are no spaces provided for person in wheelchairs to utilize any of the tables. Based on the requirement for 5% accessible seating locations and the total number of existing seating locations, at least two accessible seating locations are required. It is recommended that all tables be replaced and a minimum of two tables provide accessible seating locations at the ends of the tables.

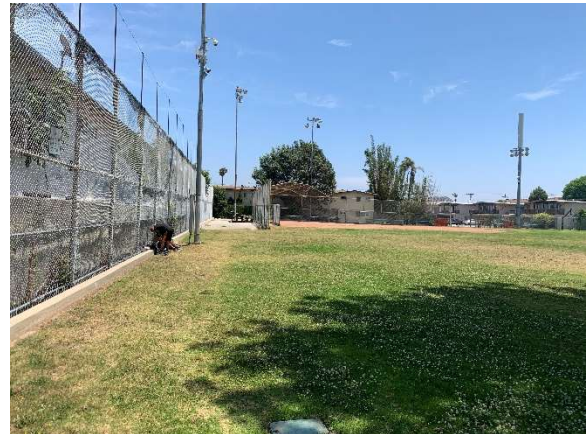
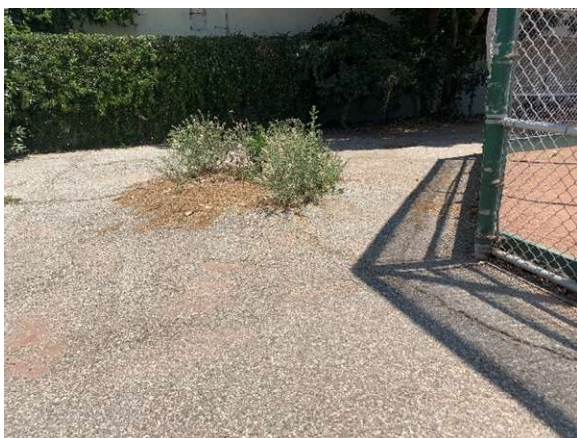
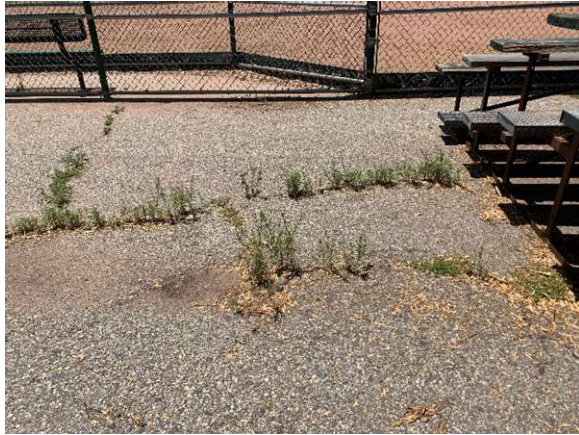
Typical asphalt condition at ballfield

The backstop for the ballfield is located at the northeast corner of the park. There are small bleachers on asphalt on both sides of the infield. While the ground surface is asphalt, it is in poor condition and there is no accessible path to these seating areas from the park. There is an asphalt pathway from the east entrance at the end of 148th Street. However, the asphalt is showing wear and should be rehabilitated. Additionally, a new accessible path of travel from the main park area to the spectator area should be provided with future park renovations.

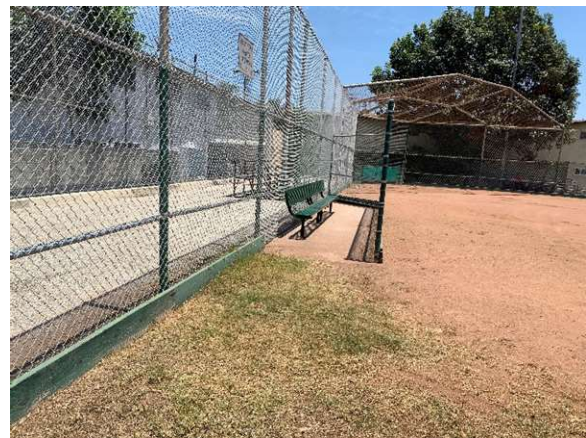
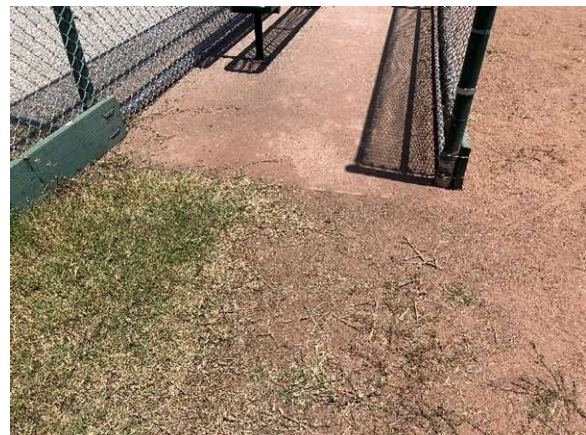
Dugout Surface Transition

While the dugouts are surfaced with concrete, the transitions between the dugouts and the sidelines are in marginal condition. Stable level surfaces from the dugouts to the entry locations should be provided with future renovations.

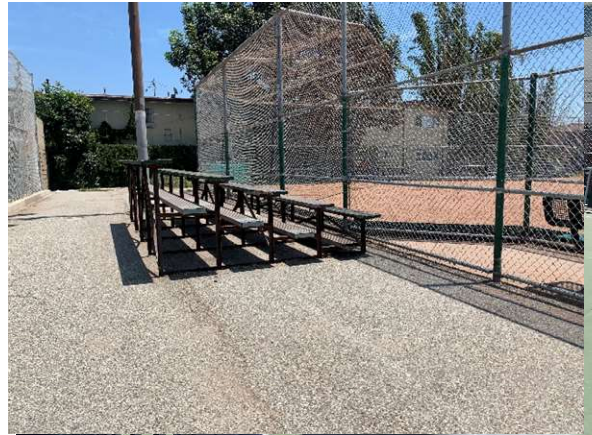
First Base Side Bleachers

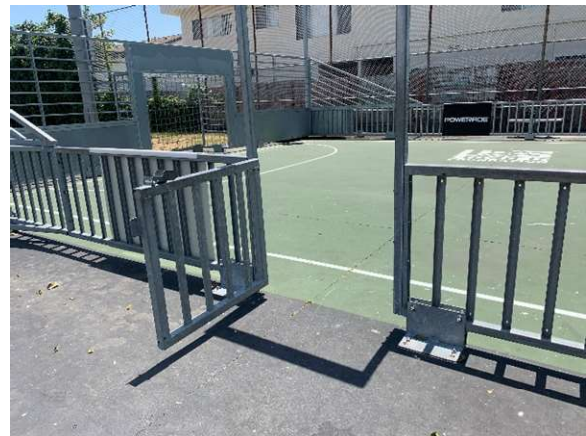
Mini-Pitch Court Gate

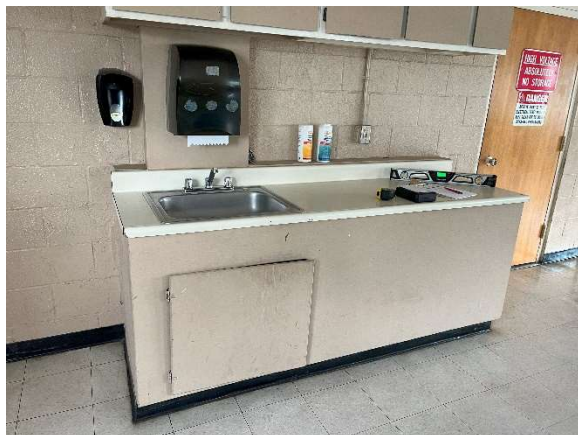
The community room also has one 36" high built-in cabinet with sink. This should be replaced with a 34" high cabinet assembly. Additionally, the soap and paper towel dispensers should be lowered to a compliant height.

Community Room Cabinet

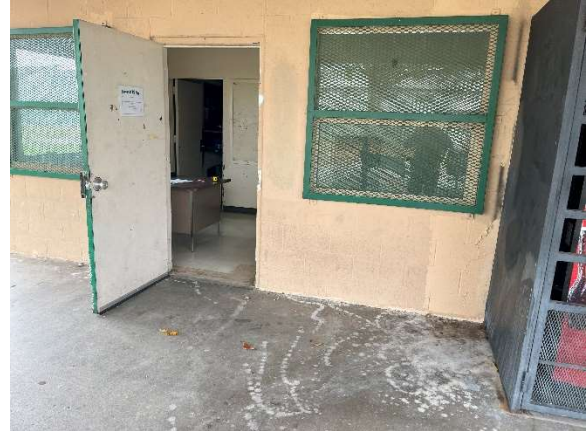
The office has one door which requires new lever hardware.

Office Door with Knob Hardware

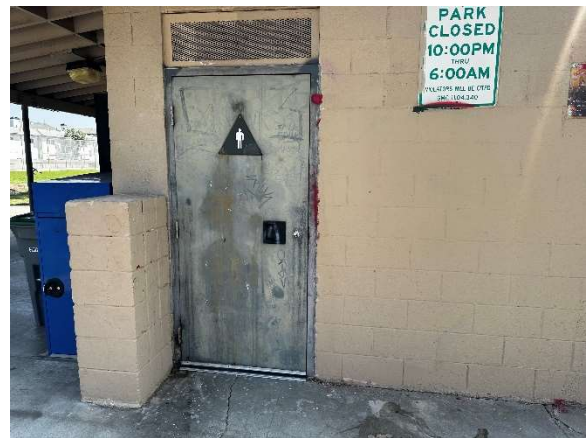
- Adjustment to the door closing speed,
- Installation of new wall sign and adjustment of geometric door signage location
- Adjustment of lavatory height,
- Re-insulation of the under sink pipes
- Adjustment of soap dispenser,
- Installation of interior toilet compartment door handle,
- Adjustment of toilet compartment self-closing mechanism,
- Adjustment of toilet compartment partition to provide 60" clear,
- Adjustment of toilet placement from side wall,
- Revision of flush mechanism to wide side of toilet,
- Adjustment of rear grab bar,
- Adjustment of toilet paper dispenser and seat cover dispenser.
- Adjustment of urinal height and urinal flush mechanism height.

Men's Restroom

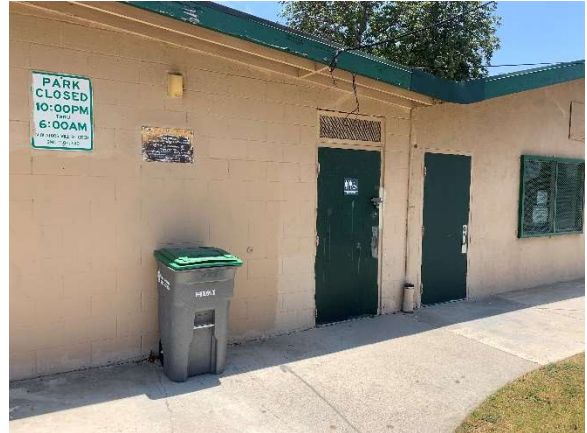
- Adjustment to the door closing speed,
- Installation of new wall sign and adjustment of geometric door signage location
- Re-insulation of the under sink pipes
- Adjustment of soap dispenser and paper towel dispenser,
- Installation of toilet compartment door handles,
- Adjustment of toilet placement from side wall,
- Revision of flush mechanism to wide side of toilet,
- Adjustment of rear grab bar,
- Relocation of toilet paper dispenser.

All-Gender (Women's) Restroom

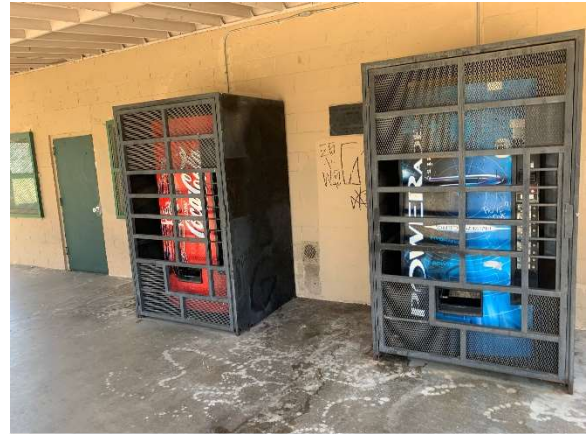
There are two vending machines on the north side of the building protected by security cages. These cages create accessibility barriers for the disabled. If security protection is required for these machines, the cages should be replaced with accessible barriers. If this is not possible, it may be advisable to remove the vending machines from the park.

Vending Machines

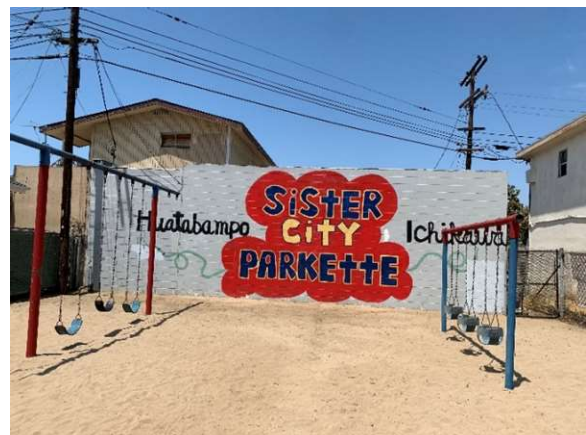
There is one play area of approximately 2,600 SF. The entire play surface is composed of loose sand and is a barrier to the disabled. There is also a raised concrete curb separating the play area from the picnic area. The play equipment which includes a steel slide, metal monkey bars, swings and crawling tubes in the sand area is extremely outdated and provide no accessible activity features. All the play equipment should be replaced, accessible play entry should be provided and accessible surface material should be installed in part or all of the play area.

Play Equipment

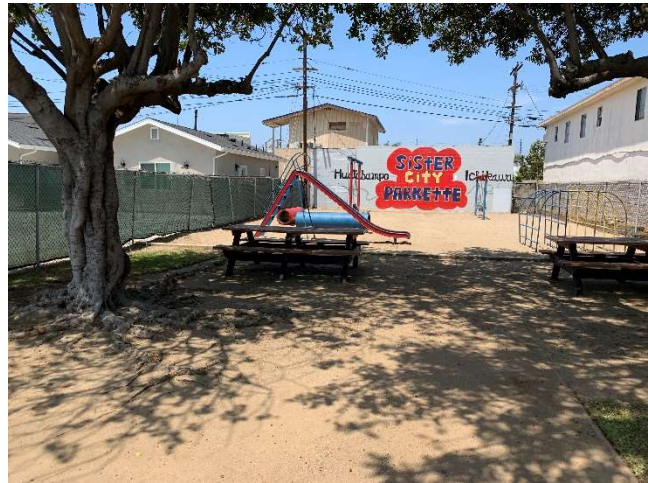
There are two older 8-person picnic tables located adjacent to the play area. Neither table provides an accessible space for the disabled. Both tables should be replaced with new tables that can provide required accessibility.

Picnic Area

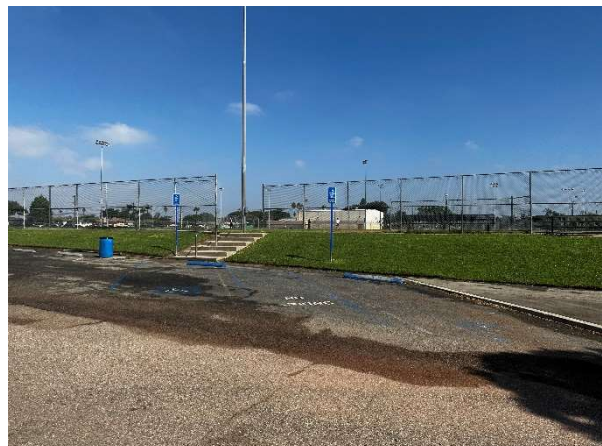
Parking Spaces 4 and 5 are located just south of Baseball Field 4. While these spaces require minimal modifications to meet access compliance requirements, they do not safely connect to any accessible routes or amenities within the park. In addition to the minor modifications to these spaces, accessible routes should be created to connect to the lower park

Parking Spaces 4 and 5

area as well as baseball fields (and specifically Baseball Field 4). This should include a new sidewalk to the lower park area and a ramp and new stair system to the upper baseball fields.

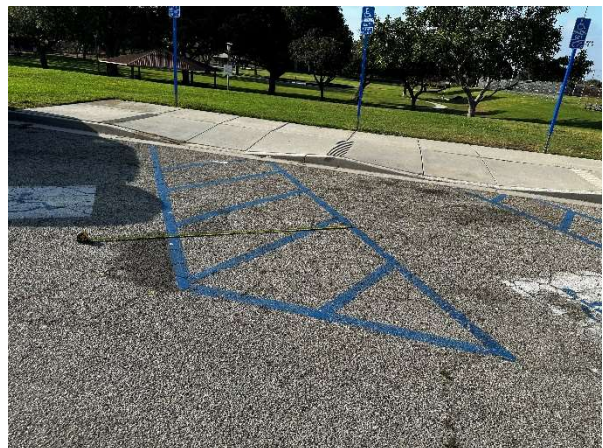
Typical Non-compliant Curb Ramps

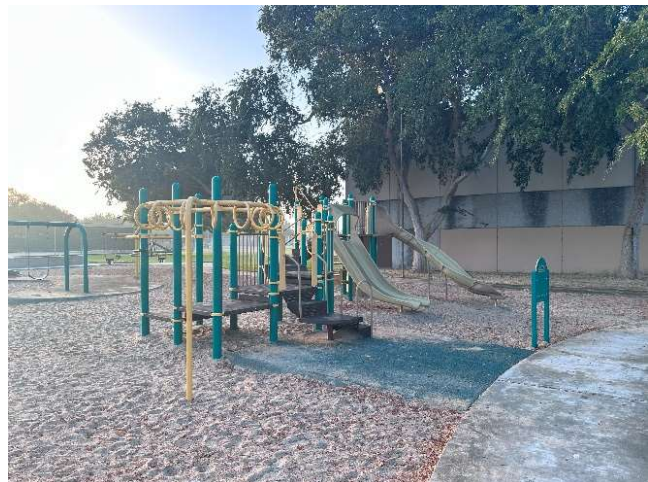
This play structure is designed for children ages 5 to 12. It was originally installed in the early 2000s and is in good condition. It includes 5 ground level play components areas and 4 elevated play components. These include the following:

Play Structure 1

Based on five elevated play components, a minimum of two accessible ground level play components are required. While the overhead rings are on the accessible route, all other ground level play equipment is located on sand surfaces and generally not accessible. The padded ground surface should be extended to at least one additional ground level play component.

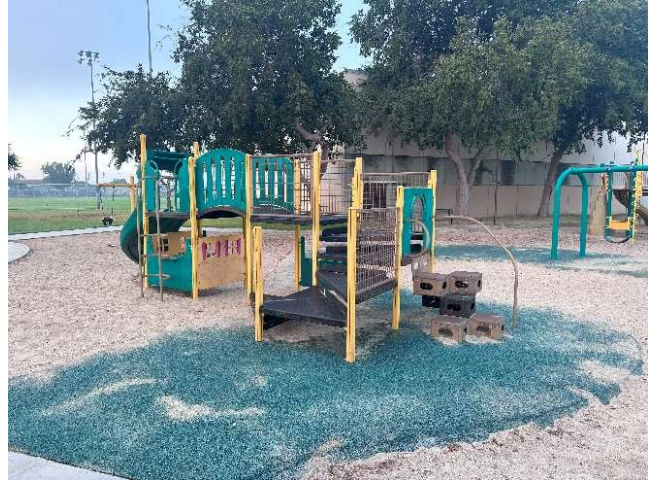
This play structure is designed for children ages 2 to 5. It was originally installed in the early 2000s and is in good condition. It includes 4 ground level play components areas and 4 elevated play components. These include the following:

Play Structure 2

Based on three elevated play components, a minimum of one accessible ground level play component is required and is provided.

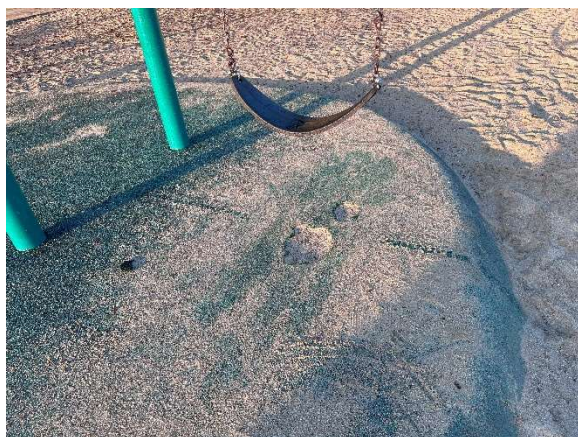
There is a single belt type swing set provided with swinging for four individuals. One of the swings is located on the padded surface, providing required accessibility to this type of play equipment. However, as noted above, the padded material under the accessible swing is worn and requires repair.

Worn Padded Surface at Belt Swings

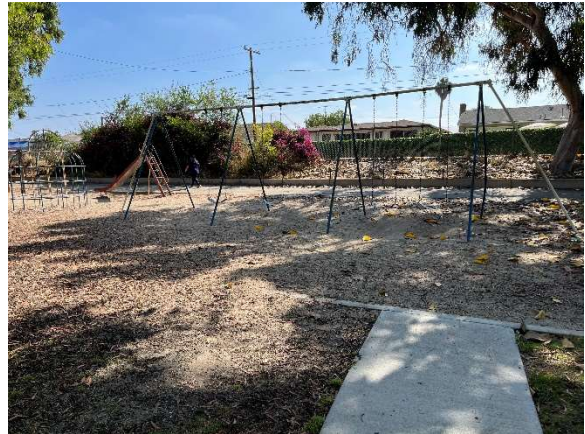
This play area is located in the lower park area on the southeast side of the park just north of Picnic Area 3. It includes a wooden play structure, an older metal slide, swings and a metal monkey bar structure. The entire area is on a sand surface and has no compliant access into it. All structures should be removed and replaced with equipment that provides accessible equipment with accessible surfaces.

Play Area 2

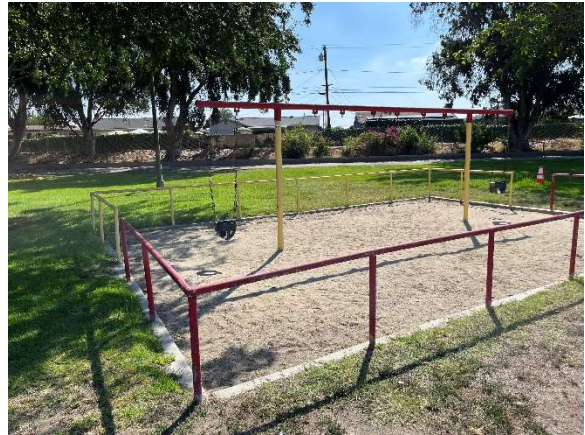
This play area contains a single swing structure which is extremely old and in very poor condition. Like Play Area 2, the ground surface is sand and provides no accessibility. This swing set should be removed and replaced with accessible equipment. Accessible surfaces should be included when renovating this space.

Play Area 3

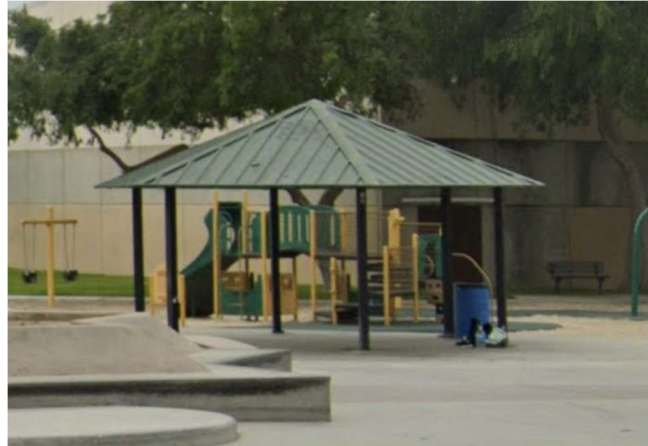
This covered picnic area is located adjacent to the playground that faces 132nd Street. It is a level surfaced concrete area. Currently there are no tables provided in this area. It appears to have a capacity of approximately 3 to 4 tables. Based on this count, at least two accessible seating areas should be provided with any new tables.

Picnic Area 1
