CITY OF GARDENA PARKS AND RECREATION MASTER PLAN APPENDIX

2024

Appendix Table of Contents

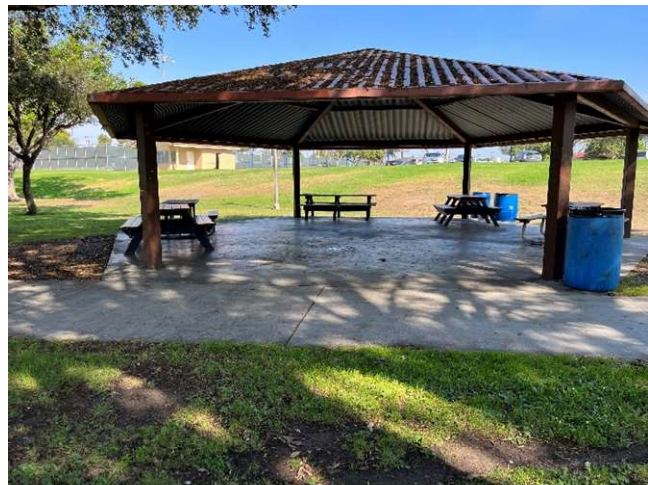
Picnic Area 2

This covered picnic area is located south of the large parking lot down a sloping hillside. There are a total of 5 picnic tables provided in this area. Based on 6 to 8 persons per table, this provides a total seating capacity of 30 to 40 persons. New tables should be provided with a minimum of 3 accessible seating areas. This area also has one older non-compliant barbeque located on the grass area. This unit should be removed and replaced with a new compliant barbeque. A compliant path to the new barbeque and clear space should be provided when replaced.

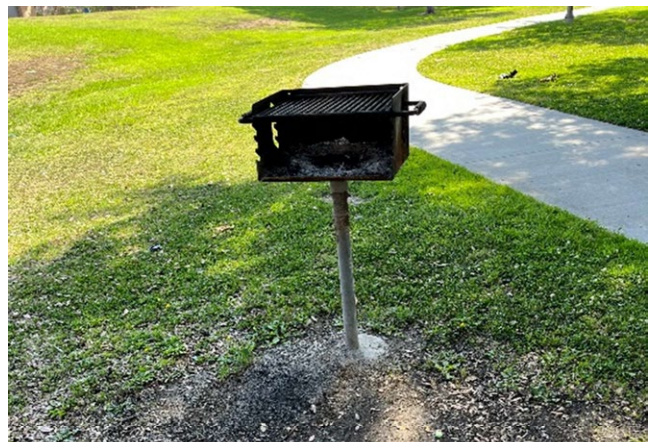
Non-compliant barbeque

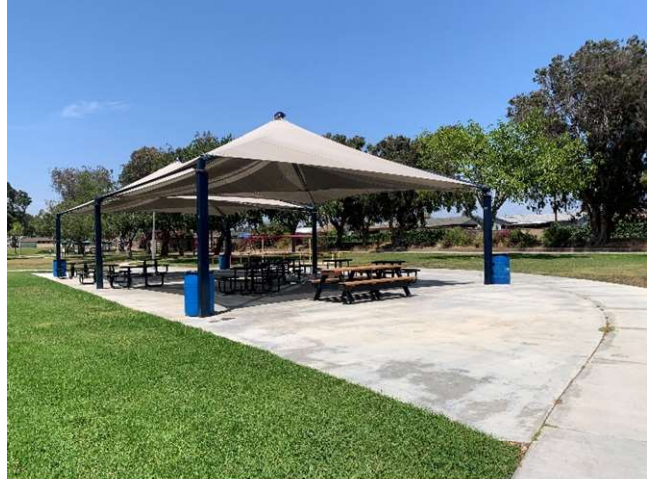
Picnic Area 3

This picnic area is the largest covered picnic facility within the park. It is located in the far southeast corner of the park. It contains ten 8-person tables throughout the covered area, providing seating for 80 persons. Two of the tables appear to be intended for accessible seating. However, the table legs block clear accessible seating. It does not appear that these tables can be modified to meet compliance requirements. When replacing tables in other areas of the park, a minimum of four tables should be replaced in this area with ones that provide accessible seating spaces.

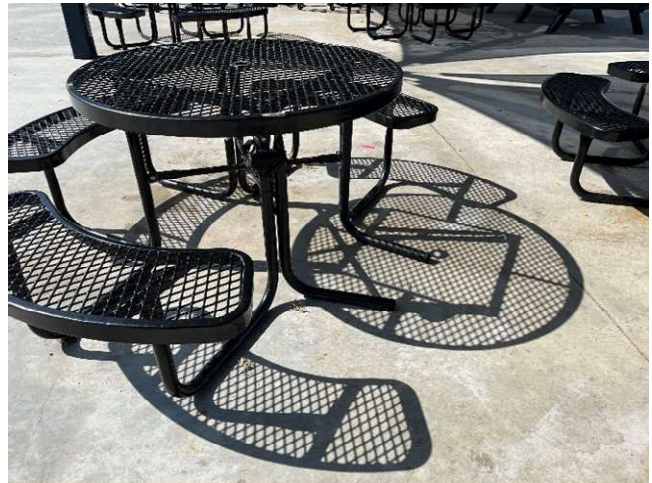
Accessible Table (not compliant)

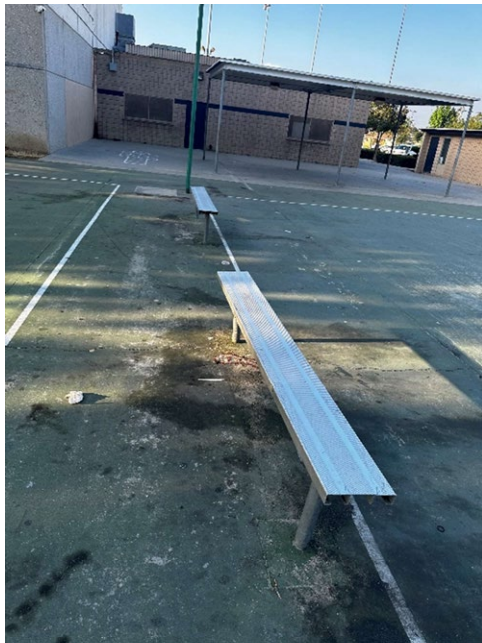
There are two metal benches located between the two half courts. These benches are in poor condition and should be replaced.

Benches at Basketball Courts

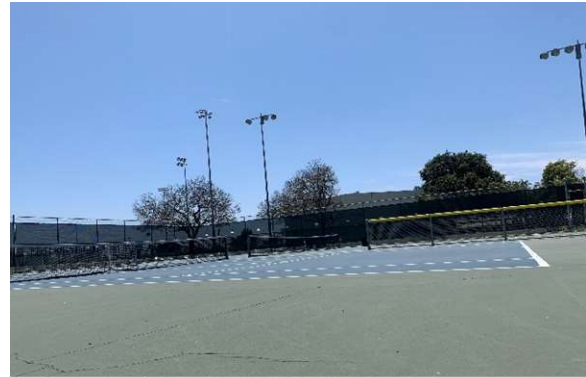
The gates on the west side of the tennis courts are padlocked. The only entrance in use are the two gates on the east side. The hardware is mounted slightly above acceptable reach ranges and is difficult to operate. New accessible hardware should be installed within acceptable reach ranges.

Tennis Courts

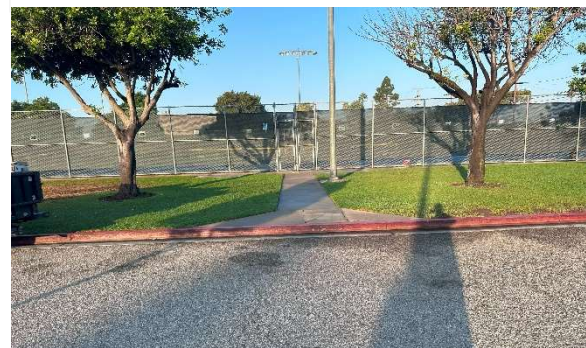
There is a pedestrian route around the tennis courts to the activity areas near the gymnasium. However, the concrete walkway is showing signs of heaving in various places. It appears that the walkway has been ground down multiple times to address the uneven surface. It is recommended that the walkway be removed and replaced with new reinforced concrete that has adequately compacted base to prevent heaving in the future.

Walkway to Tennis Courts

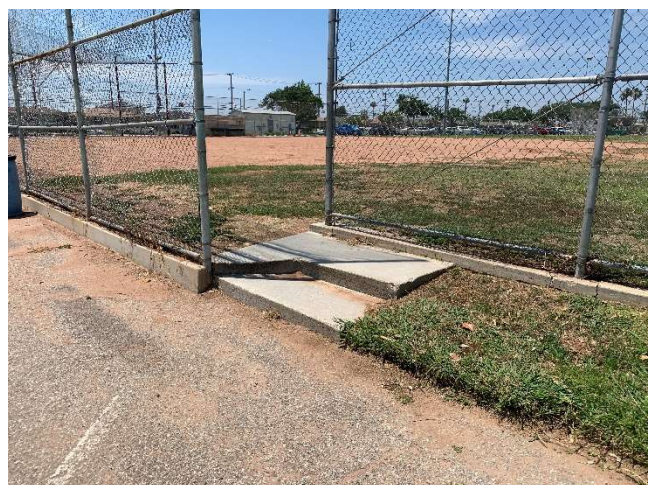
There are steps leading from the parking lot onto the right field infield and dugout. This should be modified to provide an accessible route to the dugout and field of play.

Steps onto Baseball Field 1

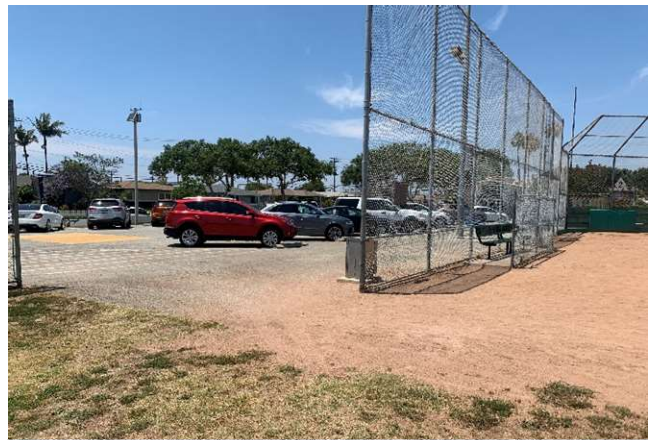
Field 2 is the northwest baseball field. It is also located immediately adjacent to the Van Ness Avenue parking lot and the accessible parking spaces. Similar to Field 1, there is no separation between the spectator area and the parking lot. Protection barriers should be installed to separate the areas.

Parking Lot Entry to Baseball Field 2

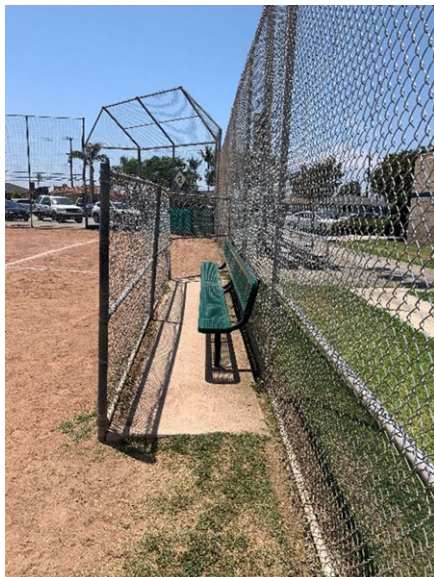
Field 2 Third Base Dugout Entry

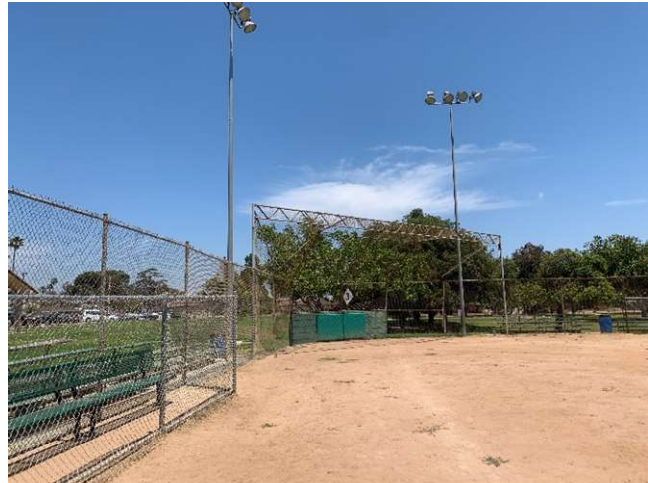
Baseball Field 3

The dugouts have concrete surfaces with space for a wheelchair on the entry side of the enclosure. However, the transitions between the dirt infield and the concrete dugout surfaces are uneven and require ongoing maintenance. Extending the concrete surface may provide better accessibility.

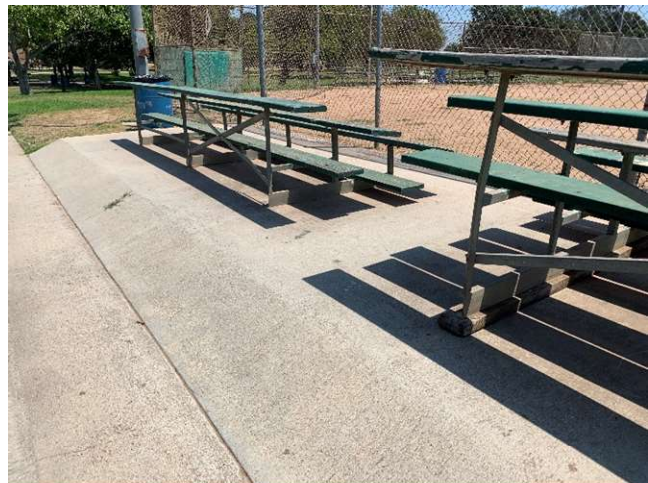
Baseball Field 3 Right Bleachers

Field 3 is the northeast field. There are no accessible routes to this field. As noted above, there is a concrete drainage swale that is used as a pathway from the Van Ness Avenue parking lot, but this is not an accessible path. A new compliant concrete pathway connecting this field to other areas of the park is strongly recommended. Additionally, the bleachers on the first base side have a steep incline to access them. This needs to be corrected to meet access standards. The bleachers on the third base side also have no pathway connecting them to any other areas.

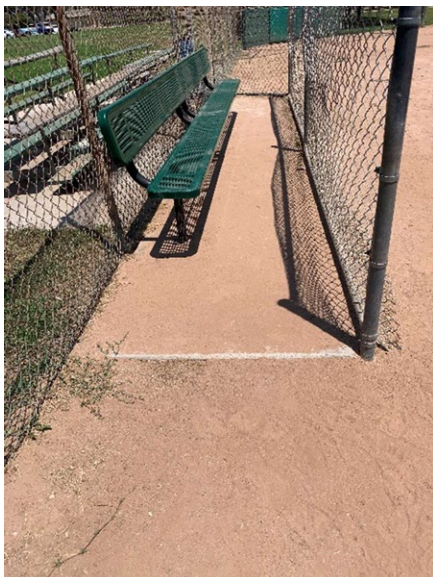
Field 3 First Base Dugout Entry

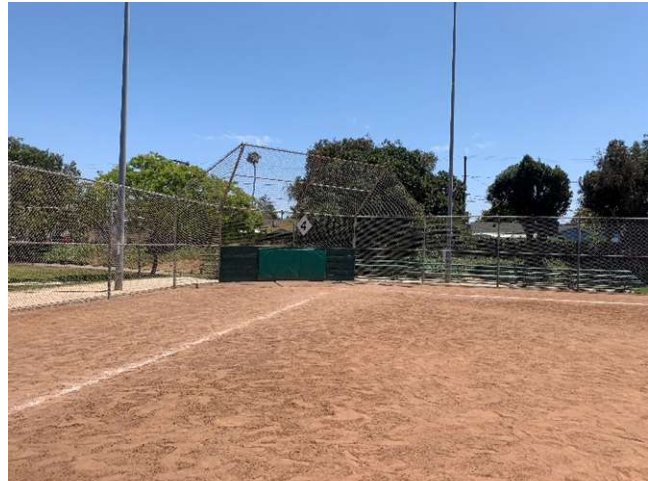
Baseball Field 4

The dugouts have concrete surfaces with adequate wheelchair space within the dugouts. However, the transitions between the dirt infield and the dugouts require routine maintenance to provide level surface for maneuverability.

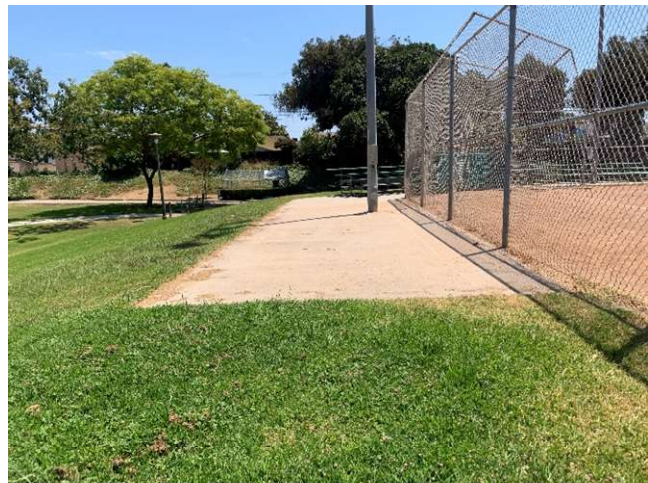
Baseball Field 4 Right Side

Bleachers are located strictly behind home plate and the third base side of the field. They are quite close together and do not provide any usable space for persons in wheelchairs. The concrete area on the first base side does not have any bleachers. It is recommended that the bleachers be redistributed to provide more open space. Additionally, clear paths at least 48" wide should be created to allow passage around both spectator sides.

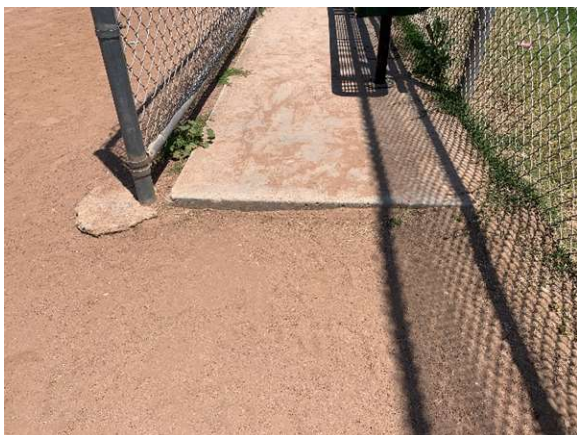
Field 4 Third Base Dugout Entry

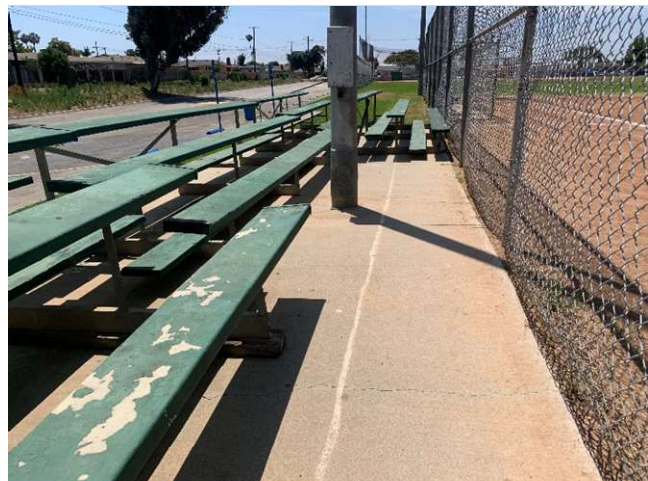
Baseball Field 4 Left Bleachers

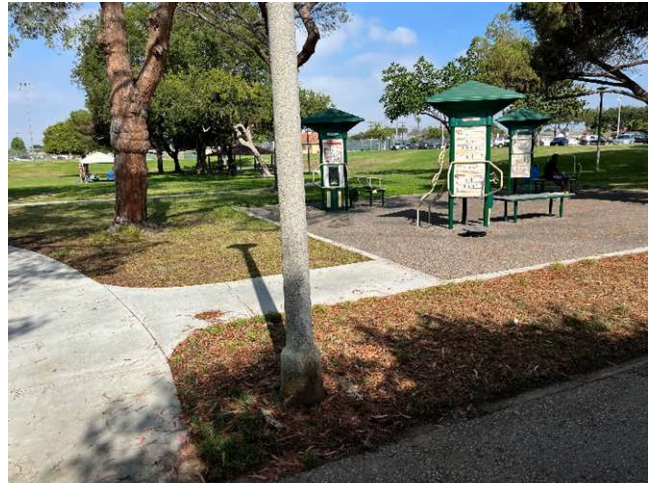
There are two separate locations in the lower area of the park with fairly recently added fitness equipment. Access to the equipment is via the concrete walkways within the lower park area. Several of the fitness equipment stations are identified as ADA accessible and provide fully compliant exercise equipment.

Fitness Area

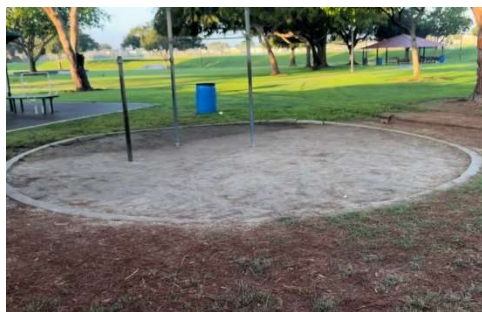
There is a parallel bar area adjacent to the newer fitness equipment. This unit is quite old and is mounted on hard pack dirt. The bar system should be replaced and the ground surface should be removed and replaced with material similar to the fitness equipment space.

Parallel Bars

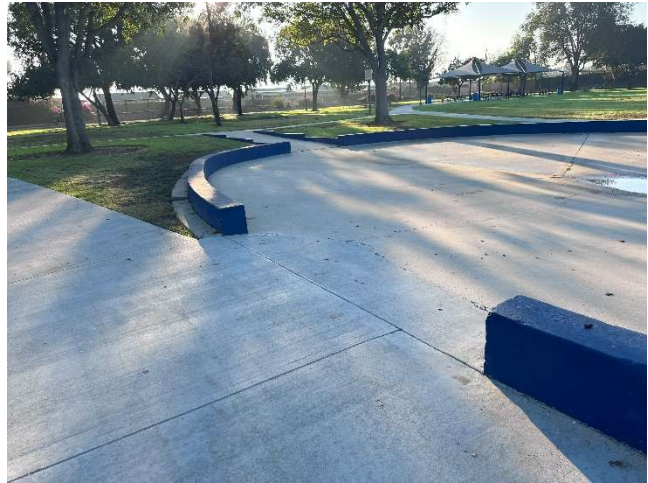
There is an older concrete skating rink located in the center of the lower park area. It appears to no longer be in use for skating. If this space is to be repurposed for other uses that require accessibility, the entry slopes on the south and east side will need to be revised to meet 5% running slope requirements.

Skating Rink North Entry

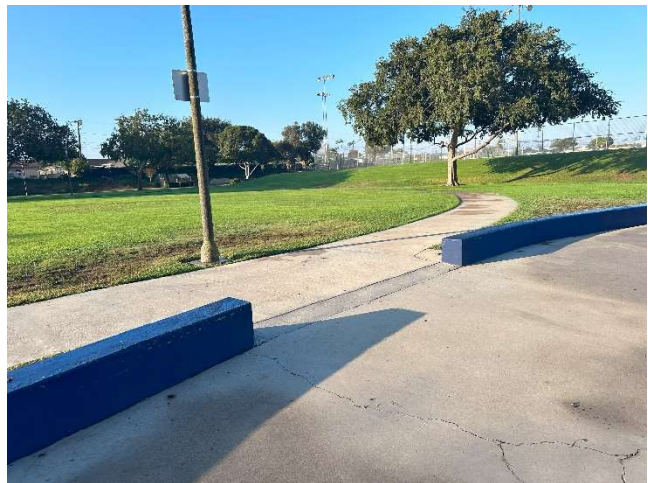
Skating Rink South Entry

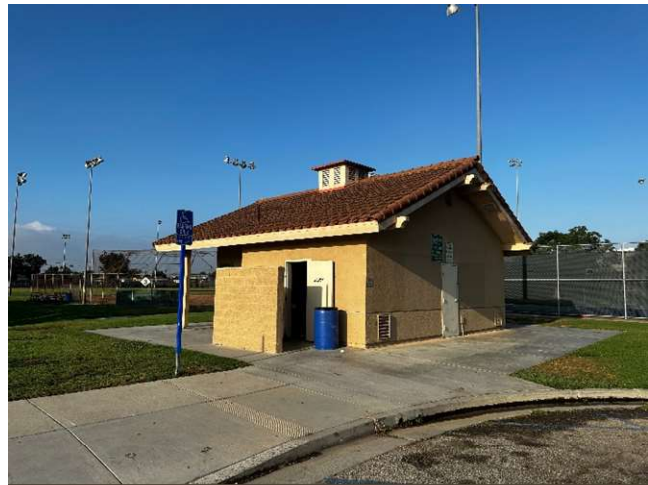
This older freestanding restroom building is located near the southwest corner of the tennis courts and adjacent to the 132nd Street parking lot. It has two multiple occupant gender-specific restrooms and one obsolete single bowl drinking fountain. The restrooms are in fair condition but require moderate repair work to meet current access requirements.

Original Restroom Building

- Compliant geometric signage is required.
- Replace damaged door signs.
- Provide pipe insulation on pipes under lavatories.
- Lower various accessories at lavatories to compliant heights.
- Repair toilet compartment hardware.
- Remove and reinstall toilet paper dispensers in compliant locations.

While these restrooms provide adequate facilities to this portion of the park, there are no accessible routes from this building to any site amenities other than the non-compliant accessible parking spaces in the 132nd Street parking lot. New concrete pathways should be installed connecting this building to the tennis courts, skateboard park, Playground 1 and other areas in the northwest side of the park. Additionally, a dedicated compliant pathway should be installed connecting this building (as well as the 132nd Street parking lot) to the lower open space located

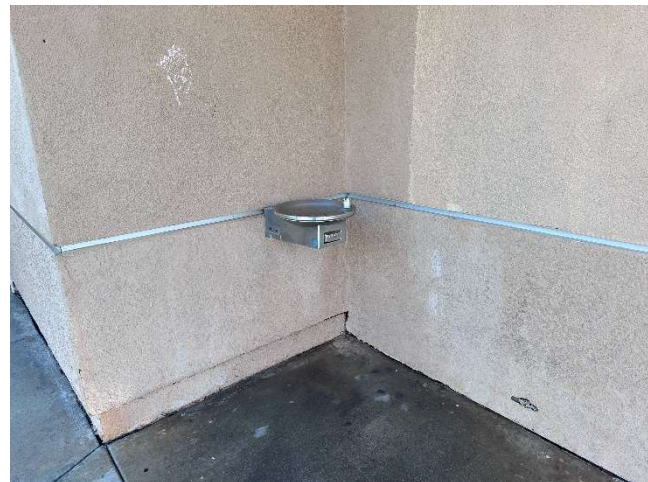
There is a single older drinking fountain on the southwest side of the restroom building. This unit is not compliant and should be removed and replaced with a new unit or a new standalone drinking fountain/water bottle filling station should be installed in the vicinity of this building.

Non-compliant drinking fountain

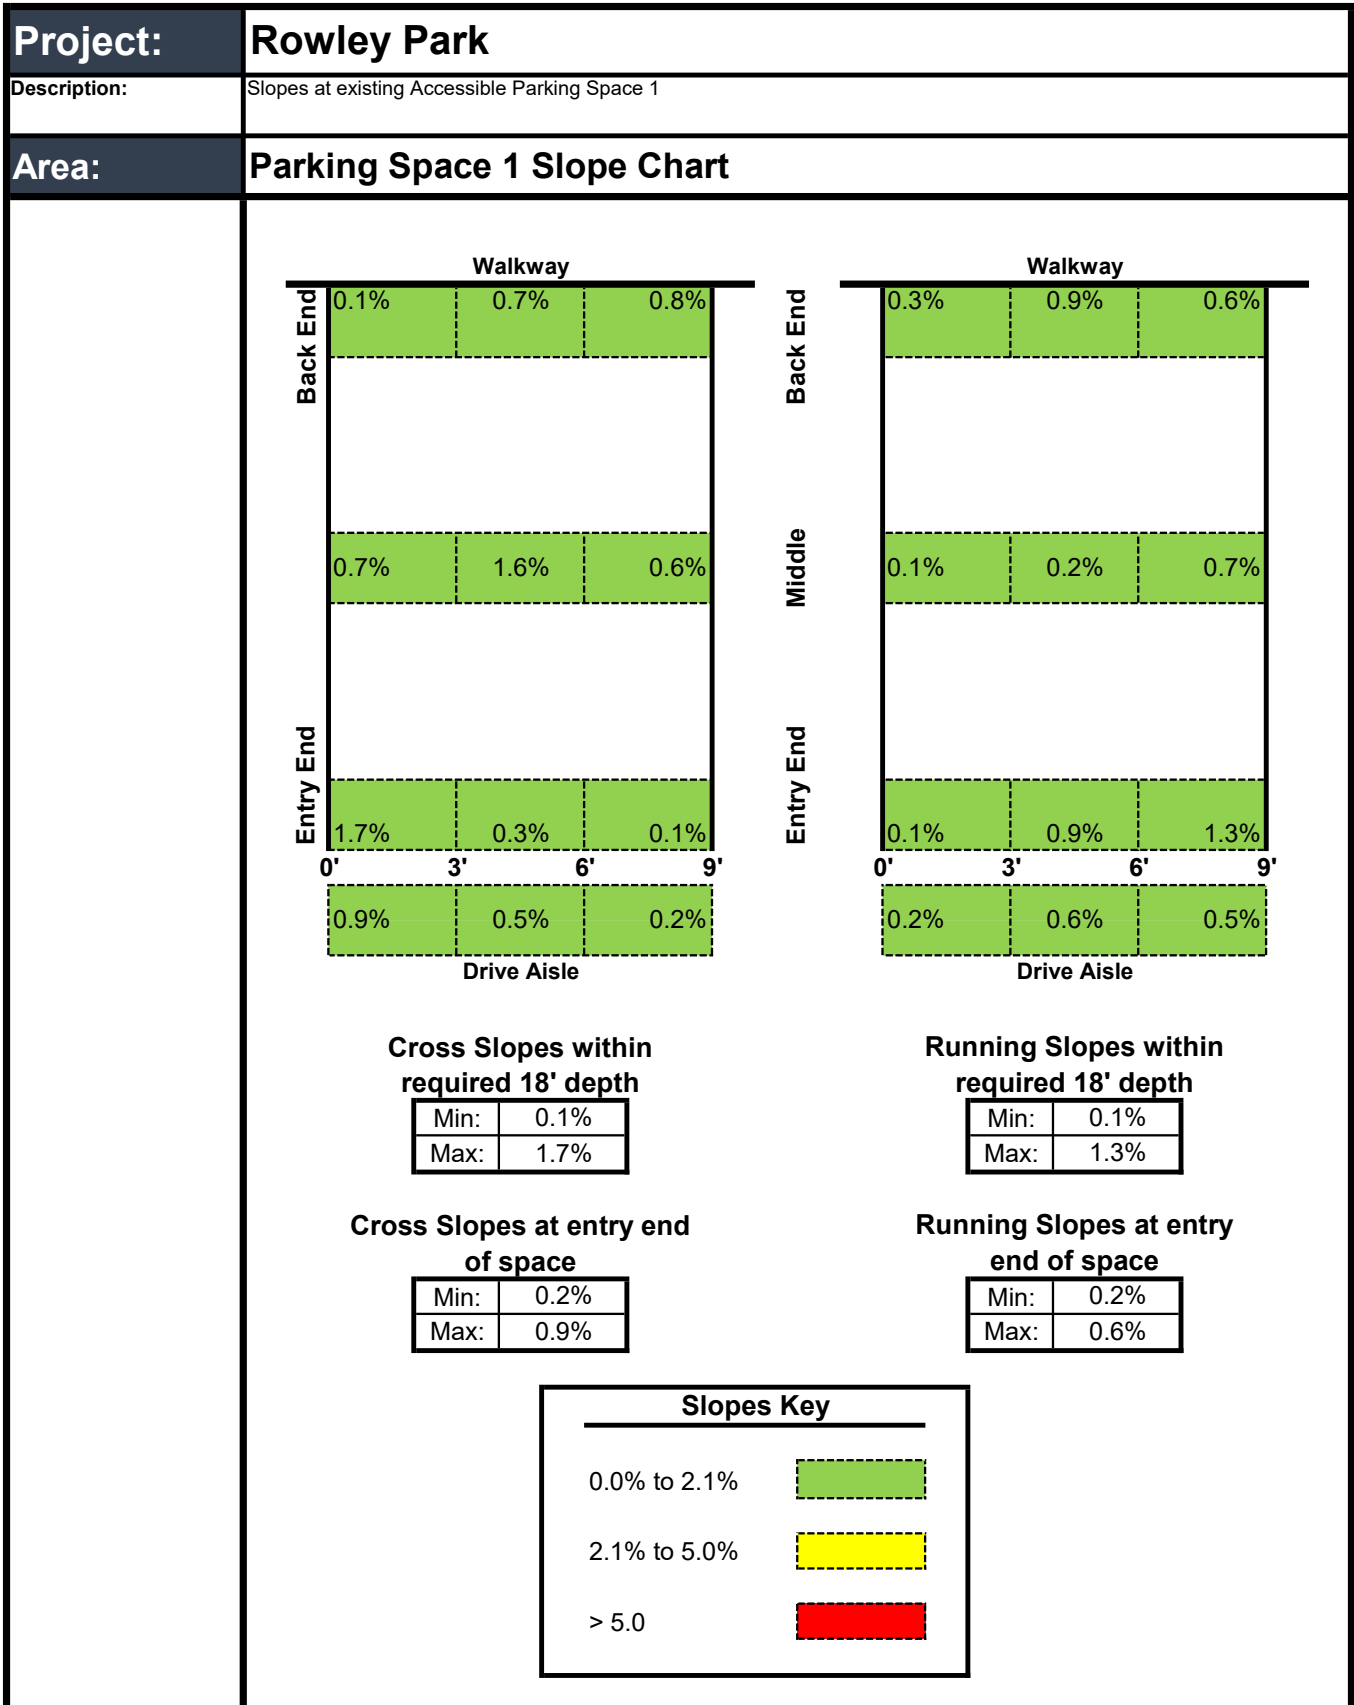
PARKING-1

ISA symbol provided at bottom of stall	PK1- 1.08	Correct location	Aligned with bottom end of space.	11B-502.6.4	
	ISA symbol width x height	PK1- 1.09	44" x 48"	36" x 36"	11B-502.6.4.1 11B-502.6.4.2	
	ISA symbol condition	PK1- 1.10	Poor condition. Requires repainting.	Unfaded, no repainting required	Assumed, not specified in code	
	ISA symbol alignment within parking space	PK1- 1.11	55.5" 54.5" Compliant alignment	Within 6" of centerline of space and sides parallel to space length	11B-502.6.4.2	
	70 Sq. In accessible signage provided at head of	PK1- 1.12	Correct Sign Provided	Reflectorized. White on blue background with ISA symbol	11B-502.6 11B-502.6.1	
	Required Fine Signage	PK1- 1.13	Sign Missing	Minimum Fine \$250	11B-502.6.2	
	<i>Van Accessible signage provided</i>	<i>PK1- 1.14</i>	<i>Unknown if sign is required at this location</i>	<i>Van Accessible signage required</i>	<i>11B-502.6</i>	
	Is the stall signage located within the accessible route?	PK1- 1.15	In planter / landscape area	Informational	---

Stall signage height	PK1- 1.16	42" to bottom of sign	80" if within accessible route. 60" if not within accessible route.	11B-502.6 11B-502.6 Exception	
	Paving surface condition	PK1- 1.17	Fair	Smooth & undamaged	Assumed, not specified in code	
Parking Space Cross Slope %	PK1- 1.18	Within space: 0.1% to 1.7% Entry End: 0.2% to 0.9%	1:48 max (2.1% max)	11B-502.4 Exception		
Parking Space Running Slope %	PK1- 1.19	Within space: 0.1% to 1.3% Entry End: 0.2% to 0.6%	1:48 max (2.1% max)	11B-502.4 Exception

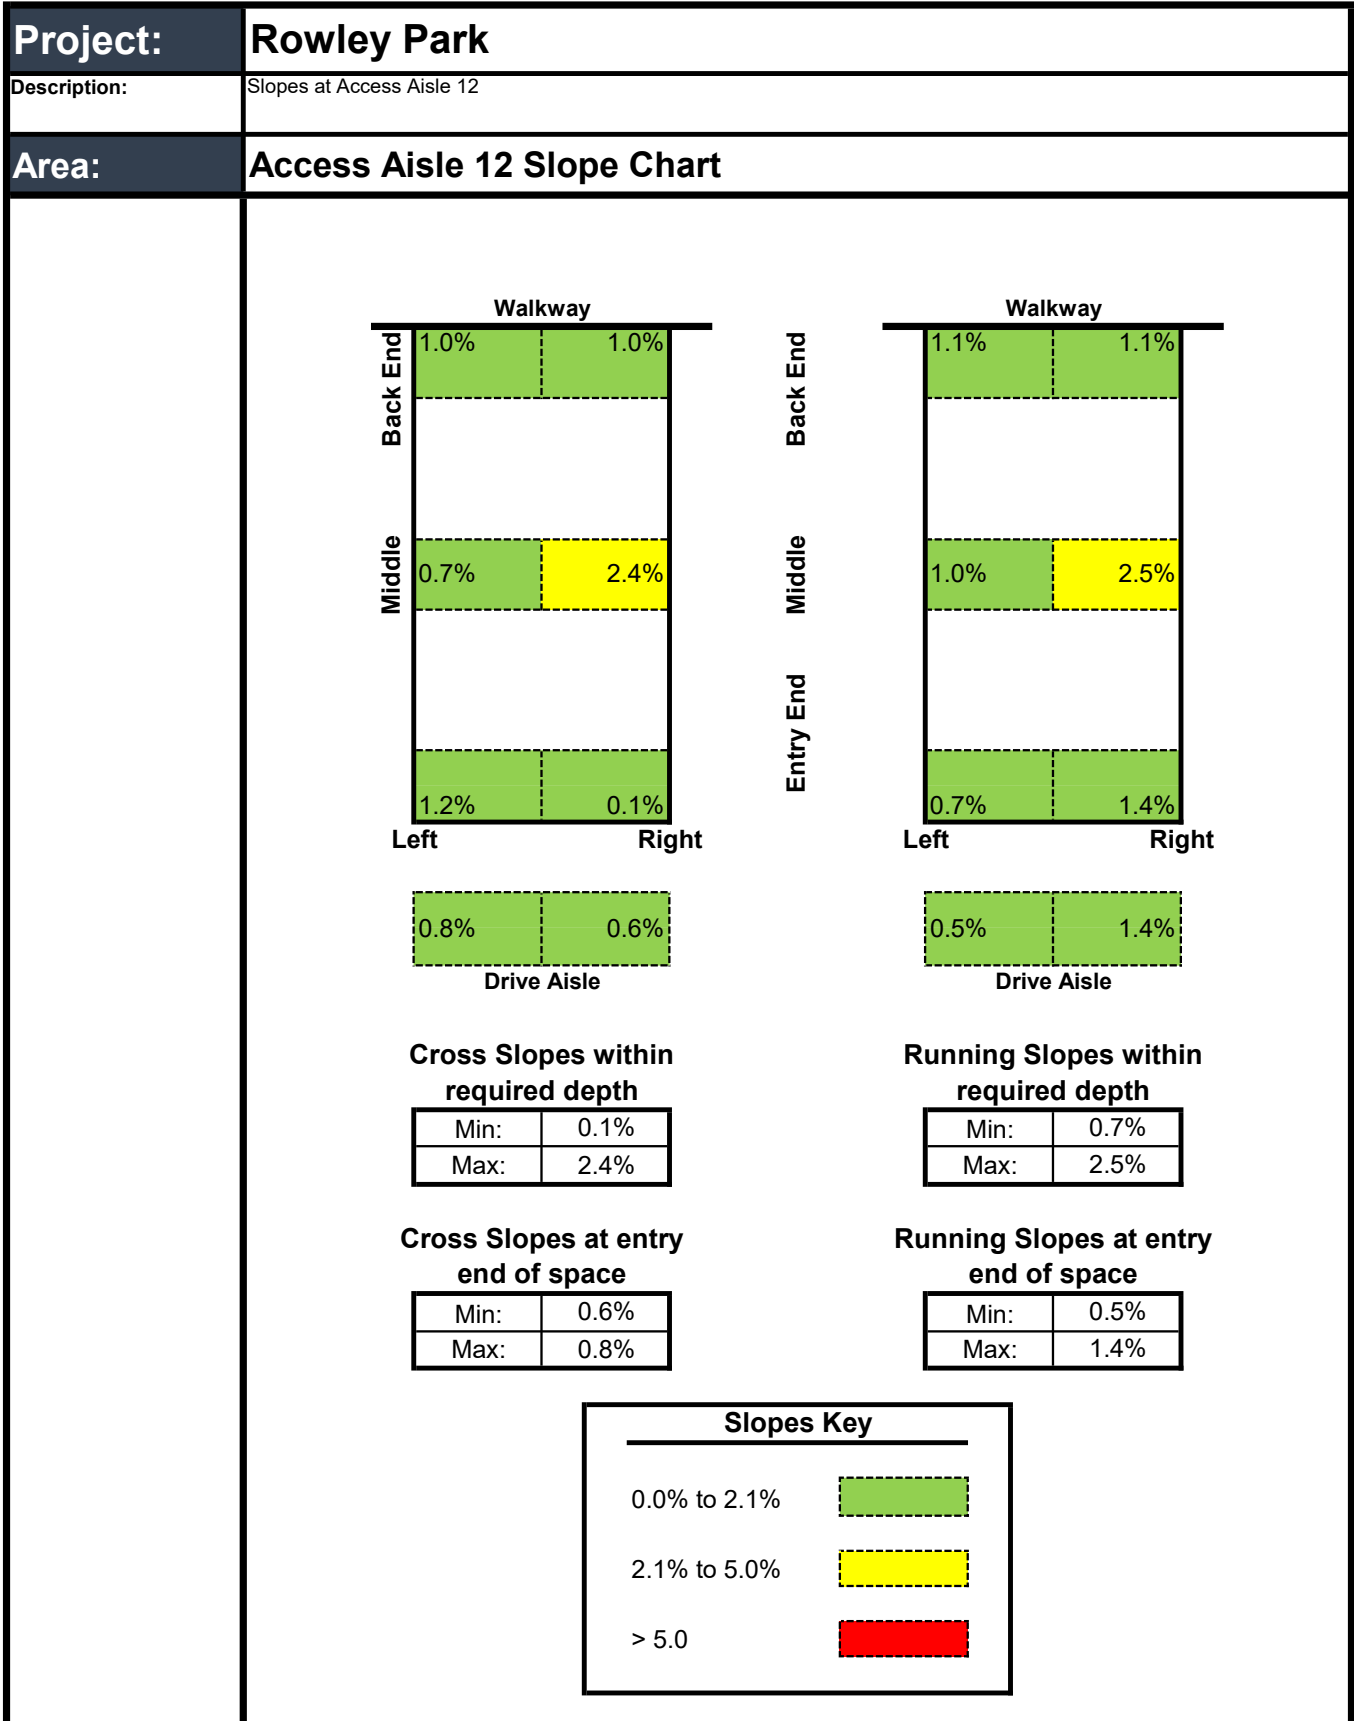
aisle-12

Project: Rowley Park					
Item Observations in RED were observed to be non-compliant. Items Observations in PINK ITALICS were observed to be partially compliant or marginally non-compliant. Please see individual findings in report for specific details.					
Area:	AA12- Access Aisle 12				Code Cycle 2022
Description:	Access aisle between Spaces 1 & 2				
MAJOR SUBJECT	MINOR SUBJECT	ITEM NO.	OBSERVATION	REQUIREMENT	CODE REFERENCE
Access Aisle	Connected to accessible route	AA12- 1.01	Aisle is connected to accessible route	Must be connected to accessible route	11B-502.3
	Parking space(s) served	AA12- 1.02	1 & 2	Informational	---
	Access aisle location	AA12- 1.03	Between spaces	Either side of standard space. Right side of van accessible	11B-502.3.4
	Are occupants required to pass behind other parked vehicles?	AA12- 1.04	No	Not permitted	11B-502.7.1
	Built-up ramp inside aisle?	AA12- 1.05	No	Not permitted	11B-502.4

Access aisle width	AA12- 1.06	59"	Std Space: 60" Van Space: 96" Van Space: 60" if 12' wide parking space	11B-502.3.1
	Access aisle depth	AA12- 1.07	Full depth	Full length of adjacent stall	11B-502.3.1
	Paving condition	AA12- 1.08	Fair	Stable, firm and slip-resistant	11B-302.1
	Access aisle cross slope %	AA12- 1.09	Within Aisle: 0.1% to 2.4% Entry End: 0.6% to 0.8%	1:48 max. (2.1%)	11B-502.4 Exception 1
	Access aisle running slope %	AA12- 1.10	Within Aisle: 0.7% to 2.5% Entry End: 0.5% to 1.4%	1:48 max. (2.1%)	11B-502.5 Exception 1
	Access aisle border	AA12- 1.11	Showing significant wear	4" wide blue border on all sides of access aisle	11B-503.3
	Access aisle diagonal hatching spacing	AA12- 1.12	35" to 36"	36" max o.c.	11B-502.3.3
	"NO PARKING" at bottom of access aisle	AA12- 1.13	Text missing	12" high letters painted white	11B-502.3.3
	"NO PARKING" paint condition	AA12- 1.14	Text missing	Text must be legible	11B-502.3.3

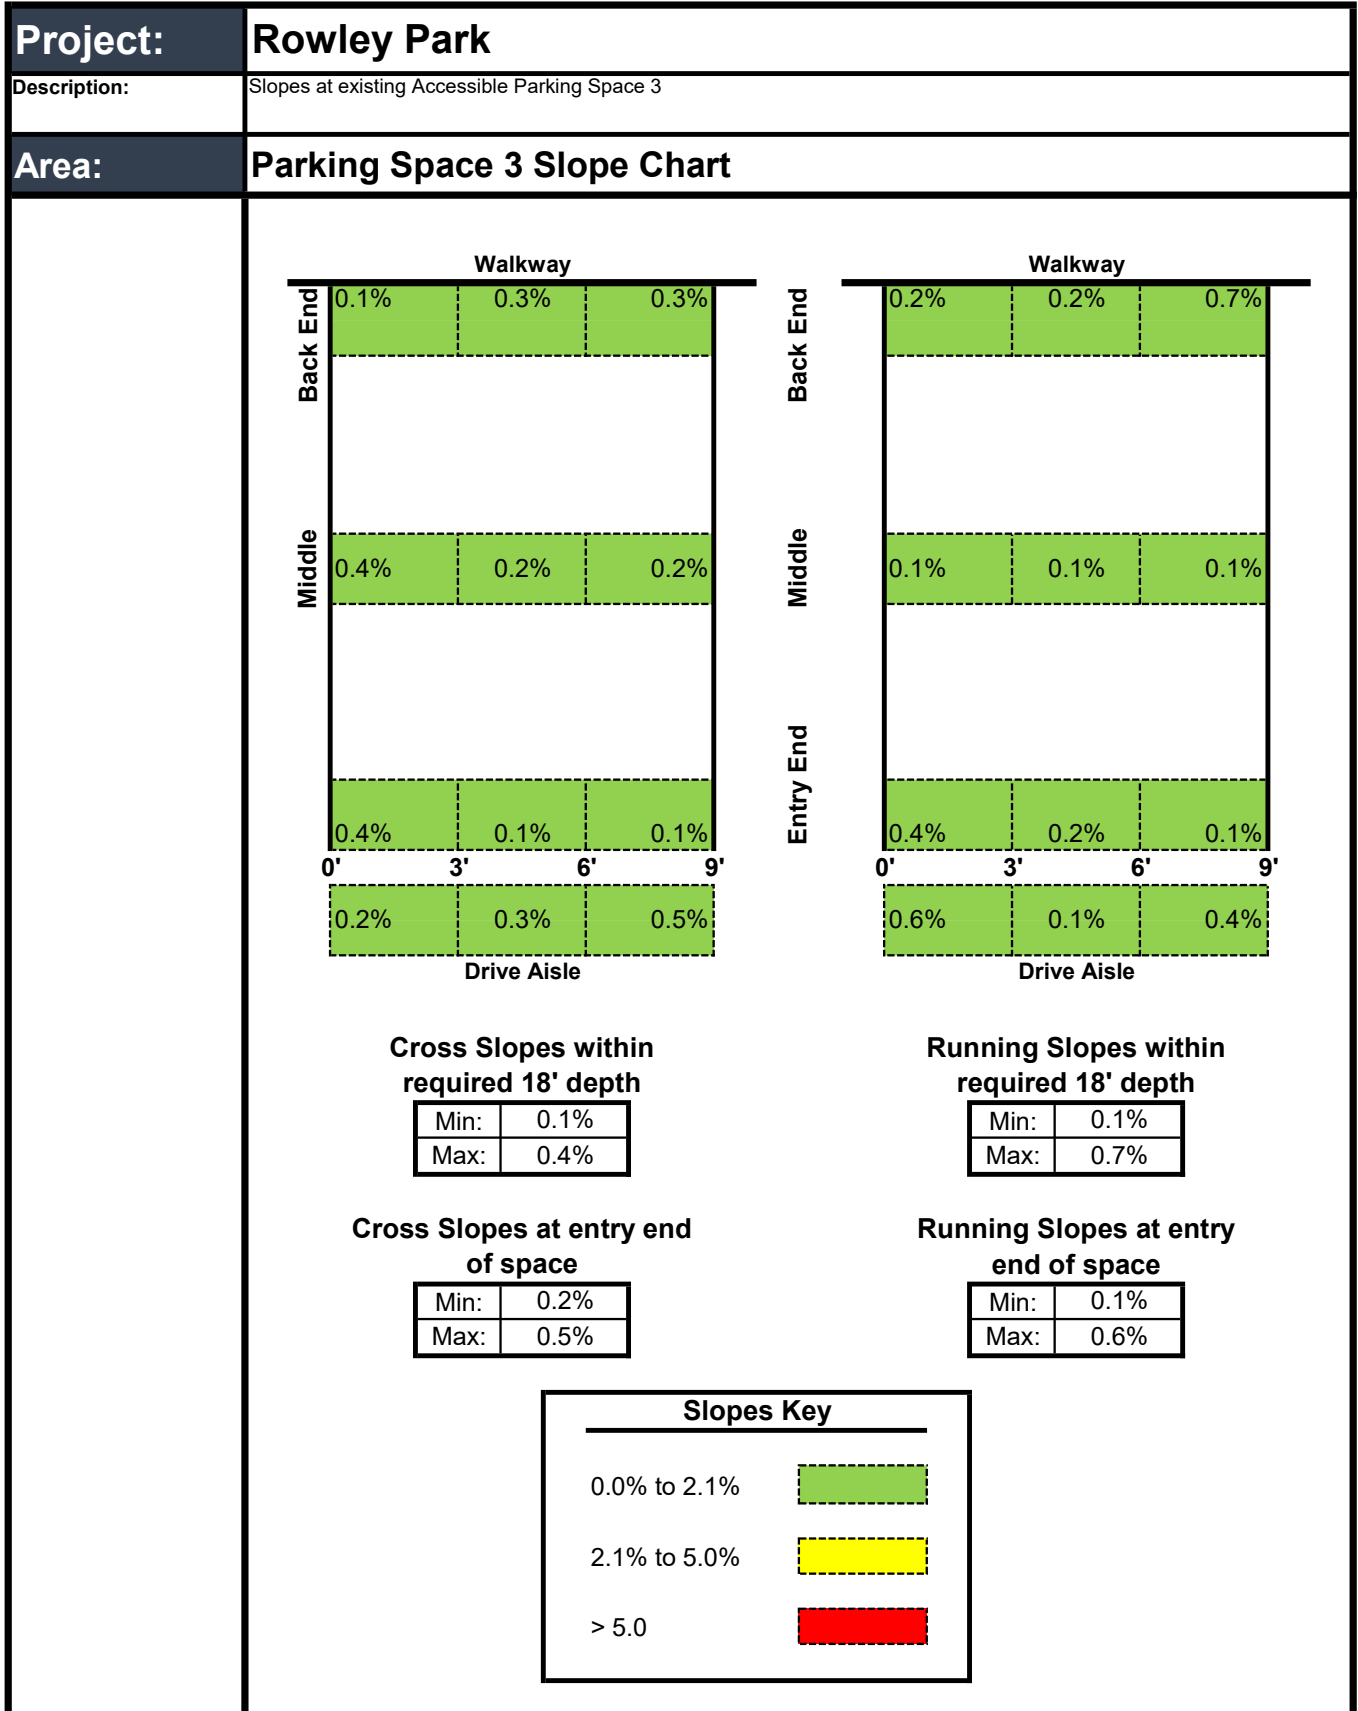
PARKING-3

Project: Rowley Park					
Item Observations in RED were observed to be non-compliant. Items Observations in PINK ITALICS were observed to be partially compliant or marginally non-compliant. Please see individual findings in report for specific details.					
Area:	PK3- Parking Space 3				Code Cycle 2022
Description:	Far right accessible parking space in Van Ness Avenue lot.				
MAJOR SUBJECT	MINOR SUBJECT	ITEM NO.	OBSERVATION	REQUIREMENT	CODE REFERENCE
Accessible Space	Angled, Straight or Parallel	PK3- 1.01	Angled	Informational	N/A
	Van or Standard accessible stall?	PK3- 1.02	Standard accessible space	Informational	N/A
	Parking space width	PK3- 1.03	9'-2"	9'-0" or 12'-0" at Van Accessible Space	11B-502.2
	Parking space depth	PK3- 1.04	Left: 17'-6" Right: 25'-6"	18'-0"	11B-502.2
	Side stripe color	PK3- 1.05	Both sides blue	Both sides blue	11B-502.3.3
	Does parked car encroach into required adjacent 48" wide pedestrian route?	PK3- 1.06	Yes	Parked vehicles may not obstruct required width of adjacent accessible route	11B-502.7.2

Wheel stop or curb provided to prevent encroachment	PK3- 1.07	Wheelstop provided within parking space	Required if vehicle encroaches into pedestrian way.	11B-502.7.2
	ISA symbol provided at bottom of stall	PK3- 1.08	Correct location	Aligned with bottom end of space.	11B-502.6.4
	ISA symbol width x height	PK3- 1.09	44" x 48"	36" x 36"	11B-502.6.4.1 11B-502.6.4.2
	ISA symbol condition	PK3- 1.10	Poor condition. Requires repainting.	Unfaded, no repainting required	Assumed, not specified in code
	ISA symbol alignment within parking space	PK3- 1.11	54" 54"	Within 6" of centerline of space and sides parallel to space length	11B-502.6.4.2
	70 Sq. In accessible signage provided at head of stall	PK3- 1.12	Correct Sign Provided	Reflectorized. White on blue background with ISA symbol	11B-502.6 11B-502.6.1
	Required Fine Signage	PK3- 1.13	Sign Missing	Minimum Fine \$250	11B-502.6.2
	Van Accessible signage provided	PK3- 1.14	Sign Not Required	Van Accessible signage required	11B-502.6

Is the stall signage located within the accessible route?	PK3- 1.15	In planter / landscape area	Informational	---
	Stall signage height	PK3- 1.16	34"	80" if within accessible route. 60" if not within accessible route.	11B-502.6 11B-502.6 Exception
	Paving surface condition	PK3- 1.17	Fair	Smooth & undamaged	Assumed, not specified in code
Parking Space Cross Slope %	PK3- 1.18	Within Space: 0.1% to 0.4% Entry End: 0.2% to 0.5%	1:48 max (2.1% max)	11B-502.4 Exception	
Parking Space Running Slope %	PK3- 1.19	Within Space: 0.1% to 0.7% Entry End: 0.1% to 0.6%	1:48 max (2.1% max)	11B-502.4 Exception

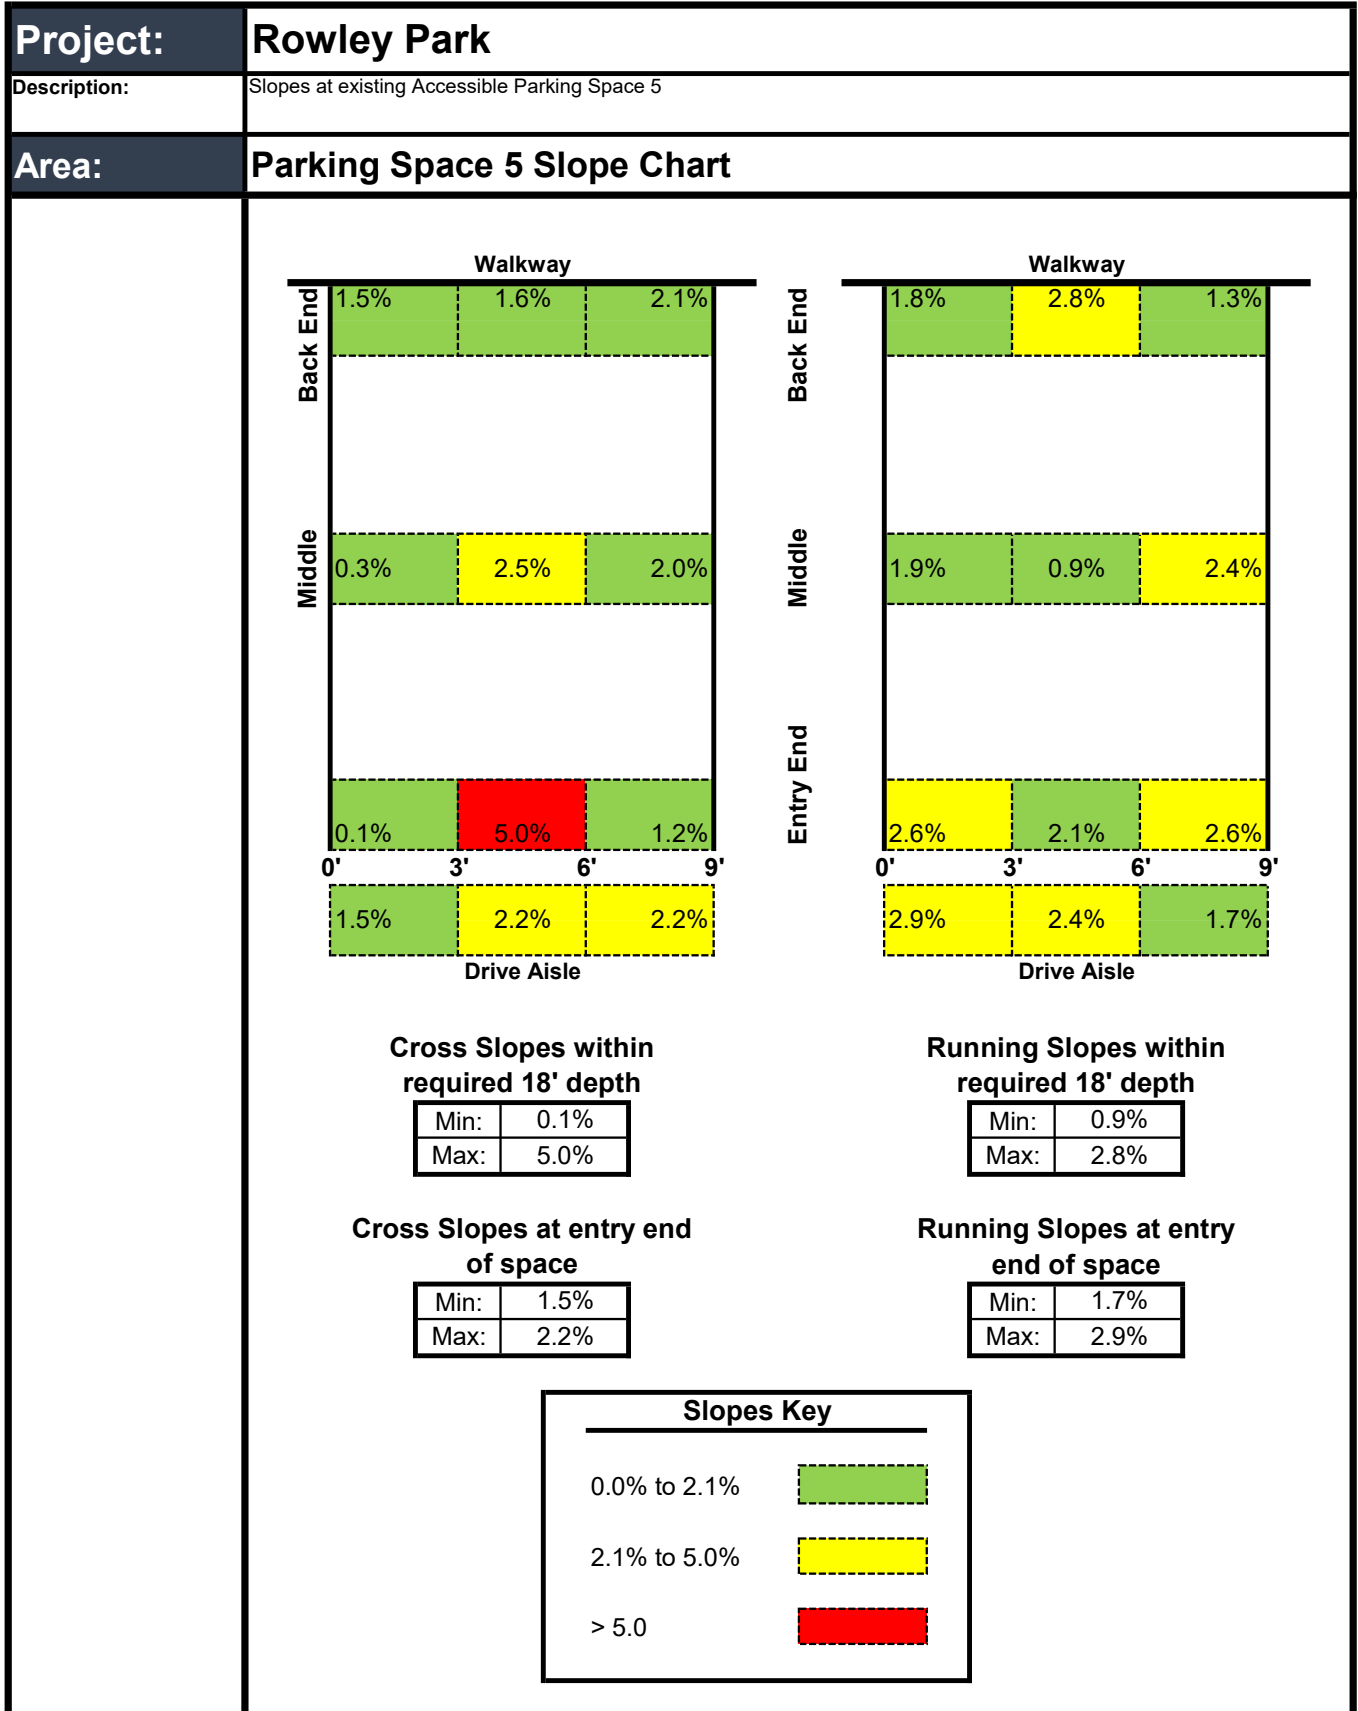
PARKING-5

Project: Rowley Park					
Item Observations in RED were observed to be non-compliant. Items Observations in PINK ITALICS were observed to be partially compliant or marginally non-compliant. Please see individual findings in report for specific details.					
Area:	PK5- Parking Space 5				Code Cycle 2022
Description:	Right hand accessible parking space south of baseball fields				
MAJOR SUBJECT	MINOR SUBJECT	ITEM NO.	OBSERVATION	REQUIREMENT	CODE REFERENCE
Accessible Space	Angled, Straight or Parallel	PK5- 1.01	Angled	Informational	N/A
	Van or Standard accessible stall?	PK5- 1.02	Identified as van, does not qualify as van accessible	Informational	N/A
	Parking space width	PK5- 1.03	10'-11"	9'-0" or 12'-0" at Van Accessible Space	11B-502.2
	Parking space depth	PK5- 1.04	Left: 16'-0" Right: 19'-0"	18'-0"	11B-502.2
	Side stripe color	PK5- 1.05	Left side blue. Right side peeling/fading/incorrect	Both sides blue	11B-502.3.3

Does parked car encroach into required adjacent 48" wide pedestrian route?	PK5- 1.06	Possibly	Parked vehicles may not obstruct required width of adjacent accessible route	11B-502.7.2
	Wheel stop or curb provided to prevent encroachment	PK5- 1.07	Wheelstop provided within parking space	Required if vehicle encroaches into pedestrian way.	11B-502.7.2
	ISA symbol provided at bottom of stall	PK5- 1.08	Correct location	Aligned with bottom end of space.	11B-502.6.4
	ISA symbol width x height	PK5- 1.09	44" x 48"	36" x 36"	11B-502.6.4.1 11B-502.6.4.2
	ISA symbol condition	PK5- 1.10	Poor condition. Requires repainting.	Unfaded, no repainting required	Assumed, not specified in code
	ISA symbol alignment within parking space	PK5- 1.11	67" 64"	Within 6" of centerline of space and sides parallel to space length	11B-502.6.4.2
	70 Sq. In accessible signage provided at head of stall	PK5- 1.12	Correct Sign Provided	Reflectorized. White on blue background with ISA symbol	11B-502.6 11B-502.6.1

Required Fine Signage	PK5- 1.13	Correct Sign Provided	Minimum Fine \$250	11B-502.6.2
	Van Accessible signage provided	PK5- 1.14	Space incorrectly identified as a van accessible space	Van Accessible signage required	11B-502.6
	Is the stall signage located within the accessible route?	PK5- 1.15	In planter / landscape area	Informational	---
	Stall signage height	PK5- 1.16	>80"	80" if within accessible route. 60" if not within accessible route.	11B-502.6 11B-502.6 Exception
	Paving surface condition	PK5- 1.17	Fair	Smooth & undamaged	Assumed, not specified in code
Parking Space Cross Slope %	PK5- 1.18	Within Space: 0.1% to 5.0% Entry End: 1.5% to 2.2%	1:48 max (2.1% max)	11B-502.4 Exception	
Parking Space Running Slope %	PK5- 1.19	Within Space: 0.9% to 2.8% Entry End: 1.7% to 2.9%	1:48 max (2.1% max)	11B-502.4 Exception
