CITY OF GARDENA PARKS AND RECREATION MASTER PLAN APPENDIX

2024

Appendix Table of Contents

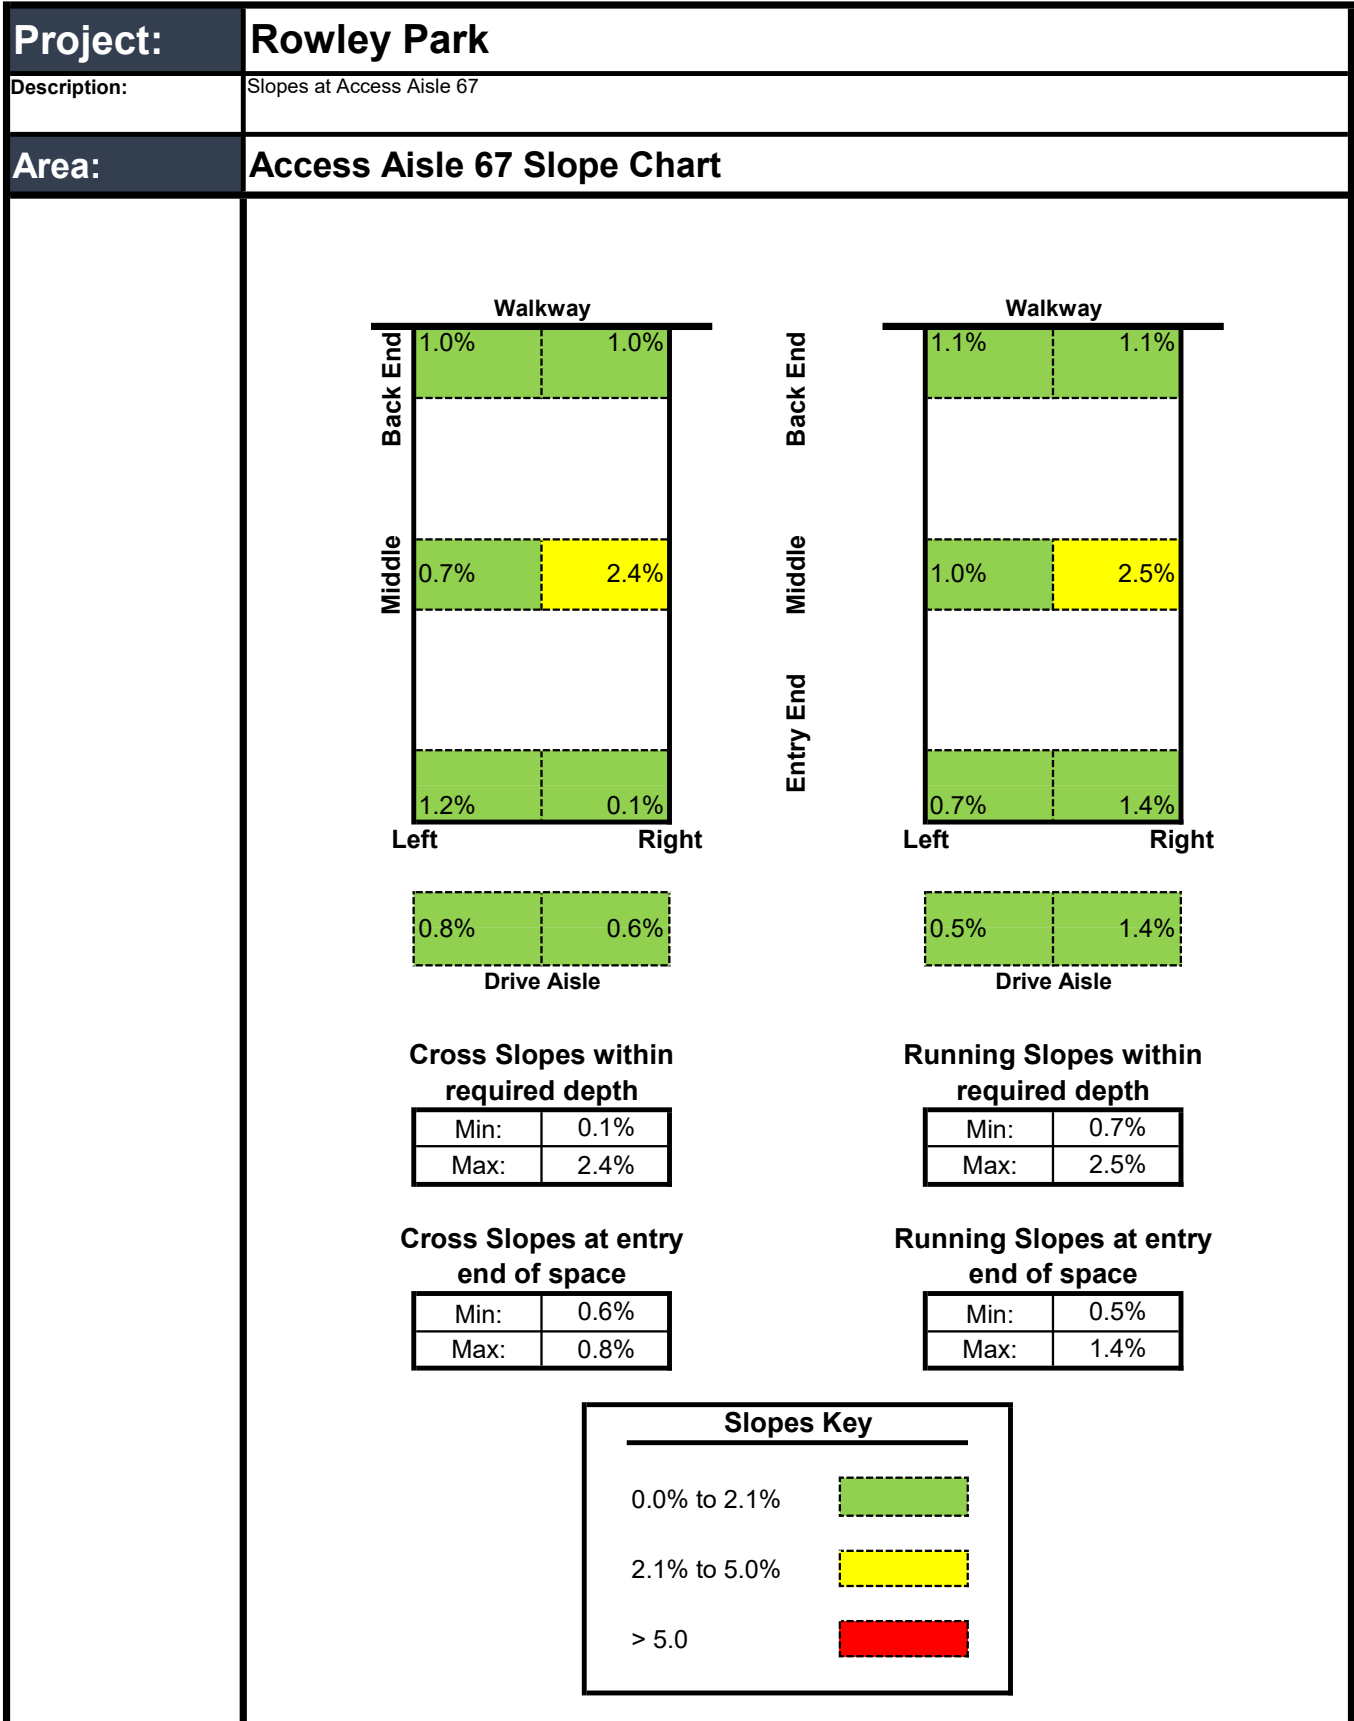
AISLE-67

Project: Rowley Park					
Item Observations in RED were observed to be non-compliant. Items Observations in PINK ITALICS were observed to be partially compliant or marginally non-compliant. Please see individual findings in report for specific details.					
Area:	AA67- Access Aisle 67				Code Cycle 2022
Description:	Access aisle between Parking Spaces 6 & 7				
MAJOR SUBJECT	MINOR SUBJECT	ITEM NO.	OBSERVATION	REQUIREMENT	CODE REFERENCE
Access Aisle	Connected to accessible route	AA67- 1.01	Aisle is connected to accessible route	Must be connected to accessible route	11B-502.3
	Parking space(s) served	AA67- 1.02	6 & 7	Informational	---
	Access aisle location	AA67- 1.03	Between spaces	Either side of standard space. Right side of van accessible	11B-502.3.4
	Are occupants required to pass behind other parked vehicles?	AA67- 1.04	No	Not permitted	11B-502.7.1
	Built-up ramp inside aisle?	AA67- 1.05	No	Not permitted	11B-502.4

Access aisle width	AA67- 1.06	5'-9"	Std Space: 60" Van Space: 96" Van Space: 60" if 12' wide parking space	11B-502.3.1
	Access aisle depth	AA67- 1.07	Full depth	Full length of adjacent stall	11B-502.3.1
	Paving condition	AA67- 1.08	Showing wear	Stable, firm and slip-resistant	11B-302.1
	Access aisle cross slope %	AA67- 1.09	Within Aisle: 0.8% to 3.5% Entry End: 1.1% to 1.4%	1:48 max. (2.1%)	11B-502.4 Exception 1
	Access aisle running slope %	AA67- 1.10	Within Aisle: 1.4% to 4.7% Entry End: 0.1% to 0.4%	1:48 max. (2.1%)	11B-502.5 Exception 1
	Access aisle border	AA67- 1.11	Showing slight wear	4" wide blue border on all sides of access aisle	11B-503.3
	<i>Access aisle diagonal hatching spacing</i>	<i>AA67- 1.12</i>	<i>36" to 37"</i>	<i>36" max o.c.</i>	<i>11B-502.3.3</i>
	"NO PARKING" at bottom of access aisle	AA67- 1.13	Text missing	12" high letters painted white	11B-502.3.3
	"NO PARKING" paint condition	AA67- 1.14	Text missing	Text must be legible	11B-502.3.3

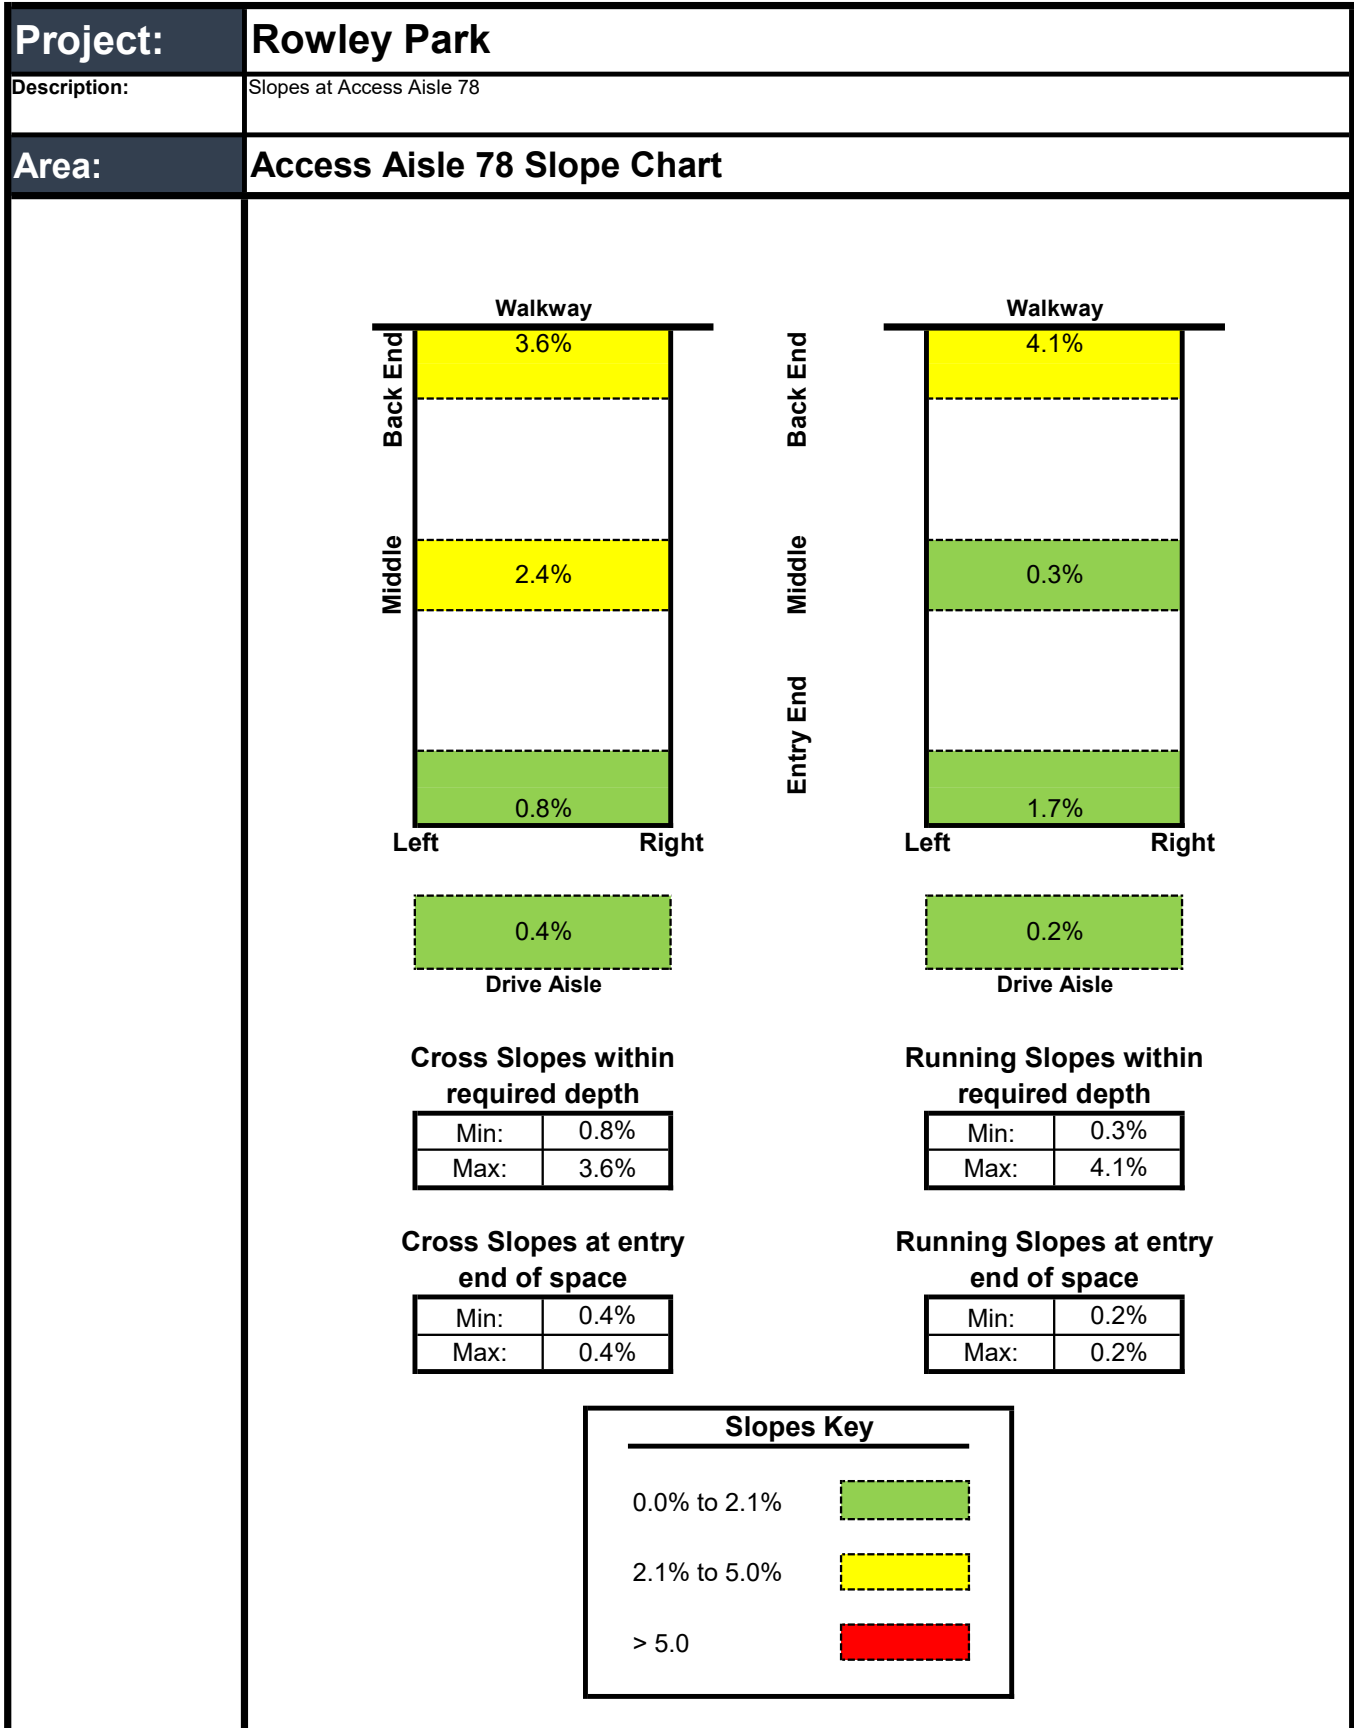
aisle-78

Project: Rowley Park					
Item Observations in RED were observed to be non-compliant. Items Observations in PINK ITALICS were observed to be partially compliant or marginally non-compliant. Please see individual findings in report for specific details.					
Area:	AA78- Access Aisle 78				Code Cycle 2022
Description:	Access aisle between Parking Spaces 7 & 8				
MAJOR SUBJECT	MINOR SUBJECT	ITEM NO.	OBSERVATION	REQUIREMENT	CODE REFERENCE
Access Aisle	Connected to accessible route	AA78- 1.01	Aisle is connected to accessible route	Must be connected to accessible route	11B-502.3
	Parking space(s) served	AA78- 1.02	6 & 7	Informational	---
	Access aisle location	AA78- 1.03	Between spaces	Either side of standard space. Right side of van accessible	11B-502.3.4
	Are occupants required to pass behind other parked vehicles?	AA78- 1.04	No	Not permitted	11B-502.7.1
	Built-up ramp inside aisle?	AA78- 1.05	No	Not permitted	11B-502.4

Access aisle width	AA78- 1.06	38"	Std Space: 60" Van Space: 96" Van Space: 60" if 12' wide parking space	11B-502.3.1
	Access aisle depth	AA78- 1.07	Full depth	Full length of adjacent stall	11B-502.3.1
	Paving condition	AA78- 1.08	Showing wear	Stable, firm and slip-resistant	11B-302.1
	Access aisle cross slope %	AA78- 1.09	Within Aisle: 0.8% to 3.6% Entry End: 0.4%	1:48 max. (2.1%)	11B-502.4 Exception 1
	Access aisle running slope %	AA78- 1.10	Within Aisle: 0.3% to 4.1% Entry End: 0.2%	1:48 max. (2.1%)	11B-502.5 Exception 1
	Access aisle border	AA78- 1.11	Showing slight wear	4" wide blue border on all sides of access aisle	11B-503.3
	Access aisle diagonal hatching spacing	AA78- 1.12	35" to 37"	36" max o.c.	11B-502.3.3
	"NO PARKING" at bottom of access aisle	AA78- 1.13	Text missing	12" high letters painted white	11B-502.3.3
	"NO PARKING" paint condition	AA78- 1.14	Text missing	Text must be legible	11B-502.3.3

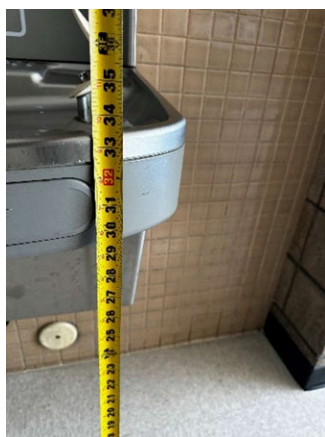
There is a single drinking fountain located in the lobby. There are minor corrections required for this drinking fountain. Primarily, the unit requires protection on either side of the unit. Ideally, a second higher unit should be installed to provide use for standing individuals.

Drinking Fountain

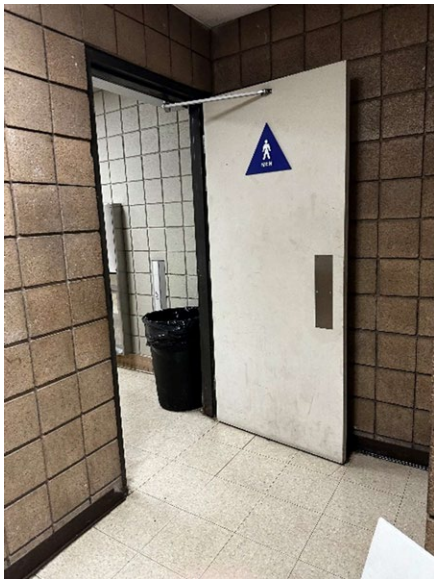
Men's Restroom Entry

- Install correct wall signage.
- Relocate geometric signage to exterior side of doors.
- Service automatic door openers (if they are to be used)
- Correct accessible lavatory heights.
- Wrap all pipes under lavatories.
- Adjust mirror heights (where applicable)
- Adjust lavatory accessory heights.
- Make necessary repairs to toilet compartment doors and hardware.
- Adjust toilet offsets from side wall.
- Adjust toilet grab bar locations.
- Relocate toilet paper dispensers to compliant locations.
- Adjust coat hook location (where applicable).

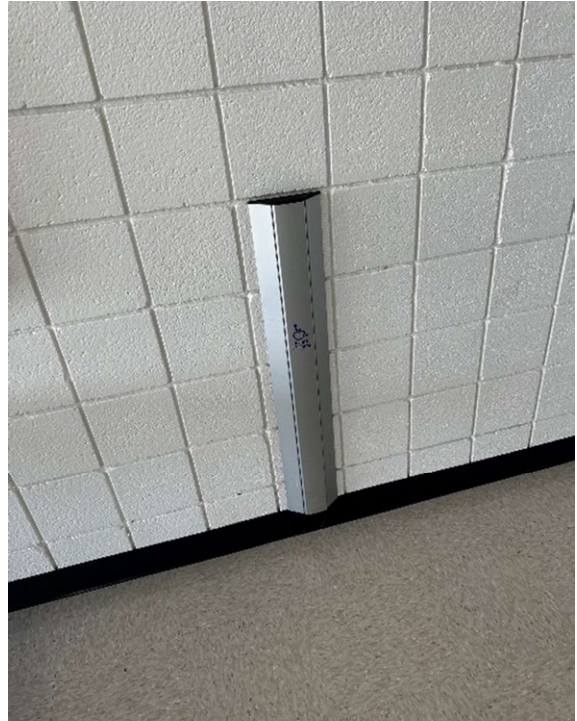
Automatic Operator
(non-functioning)

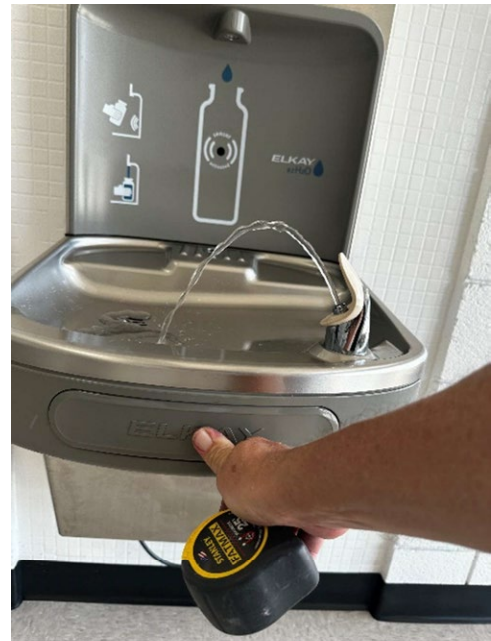
There is one drinking fountain/water bottle filling station within the lobby. There is no drinking fountain for standing individual. While there is full access within the lobby space, there is no required side protection on either side of the unit. Rails should be installed on either side to meet this requirement.

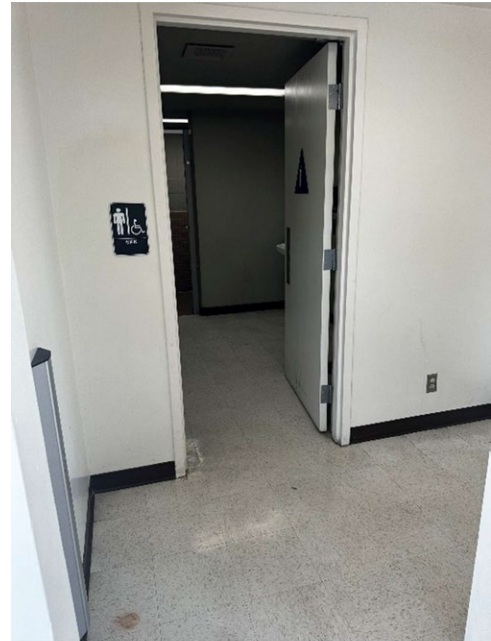
There are two separate gender-specific multiple occupant restrooms located at the front of the building near the lobby. Access into both restrooms is unimpeded. However, both restrooms are equipped with automatic door openers which were not operational at the time of the inspection. Testing of the door pressure and closing speeds was not possible. There are also several other non-compliant issues that should be addressed. One of the most significant issues to correct is the width of the accessible toilet compartments in both restrooms. Adjustment of the partitions may require significant redesigning of the restrooms.

Men's Restroom Entry

- Automatic Door Openers need to be repaired.
- Door signage at both restrooms require correction/relocation.
- Minor repair work at the accessible lavatories in both restrooms.
- Relocation of lavatory accessories to meet height requirements.
- Accessible toilet compartment door handles need to be installed.
- Modification of the accessible toilet compartment widths.
- Adjustment of the grab bar locations.
- Relocation of the toilet paper dispensers to below side grab bars with compliant offsets.
- Adjustment of coat hook locations.

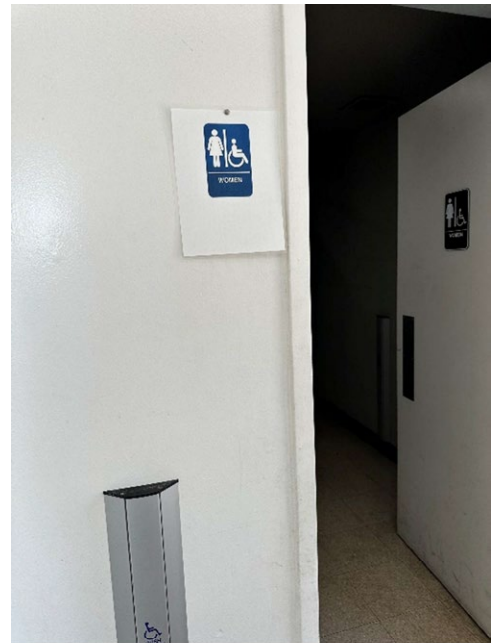
Women's Restroom Entry

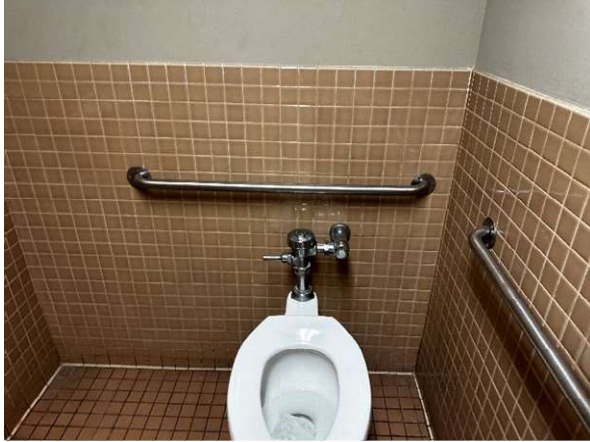
Men's Accessible Toilet Compartment
57.5" wide

Area:		RR1- Men's Restroom				Code Cycle 2022
Description:		Men's restroom adjacent to lobby				
MAJOR SUBJECT	MINOR SUBJECT	ITEM NO.	OBSERVATION	REQUIREMENT	CODE REFERENCE	
Accessible Water Closet Compartment	Compartment door width	RR1- 4.01	35.5"	34" min. at side entry	11B-604.8.1.2	
	Compartment door handle types	RR1- 4.02	Missing	Door pull on both sides of door	11B-604.8.1.2	
	Compartment door handle height (interior)	RR1- 4.03	Missing	34" to 44"	11B-404.2.7	
	Compartment door handle height (exterior)	RR1- 4.04	Missing	34" to 44"	11B-404.2.7	
	Compartment door self-closer	RR1- 4.05	Compliant	Self closer required	11B-604.8.1.2	
	Compartment door latch type & height	RR1- 4.06	Lock at 41"	Operable with no tight grasping, pinching, twisting of wrist. 48" high max.	11B-404.2.7	
	Compartment width	RR1- 4.07	57.5"	60" min. with 12" vertical clearance on one side. 66" min. with full height walls.	11B-604.3

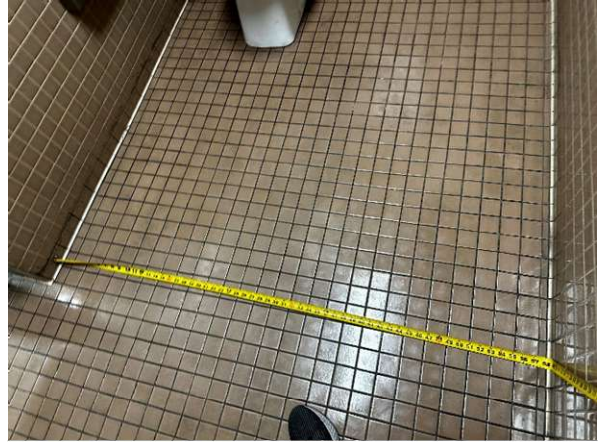
Women's Accessible Toilet Compartment
58" wide

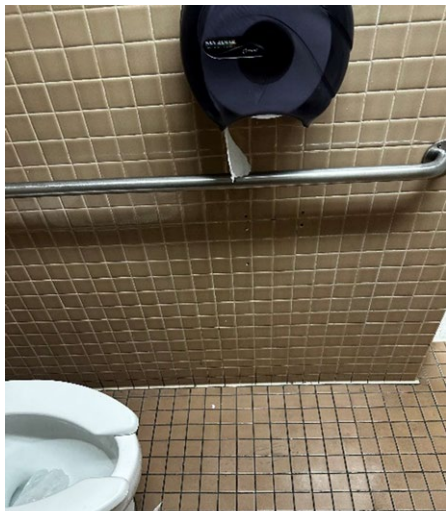
Men's Toilet Paper Dispenser
(wrong location)

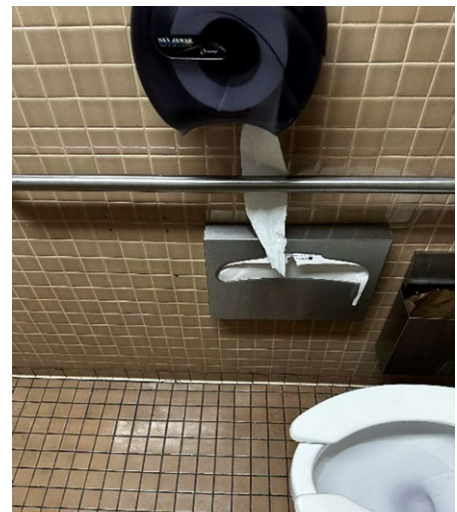
Women's Toilet Paper Dispenser
(wrong location)

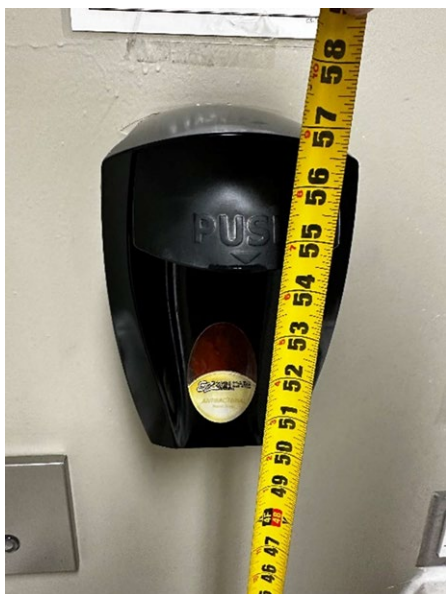
Men's non-compliant dispenser height

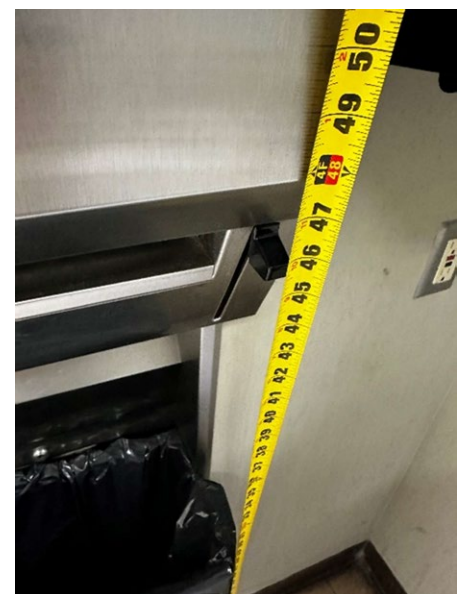
Women's non-compliant dispenser height

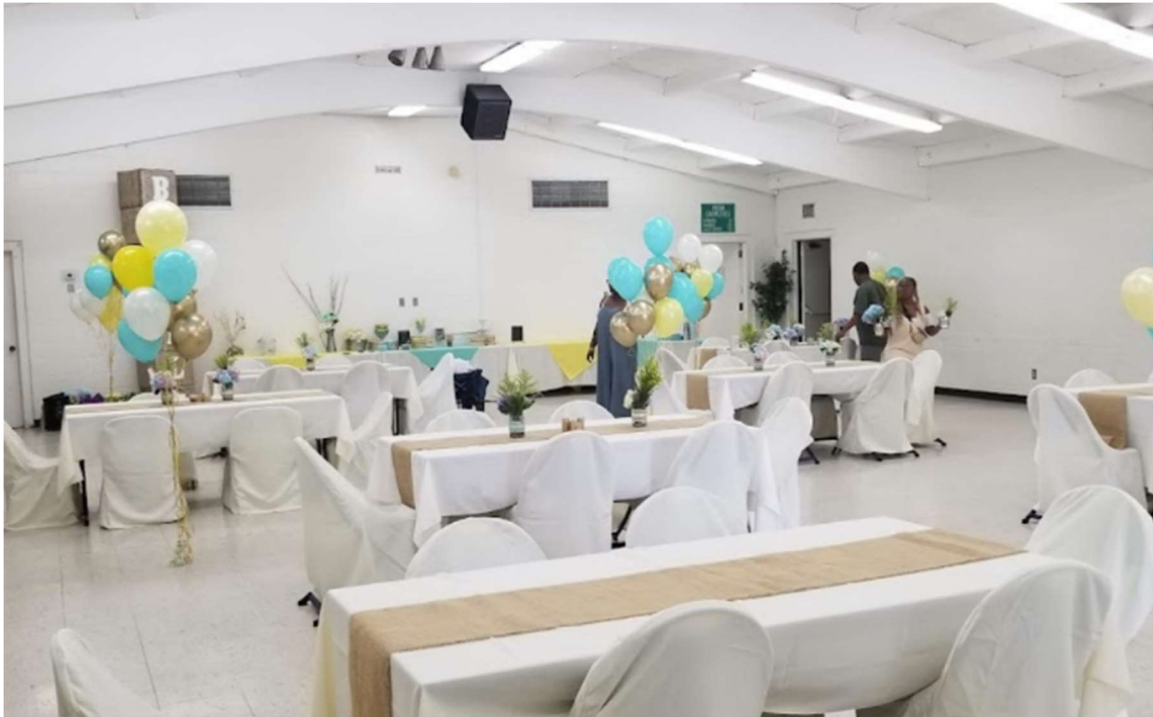
Recreation Center Meeting Room

There is one large community room in the building. It is accessed through a double door entry with automatic operators. These operators were non-functional at the time of the inspection (see above). The room has no fixed furniture, allowing multiple configurations. The entire space is level and provides full accessibility and requires no accessibility modifications.
