City of Gardena

SEWER MASTER PLAN

FINAL | September 2023

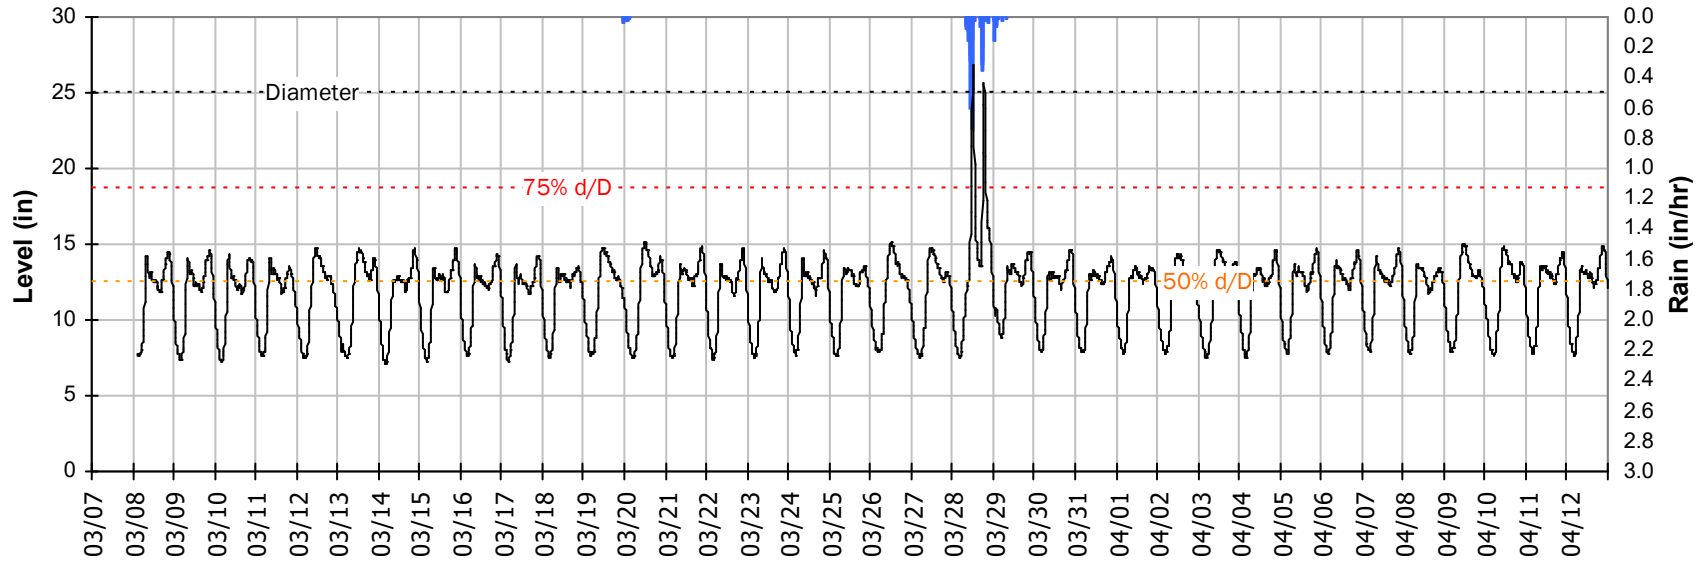
SITE 13

Pipe Diameter: 25 inches
 Peak Measured Level: 26.8 inches
 Peak d/D Ratio: 1.07

Surcharged 1.8 inches over crown

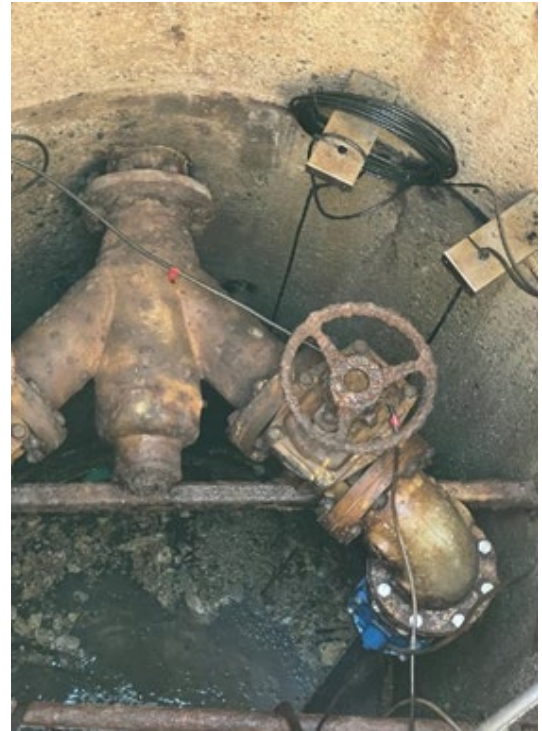
Image B

- The pumps and motors are two years old and are in good operating condition. The City has not had any previous capacity issues here.
- Wet well storage capacity appears to be sufficient to prevent excessive pump cycling.
- It was not possible to see the condition of all mechanical equipment within the wet well to confirm if corrosion was present (See Figure 1.8).

Figure 1.8 Buildup on Piping and Equipment
